# 10 True Case Histories Of Electronics Equipment Repair

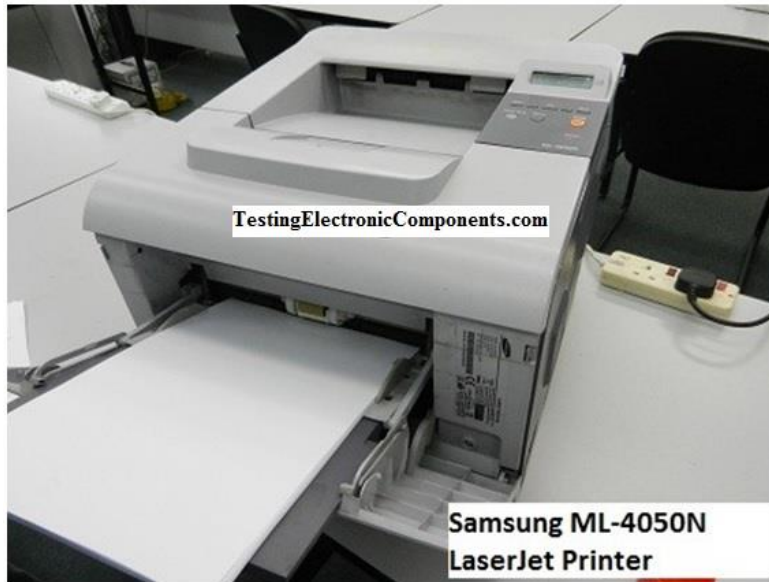
The complaint of this printer was no power and in order to see the circuit board, one has to remove the cover. It was not easy to dismantle the cover. Remember to use a digital camera to take some photos. If you have a hard time putting the cover back, you can always refer to the photos you have taken. This will simplify your job.

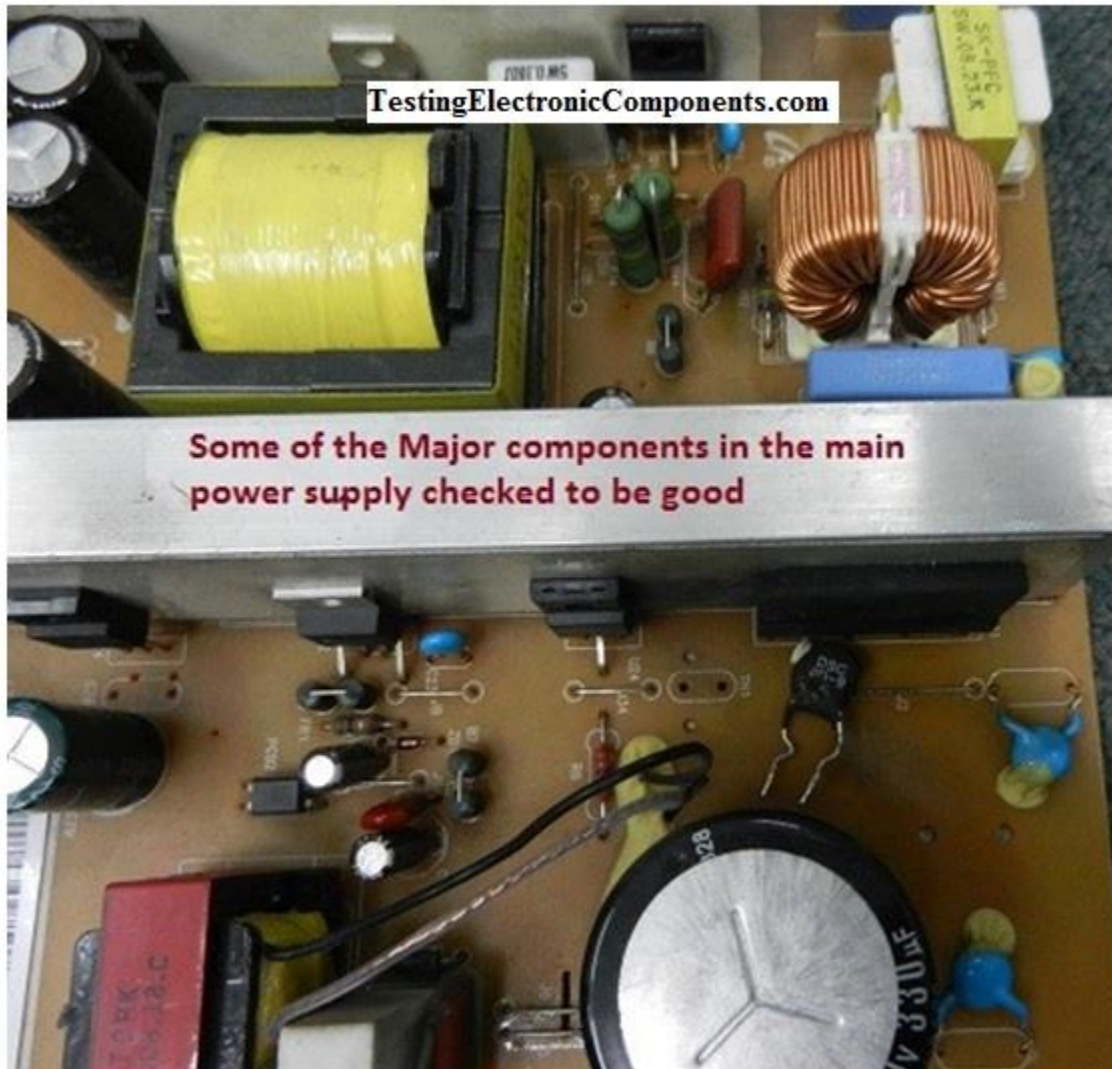
A good Thermistor when testing it with an Ohm meter it should show low Ohms reading (between 3 to 30 Ohms). This particular Thermistor does not show any reading which means it is already open circuit. Please take note on this- whenever you found a burnt or open circuit Thermistor, you need to

check the corresponding components as well. The main fuse did not blow does not mean other power semiconductors are good.

In my case, I did checked on the power FET, primary winding of the transformer and secondary diodes and all of these components were tested good. I'd also put special attention on the SMD power IC (next page) to see if there is any tiny burnt mark on the surface of the IC with the help of my X35 magnifying glass. Well, the SMD IC and the surrounding SMD components were in good condition too.

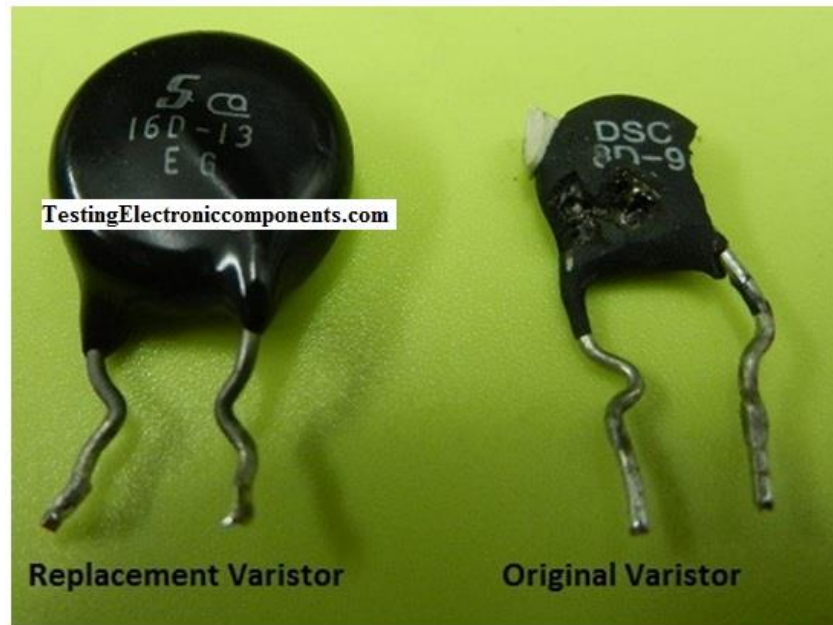
I concluded that only the Thermistor having problem and I believe by replacing only the Thermistor could solve the problem. The question now is where to find the exact replacement since I could not trace the original part number datasheet? I left only two choices-either just connect a wire across it or use a replacement number. For your information if you use a wire as a replacement, then the power supply no longer have protection against inrush current. In the future if there is any excessive inrush current, many of the primary side components will be badly affected.

Since my store room has some junk Laserjet power boards, I took out a good Thermistor and used it as a replacement. My expectation was correct; the Laserjet came back to life once the AC power is applied. For your information, you need to turn On and Off the power many times to see if the replacement component is stable or not. If the replacement component has a too low spec then it may blow again. So, the best is to try On/Off the power supply many times before sending it back to your customer.

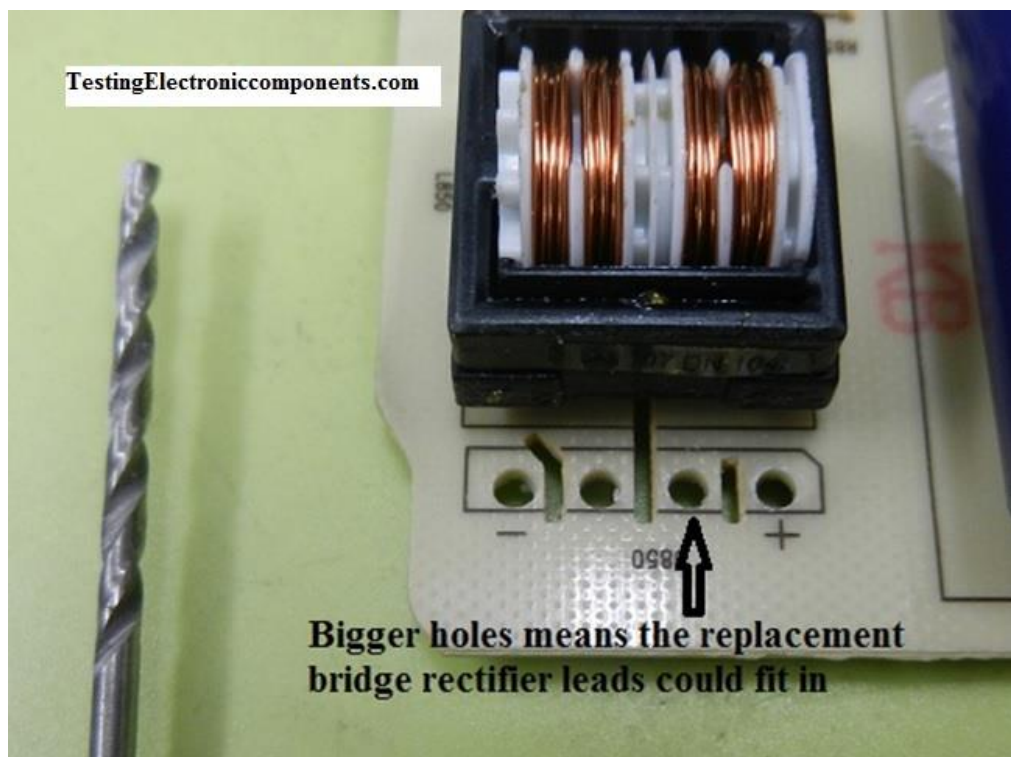
The problem now was that the replacement bridge rectifier 4 leads (legs) were much bigger than the original one thus it can't be fitted into the original holes. I had to use a power drill with the right drill bit to make the holes bigger as seen from the photo below:

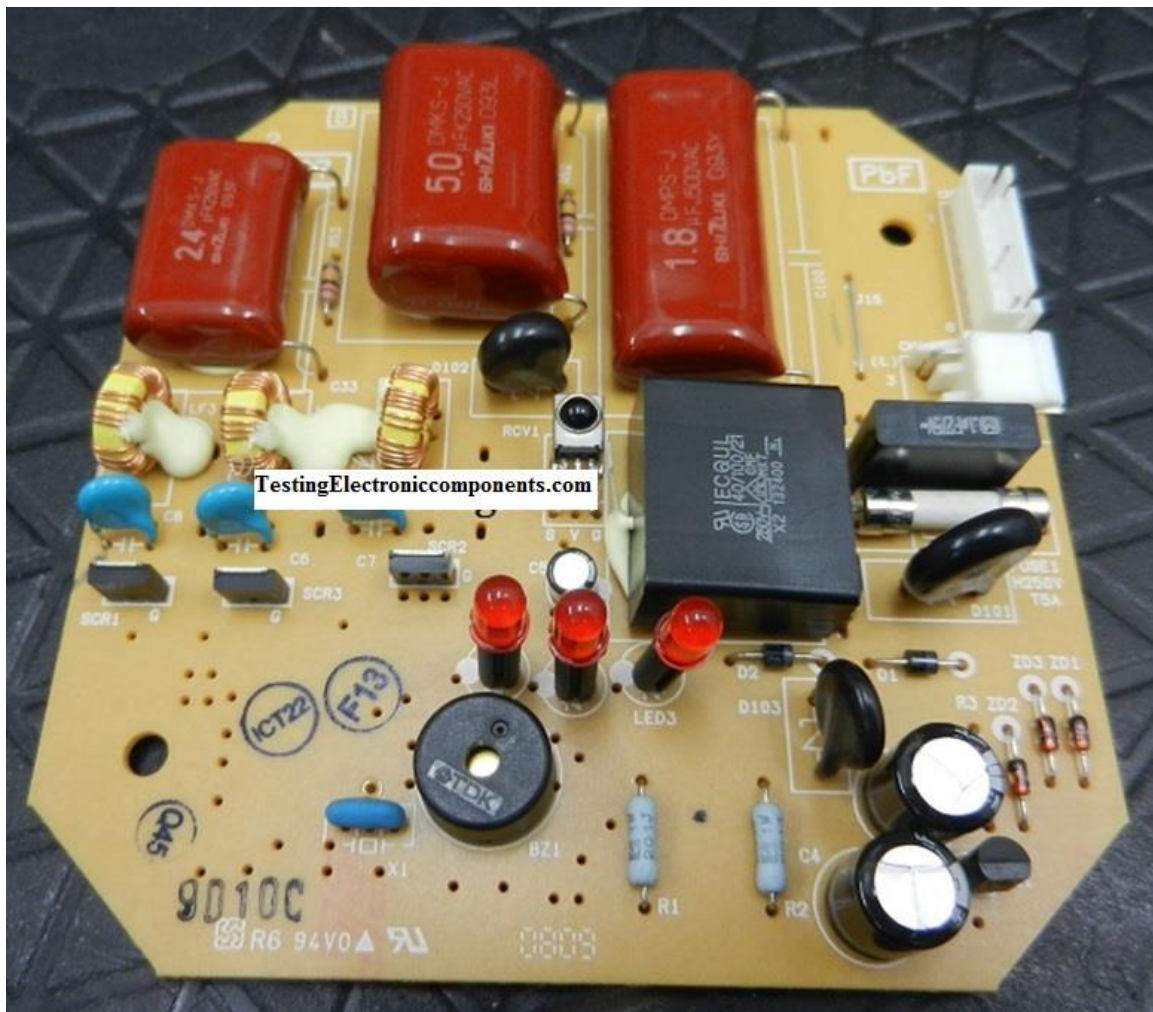
A friend of mine brought to me his friend's ceiling fan circuit board for repair. The complaint was no response when the remote control was pressed. He did not suspect the remote control because he could use that remote control to turn on another similar fan. The first thing I did was to look at the board and see if there is any burnt component and dry joints. There were no burnt components and dry joints.

Since I do not have the complete fan with me to hook up for testing, the only thing that I can do is to check some of the suspected components like fuse, capacitors, diodes and transistors. The first component I checked was the main fuse and it was fine. The next component was the big black square capacitor. To my surprise the capacitance value was way out.

After the replacement of the capacitor was done, I gave it back to my friend. He then sent it back to his friend and fixed it- the fan worked like a charm.

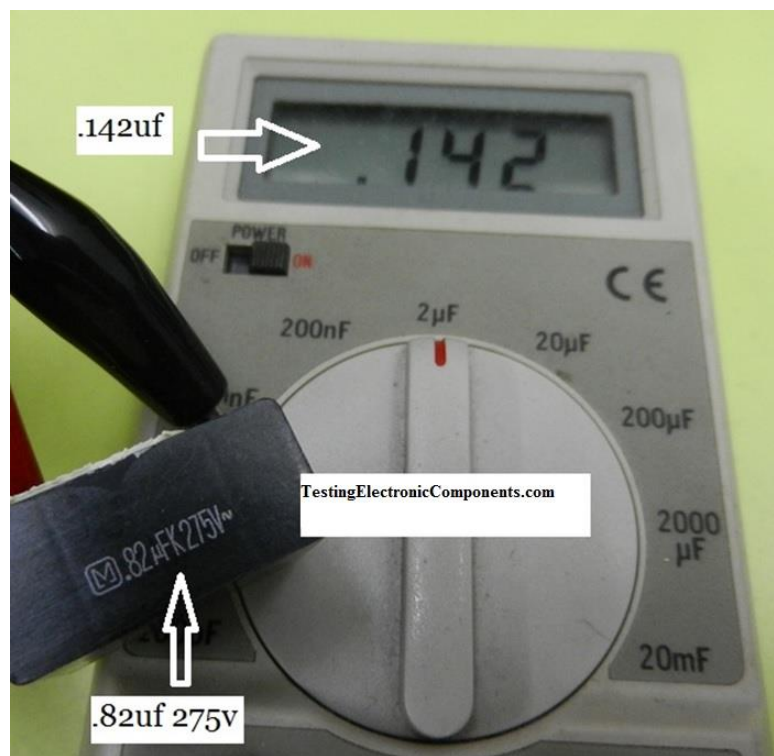
It was a .82uf 275v capacitor and it measured only .142uf (see the photo below).

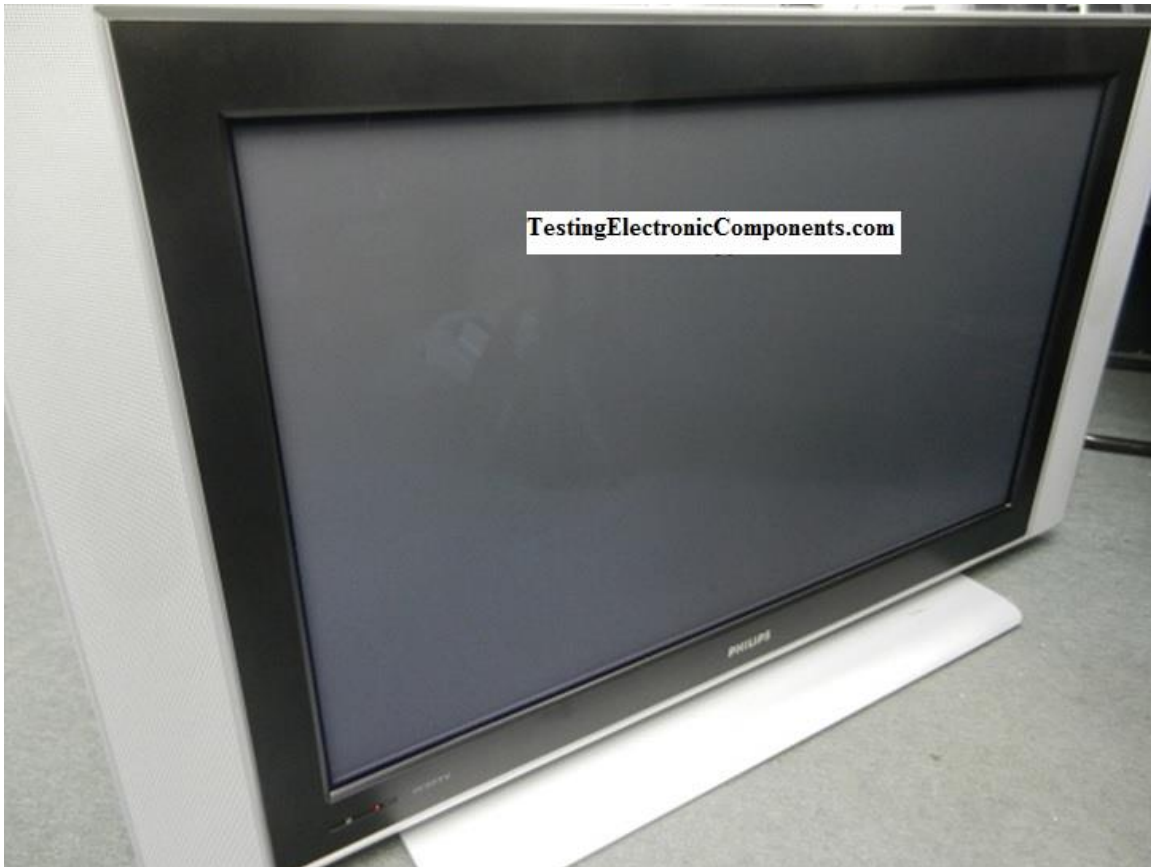
It was an older model of Philips 42" plasma TV with the model of 42PF7320/98. The complaint was the power green light would automatically switched back to red light after you have pressed on the power button in the remote control. There was no display.

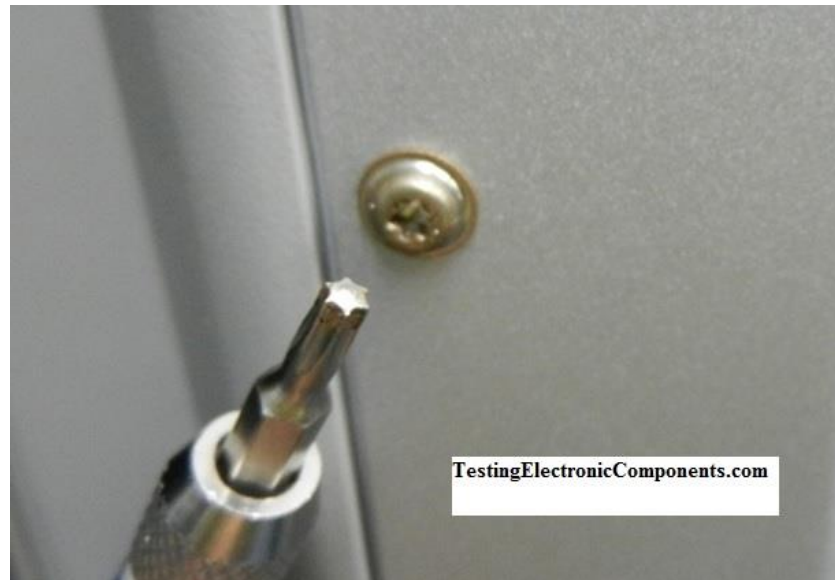
The first thing to do is to remove the tons of special screws (you need a 6 point star tip screw driver) that secured the back cover.

It took me a while to remove all the screws and the big metal cover.

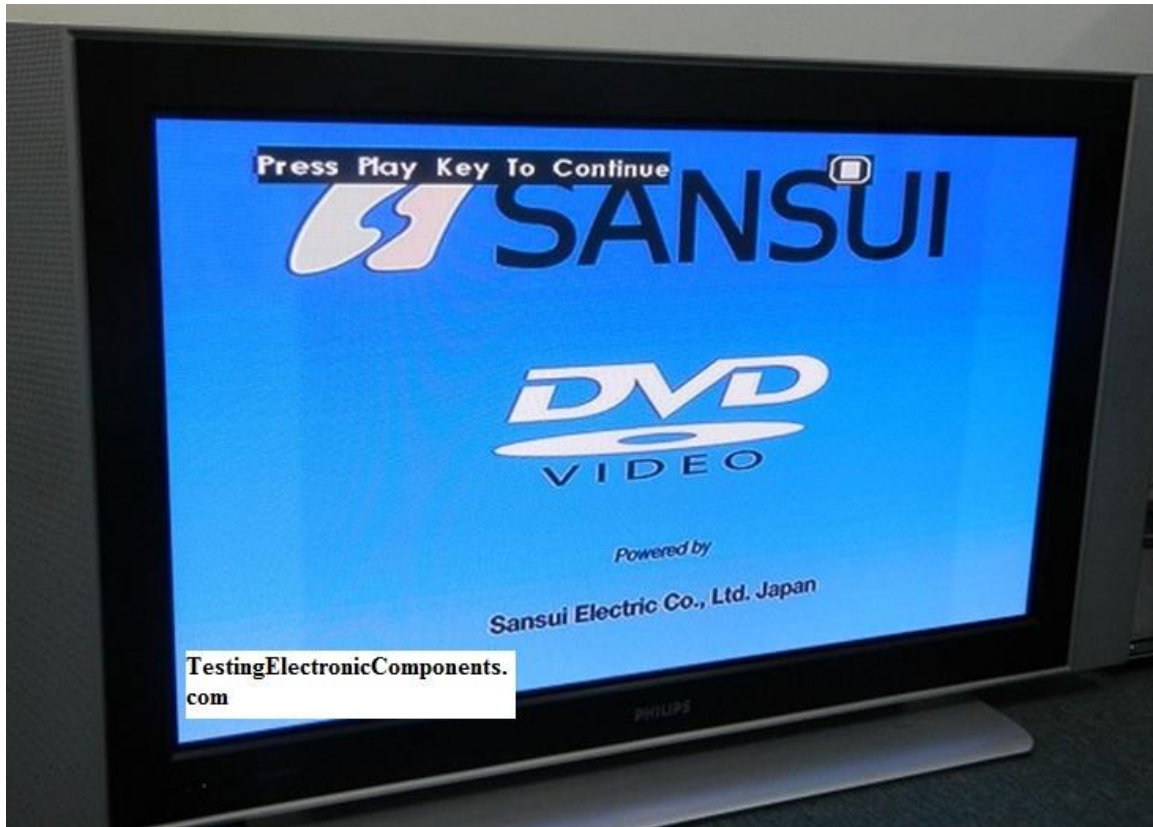
This could be the reason why the power LED light will switched back to red once it turned green. The ripple from the DC line could have cause the mainboard to malfunction. With the replacement of only 2 e-caps (cost less than 1 USD) the Plasma TV was brought back to life again.

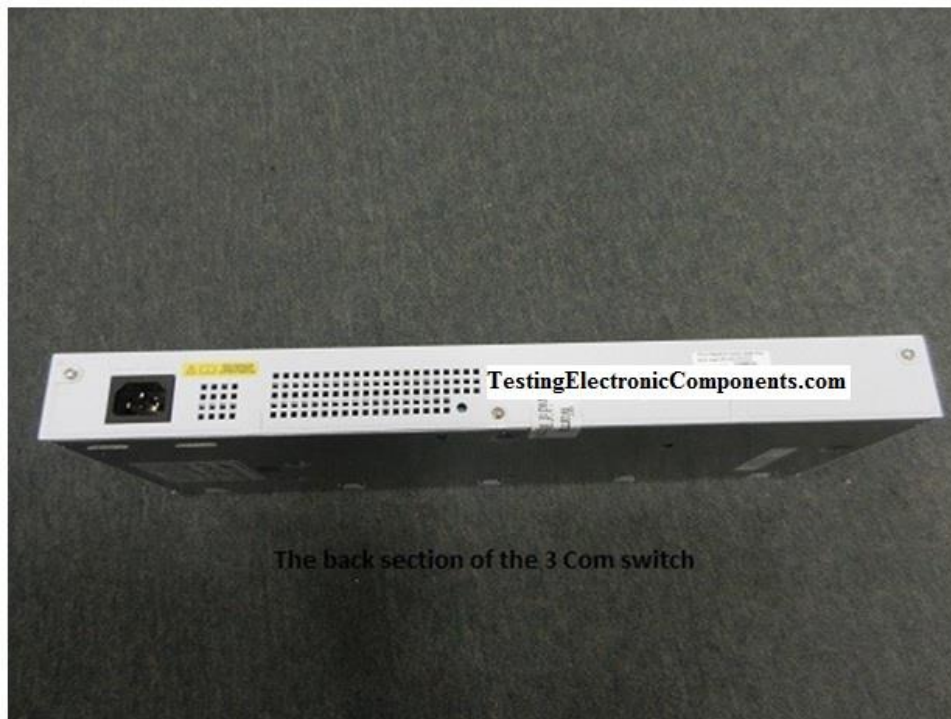
The back section of the 3 Com switch

Once the cover was removed I could see two boards i.e. the mainboard and the switch mode power supply board. Testing the power supply output connector with power on confirmed that the power supply have problem because the voltmeter reads zero volt on the output lines. By right it should have 5 and 3.3 volt outputs.

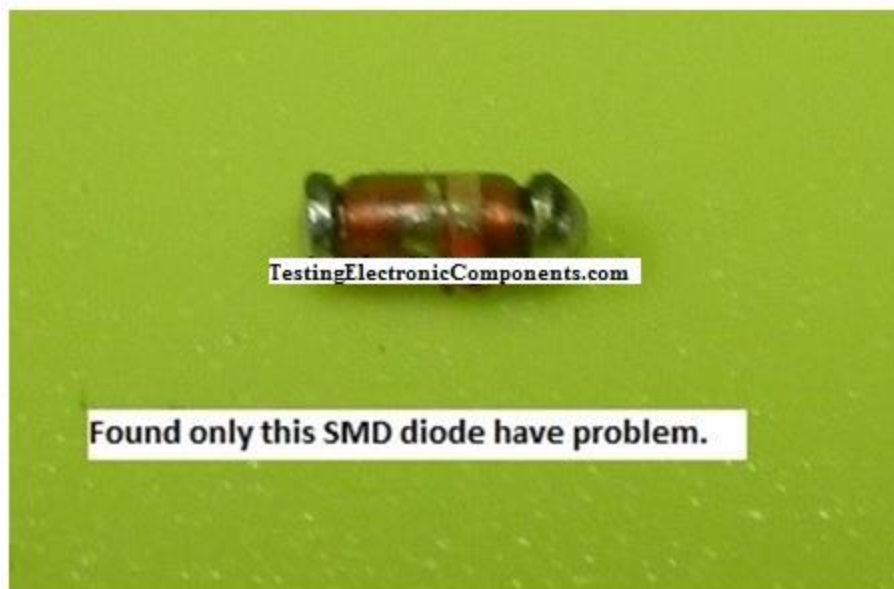
The last step was to check on the SMD diodes. True enough there was a SMD diode (board location D2) that has shorted under analogue meter x 10 k Ohm range. It had two low readings either way.

Note: This diode was tested good under x 1 Ohm range. When you check on the SMD resistors, diodes and non-polar caps, make sure you test it off board and not onboard. On board will produce misleading result thus it is not recommended.

For your information I do not have data for the below diode. Since this is a SMD diode, I used a normal signal diode 1N4148 as replacement. It turned out to be working well after running the set for few days. The supply voltage to the SMD power IC now is 10.9volt.

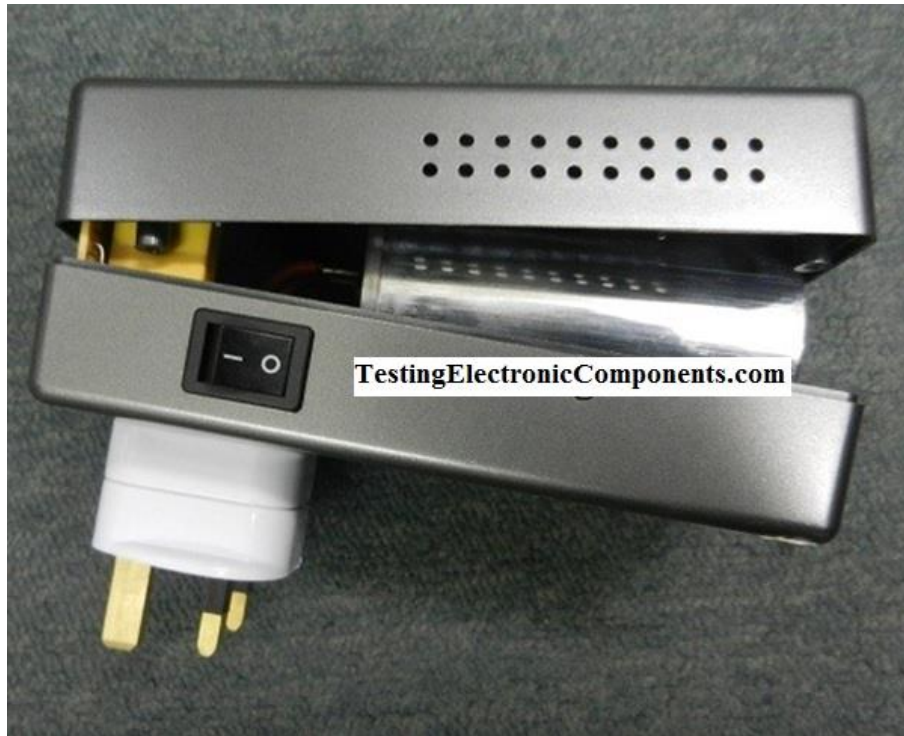
Once the cover was removed, the first thing I saw was the big silver capacitor.

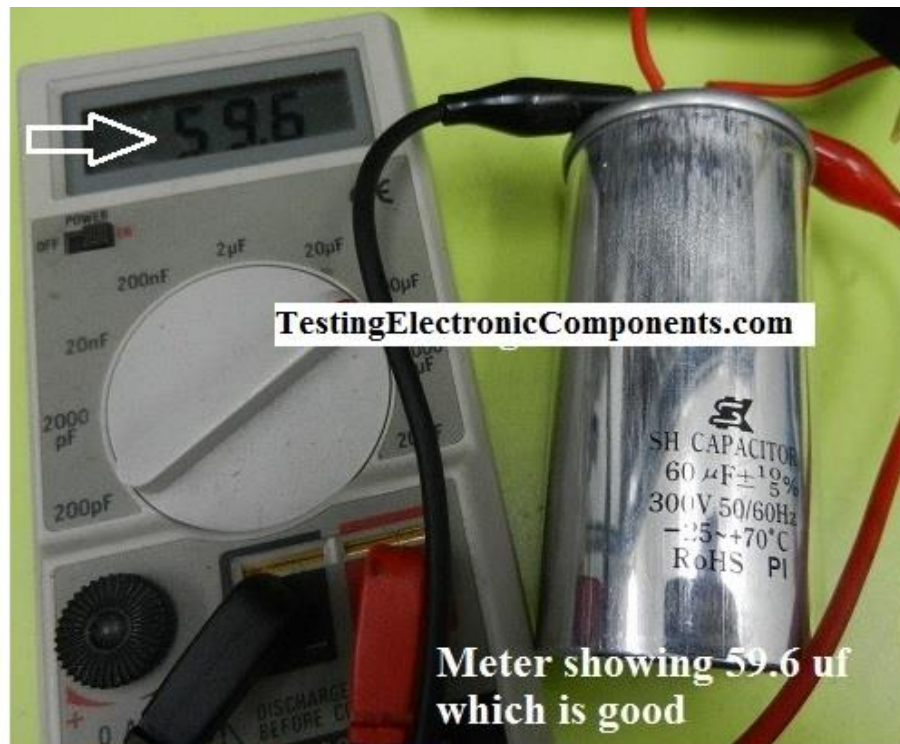
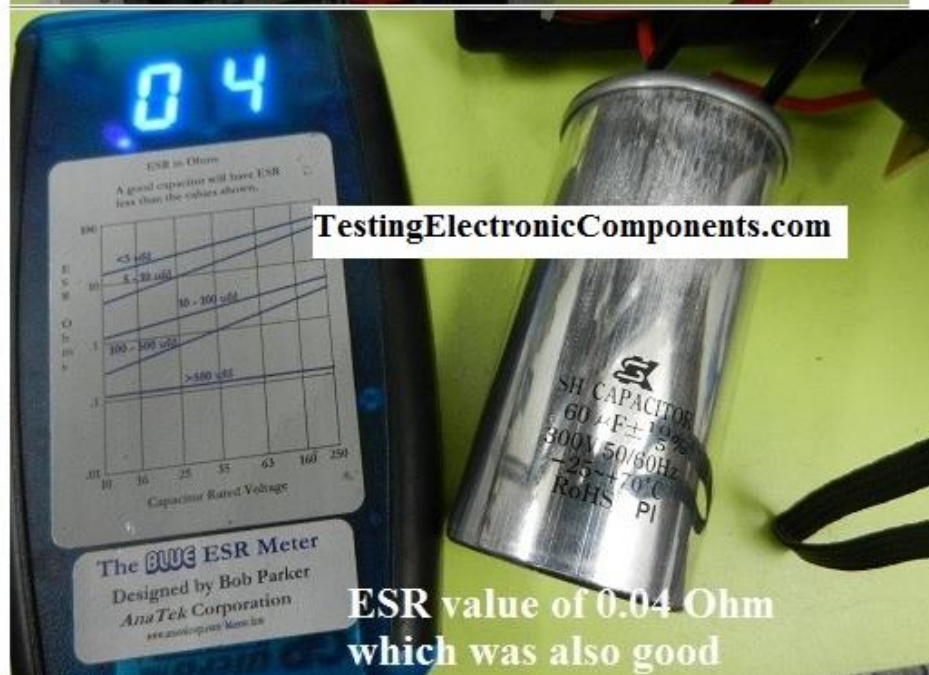
In order to be in the safe side, the big capacitor had to be checked first and I found there was no charge in when measuring it using my dc voltmeter. I tested the capacitance value of this big capacitor with a digital capacitance meter and [Blue ESR meter](#). Take a look at the photos below:

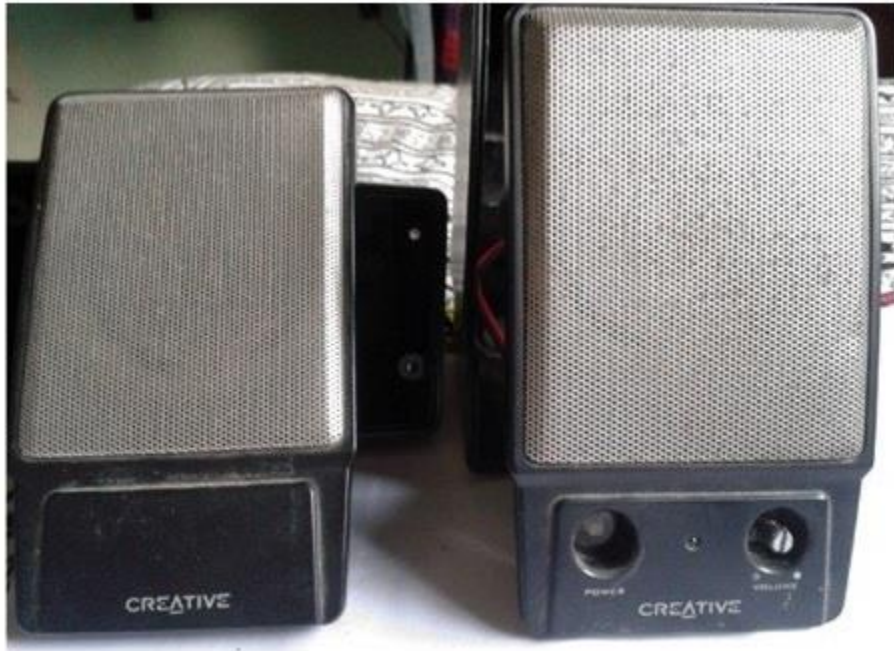
One of my customers sent to me his computer speakers with the complaint of no sound in one side. I tested the computer speaker and indeed the left speaker does not produce any sound.

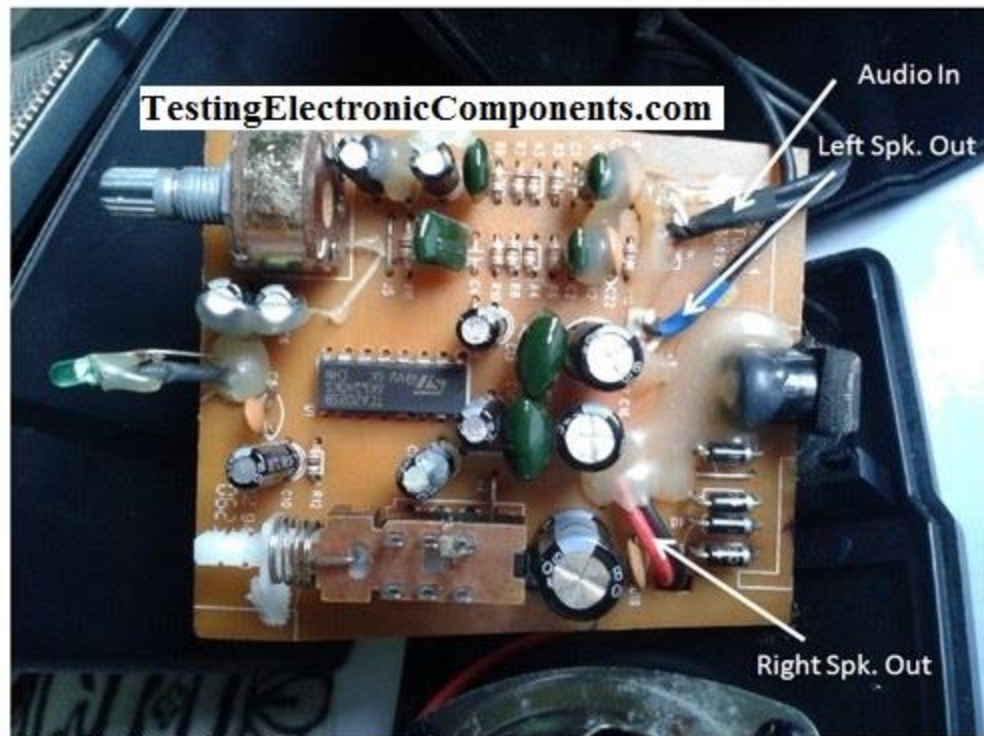
The troubleshooting begins by comparing (sight) the components between the right and the left channel (speaker circuit). All of the components seem to be in good condition. This led me to check the components in the left speaker circuitry.

When I placed my meter probe between point A and ground (previous page schematic 1) the Ohmmeter buzzer sound indicated short circuit. It can be shorted components or the IC. I removed all the corresponding components and found that the short circuit was still present. I then removed pin 2 of the IC and the short circuit gone and the buzzer was silent. When I soldered back pin 2 and powered On the IC, it was quite hot. I should have test the IC first with my finger. A replacement of new IC solved the no sound problem in the left speaker.

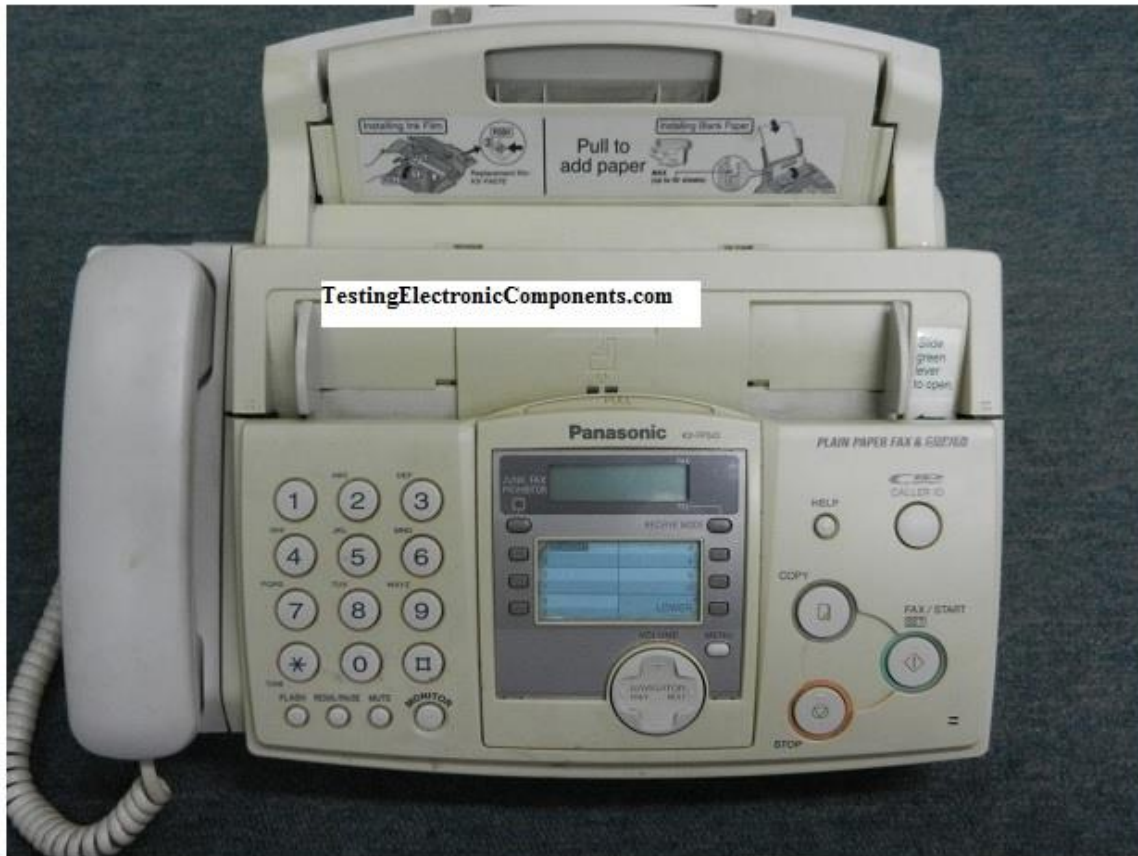
One of my customers sent me a Panasonic Fax machine (Model: KX-FP343ML) and the complaint was no power. In order to see the power supply, one has to remove the cover located at the bottom of the machine. Few screws removed and you could see all the circuit boards and power supply inside as seen from the photo in the next page:

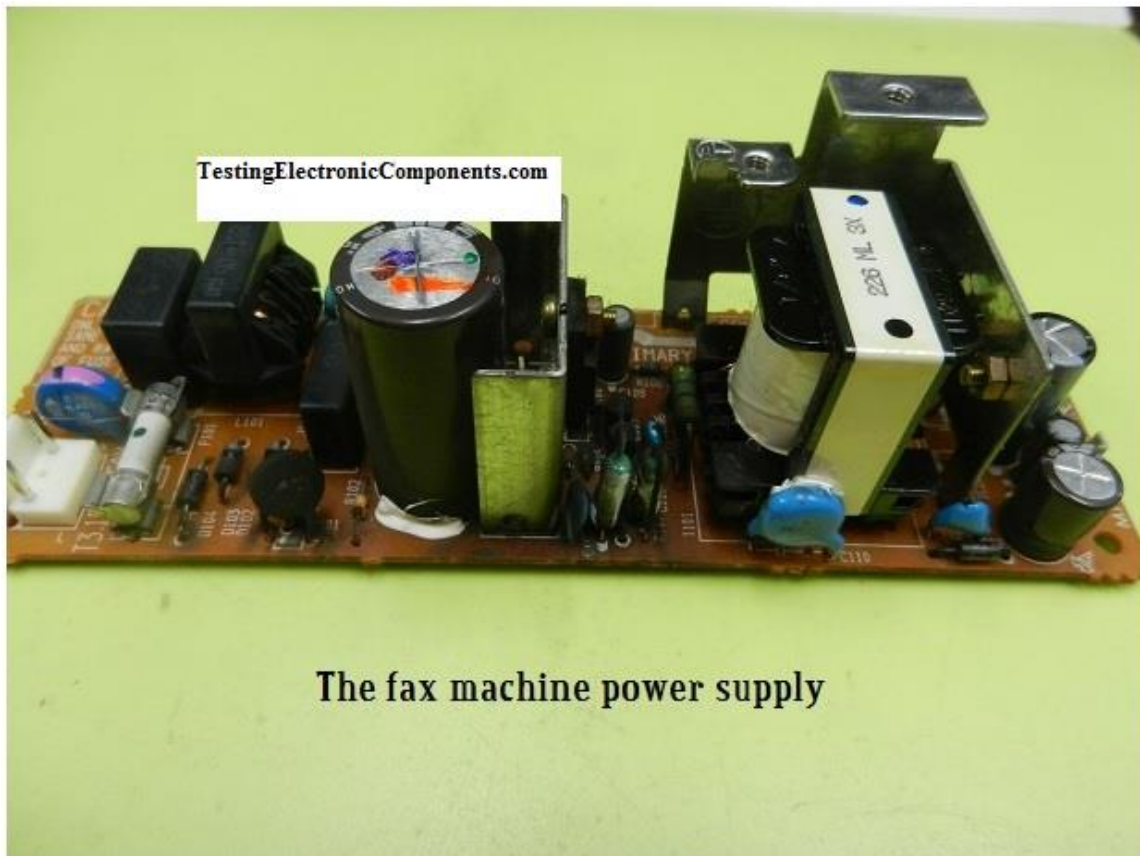
The first component I checked was the main fuse and I found it had open circuit. When a fuse have problem it could mean the fuse can break by itself after serving for few years or there are some shorted components causing the fuse to blow. I proceeded to check on some of the major components in the power primary side like the Thermistor,Varistor, bridge rectifier diodes and power FET.

The two diodes that were shorted had a part number of 1N4005 and I replaced all the four diodes with 1N4007 which have a higher voltage but same ampere. For your information you can replace diodes with the same or higher voltage and ampere but not lower. The reason I replaced the other two working diodes is because somehow I believe the other two working diodes will break down again in a short time. I have experienced this before and this is why you need to replace all the four diodes (even if you found one of the four diodes have problem) if you don't want repeated call from your customer. A repeated call means a loss in your repair time. The fax machine was back in working condition after the diodes and the fuse were replaced.

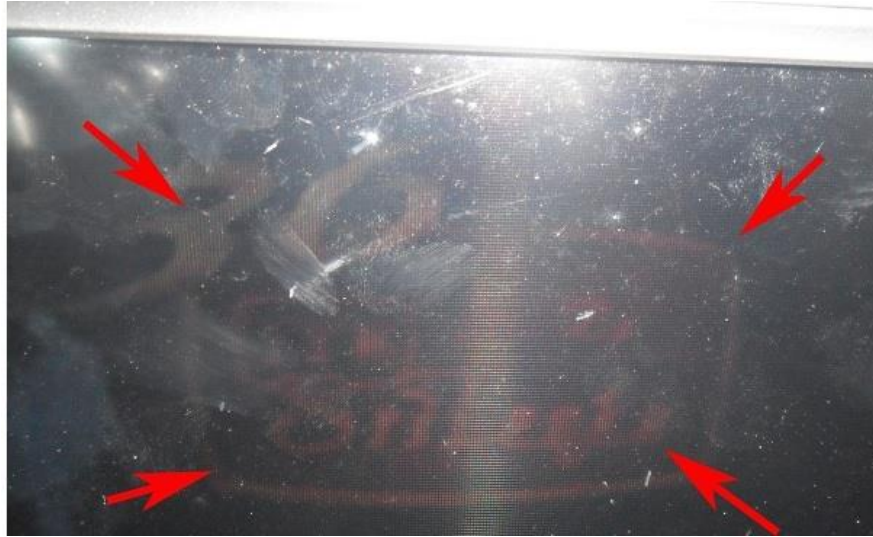
The cause of this problem was the LED backlight circuit not functioning-see the photo in the next page:

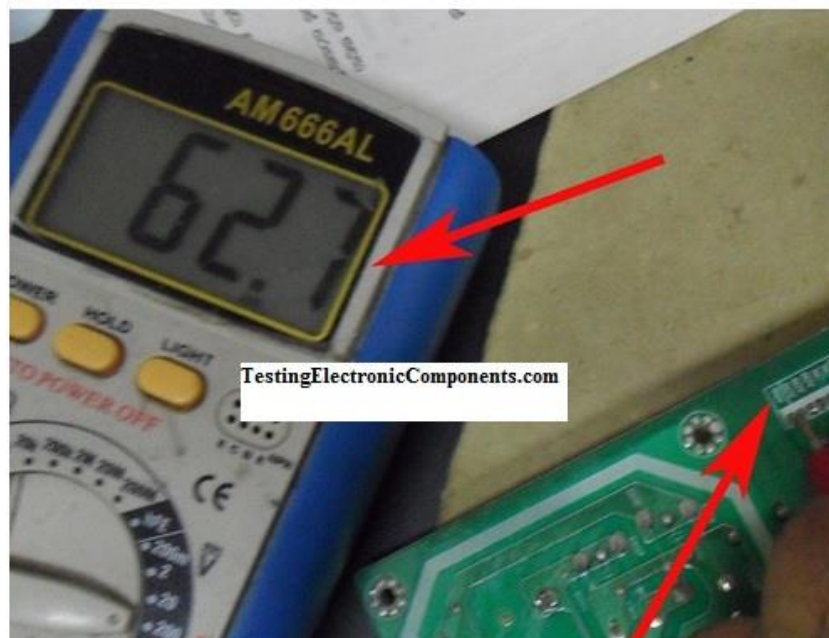
After the installation of the diode, I powered On the LED TV and as expected, I've got 62.7 volt at the LED backlight connector.

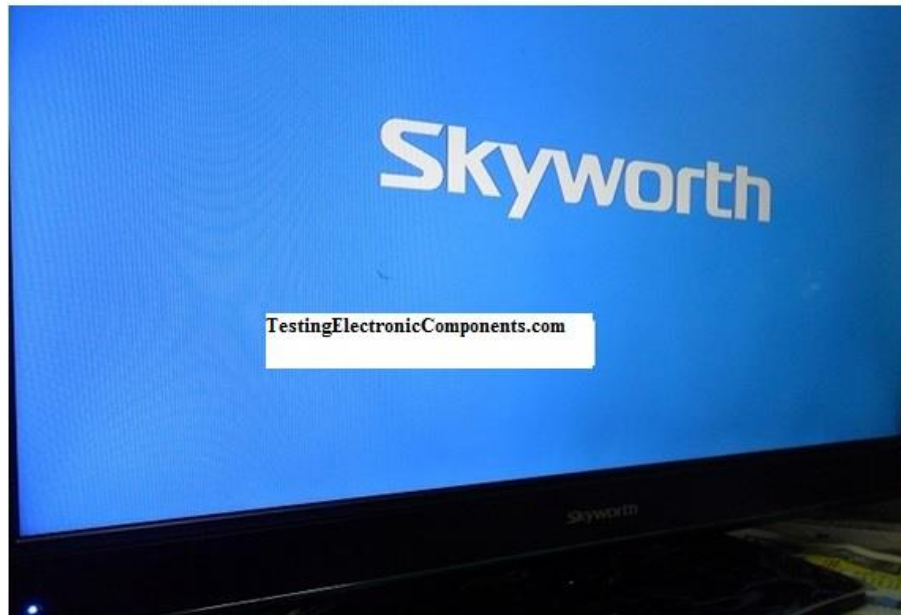
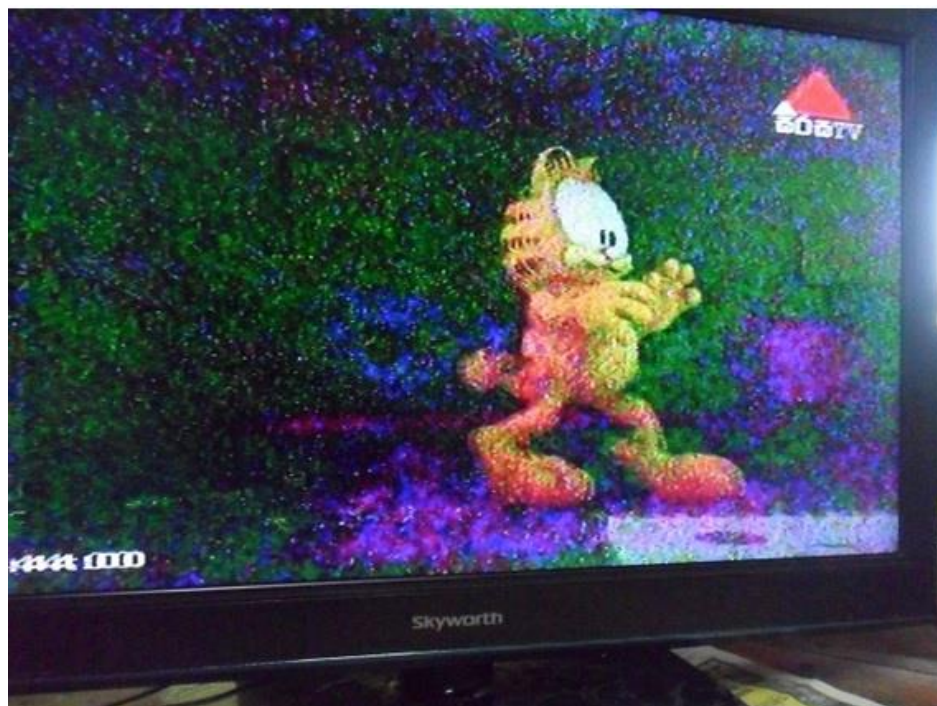
The below two pictures is what I saw when everything were put back to normal. Another job was done and made some profits from this repair. If you wish to learn how to repair LCD/LED TV fast you can check out John's ebook [Here](#) and Kent's ebook [Here](#).
