LKB-ADDs, Plus Schematic

DDQ12/LA1901 Schematic with Capture CIS and Function field
uFCPGA Banias
01-02-2004
REV: 3.0

Title		
Cover Sheet		
Size	Document Number	Rev
	DDQ12/11/01 with LA-1901	3.0
Date:	Wednesday, January 07, 2004	Sheet 1 of 59

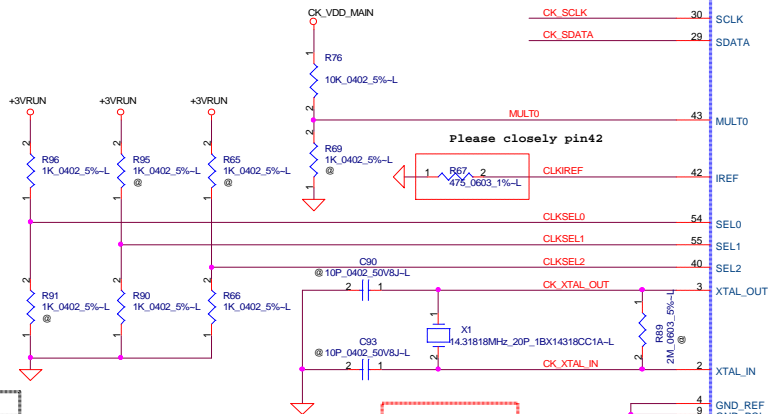
Place crystal within
500 mils of CK408

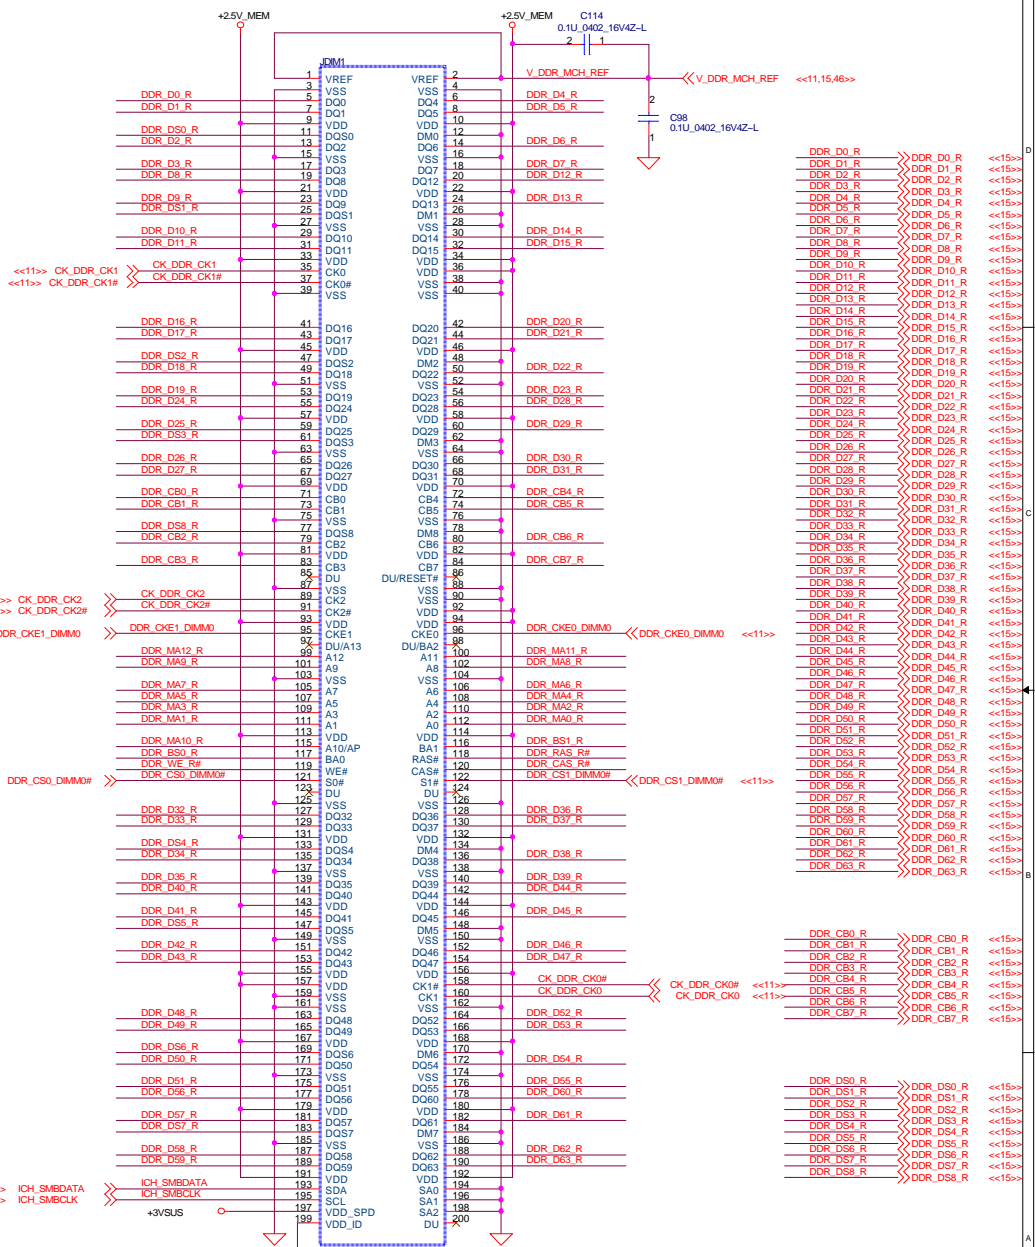
Title			
DDR-SODIMM SLOT1			
Size	Document Number	Rev	
	DDQ12/1/01 with LA-1901	3.0	
Date:	Wednesday, January 07, 2004	Sheet	14 of 59

Layout Note:
 Place these resistor
 closely DIMM0,all
 trace length<750 mil

Layout Note:
 Place these resistor
 closely DIMM0,all
 trace length
 Max=1.3"

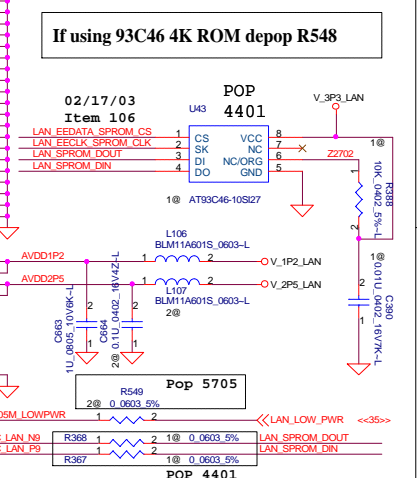
Compal Electronics, Inc.	
ETHERNET	
File	Document Number
Size	DDQ12/11/01 with LA-1901
Date:	Wednesday, January 07, 2004
Page	27 of 59

R318
for 4401 : 1.18K
for 5705M : 1.15K

Item	Page#	Title	Date	Request Owner	Issue Description	Solution Description	Rev.
106	27	LOM	02/11/2003	Dell	Added 4401 Optional Circuit	Added U43, R367, R368, R388, C390 (1@)	X00
107	25	USB 2.0	02/11/2003	Compal	DH_PWRSRC_OC Pull-Down for L2	Added R403 (1@)	X00
108	25	USB/DH	02/11/2003	Dell	Added TPS2042 to Replace TPS2043 for Lindbergh2	Added U70 (1@)	X00
109	34	SIO	02/12/2003	Compal	PR65 Has Wrong Naming Rule and Have to Rename to R405	Deleted PR65 Added R405	X00
110	27	LOM	02/18/2003	Dell	Need to Add Pin A7 with Bead for +3VRUN and +V_3P3_LAN	Added L109(1@), L110(2@)	X00
111	28	Magnetic	03/11/2003	Compal	LAN Analog Switch Pin 14 Changed to NC	U30	X00
112	25	USB/DH	03/18/2003	Dell	put the pads for zero ohms pop options for L21, L22 , L23, L28, L41, L13 common mode choke.	Added R348-R359 (@)	X00
113	27	LOM	03/18/2003	Dell	1K for 4401 and 4.7K for 5705M [Overlap with R317(2@)]	Added R317 (1@)	X00
114	20	ICH4M	03/18/2003	Compal	Board ID X00 (LBK-Adds)	Pop R267, R281, R279, R287 Depop R286, R278, R280, R266	X00

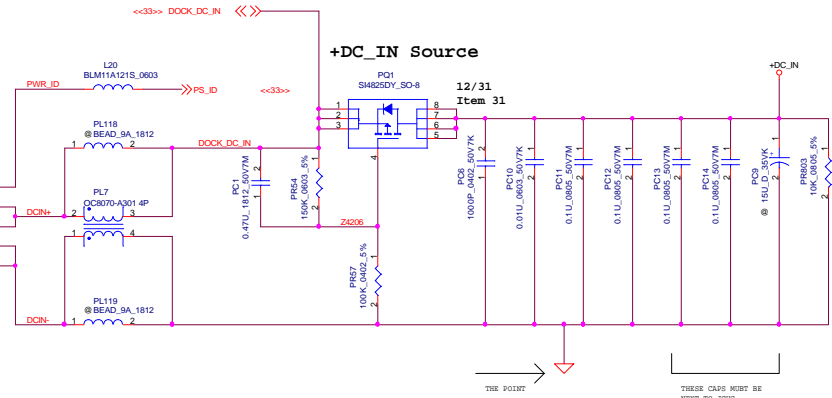
Z-series AC Adaptor Connector

NOTE: *THE POINT LOCATED AT PS MODULE
