Kapalua Schematic

BDQ11/LA1601 Schematic with Capture CIS and Function field
uFCPGA Banias
02-12-2003
REV: 0.5

Title Cover Sheet		
Size	Document Number BDQ11/LA-1601	Rev 0.5
Date: 星期三, 二月 12, 2003	Sheet 1	of 56

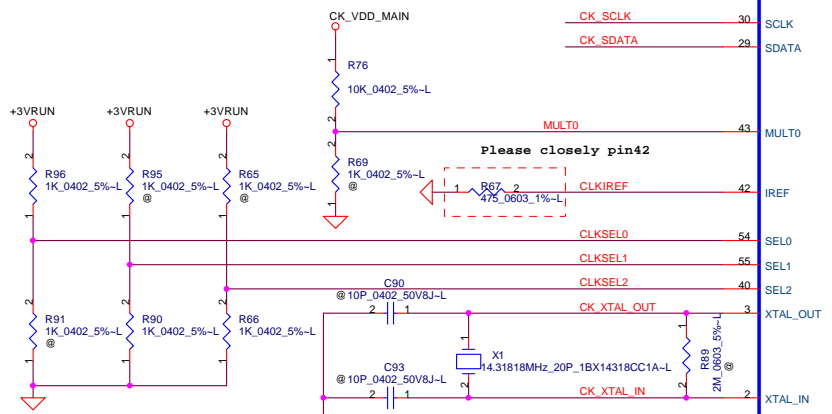
Place crystal within
500 mils of CK408

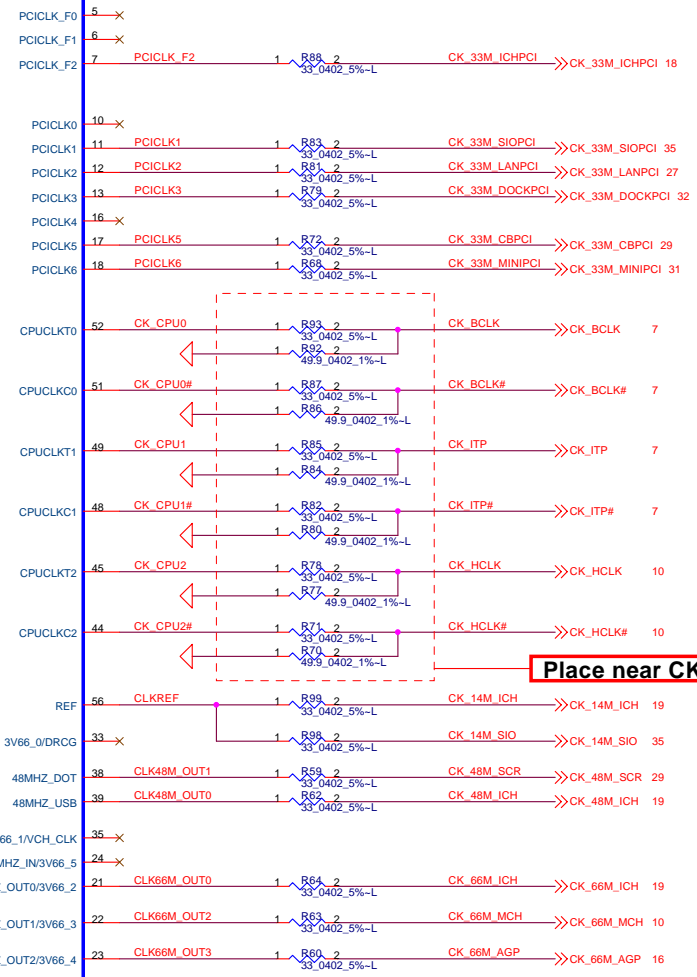
Place near CK408

S2	S1	S0	CPU	3V66[0.4]	3V66_5/66IN	
1	0	0	66	66IN	66	Input
1	0	1	100	66IN	66	Input
1	1	0	200	66IN	66	Input
1	1	1	133	66IN	66	Input
0	0	0	66	66	66	Input
0	0	1	100	66	66	Input
0	1	0	200	66	66	Input
0	1	1	133	66	66	Input
Mid	0	0	Hi-z	Hi-z	Hi-z	
Mid	0	1	TCLK/2	TCLK/2	TCLK/2	
Mid	1	0	Reserve	Reserve	Reserve	
Mid	1	1	Reserve	Reserve	Reserve

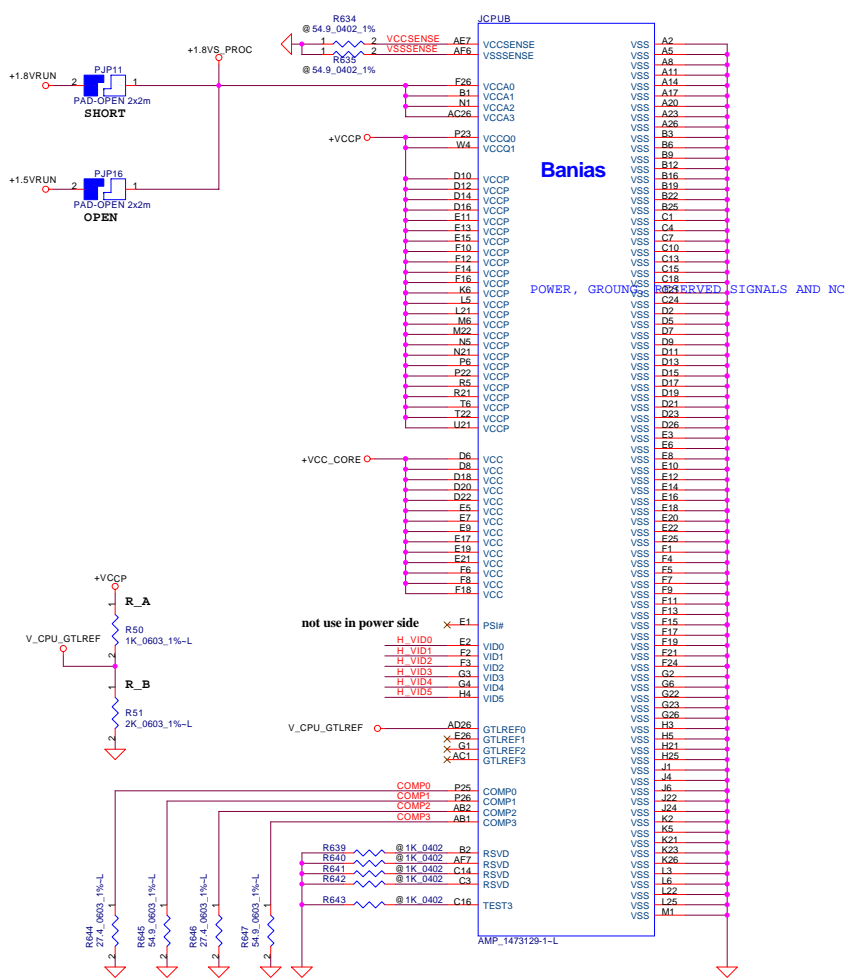
Resistor placed within 0.5" of CPU pin. Trace should be at least 25 miles away from any other toggling signal.

**For test ,Cmos output
CPU Voltage ID**

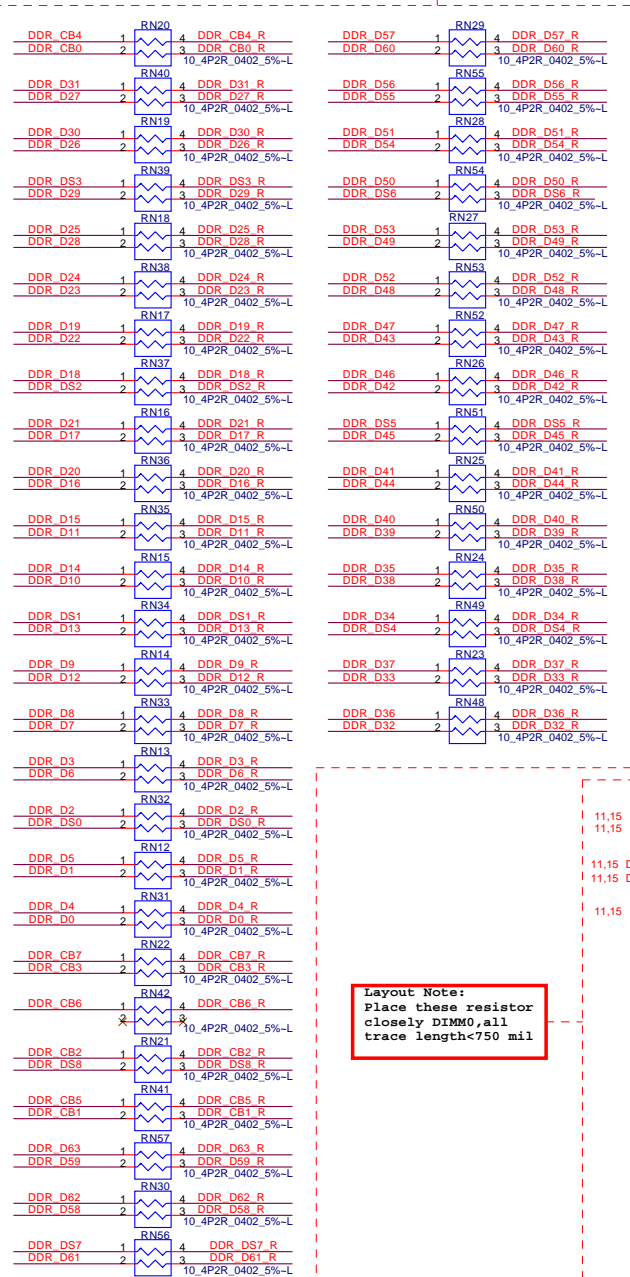
Layout Note:
Place these resistor
closely DIMM0, all
trace length < 750 mil

Layout Note:
Place these resistor
closely DIMM0, all
trace length
Max=1.3"

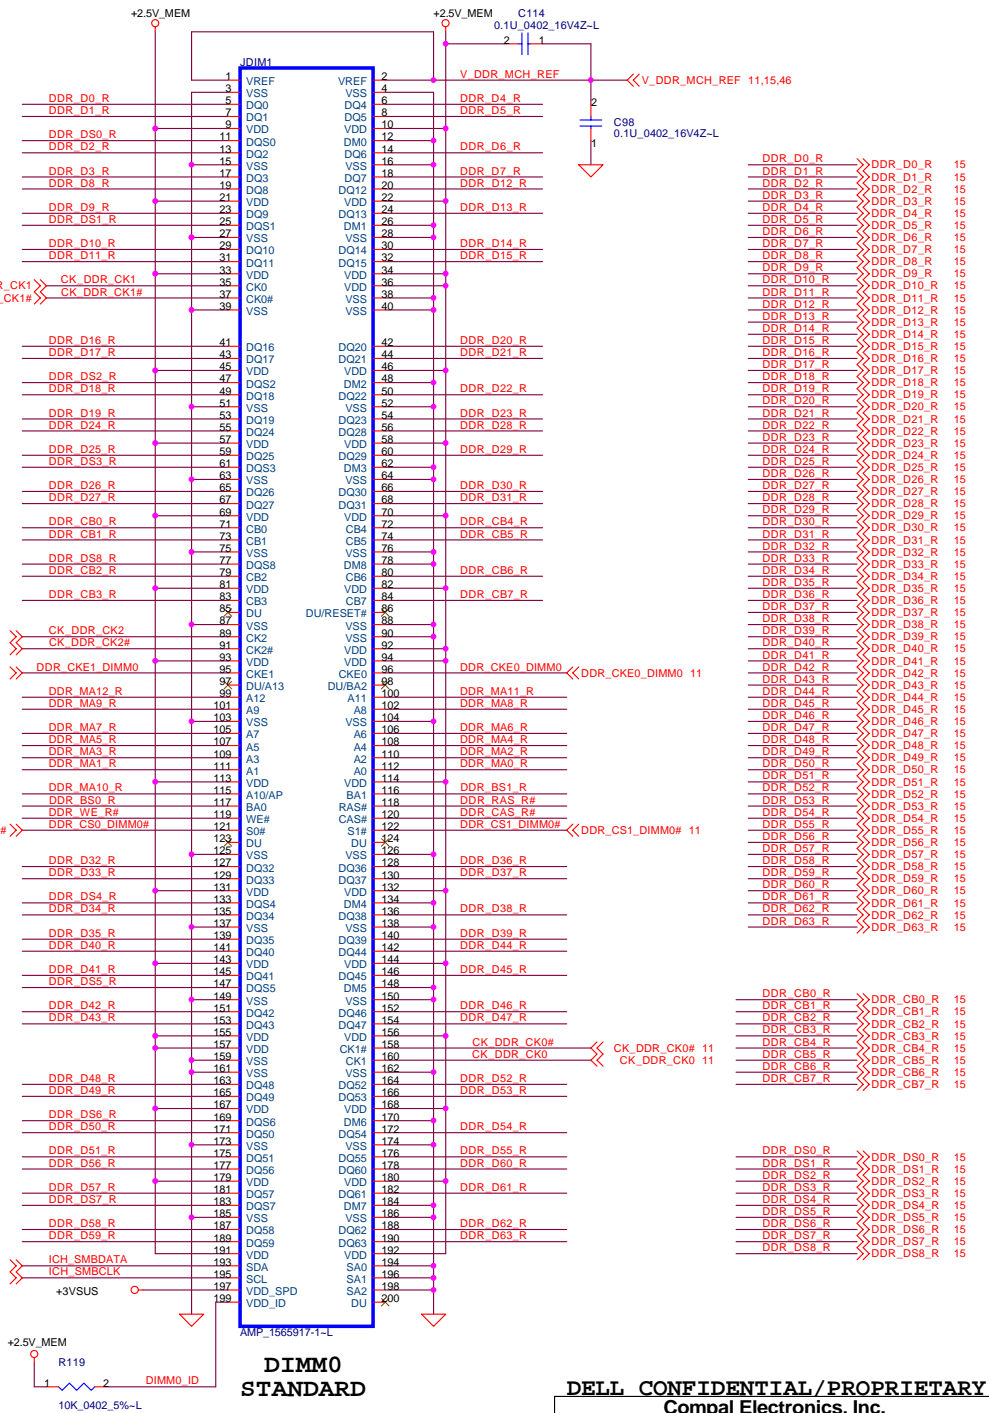
Layout Note:
Place these resistors
closely DIMM1,all
trace length<=800 mil

Layout Note:
Place CAP
near DIMM1

One .1uF cap per power pin.
place each cap close to
pin.

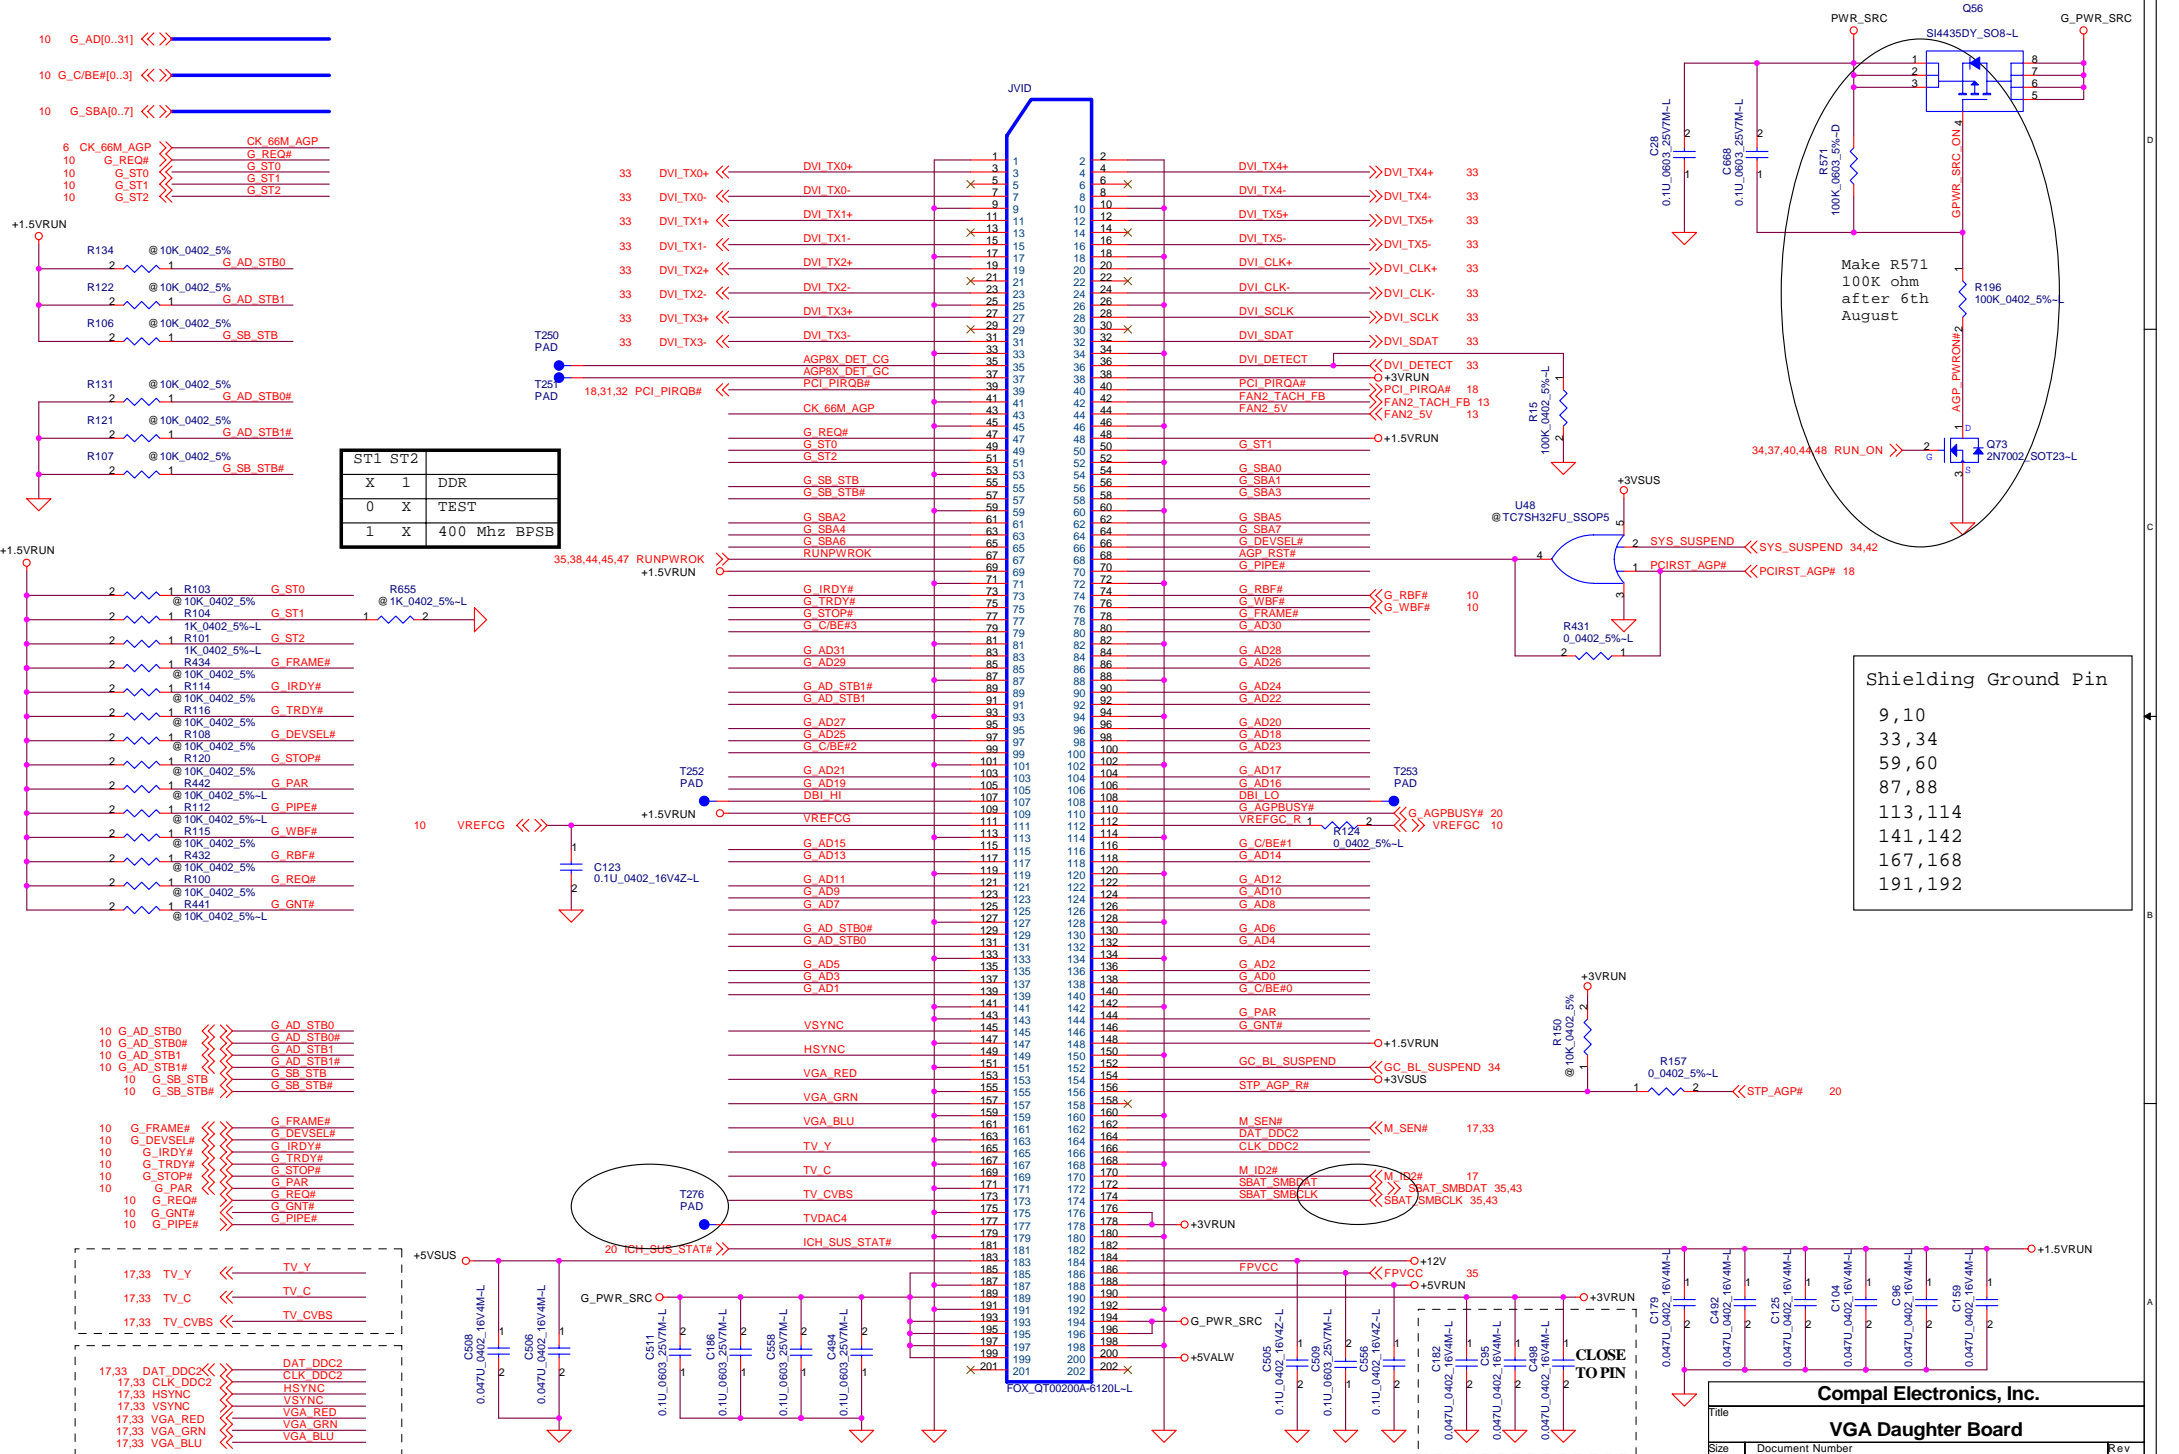
VGA Daughter Board

ST1	ST2	
X	1	DDR
0	X	TEST
1	X	400 Mhz BPSB

Shielding Ground Pin

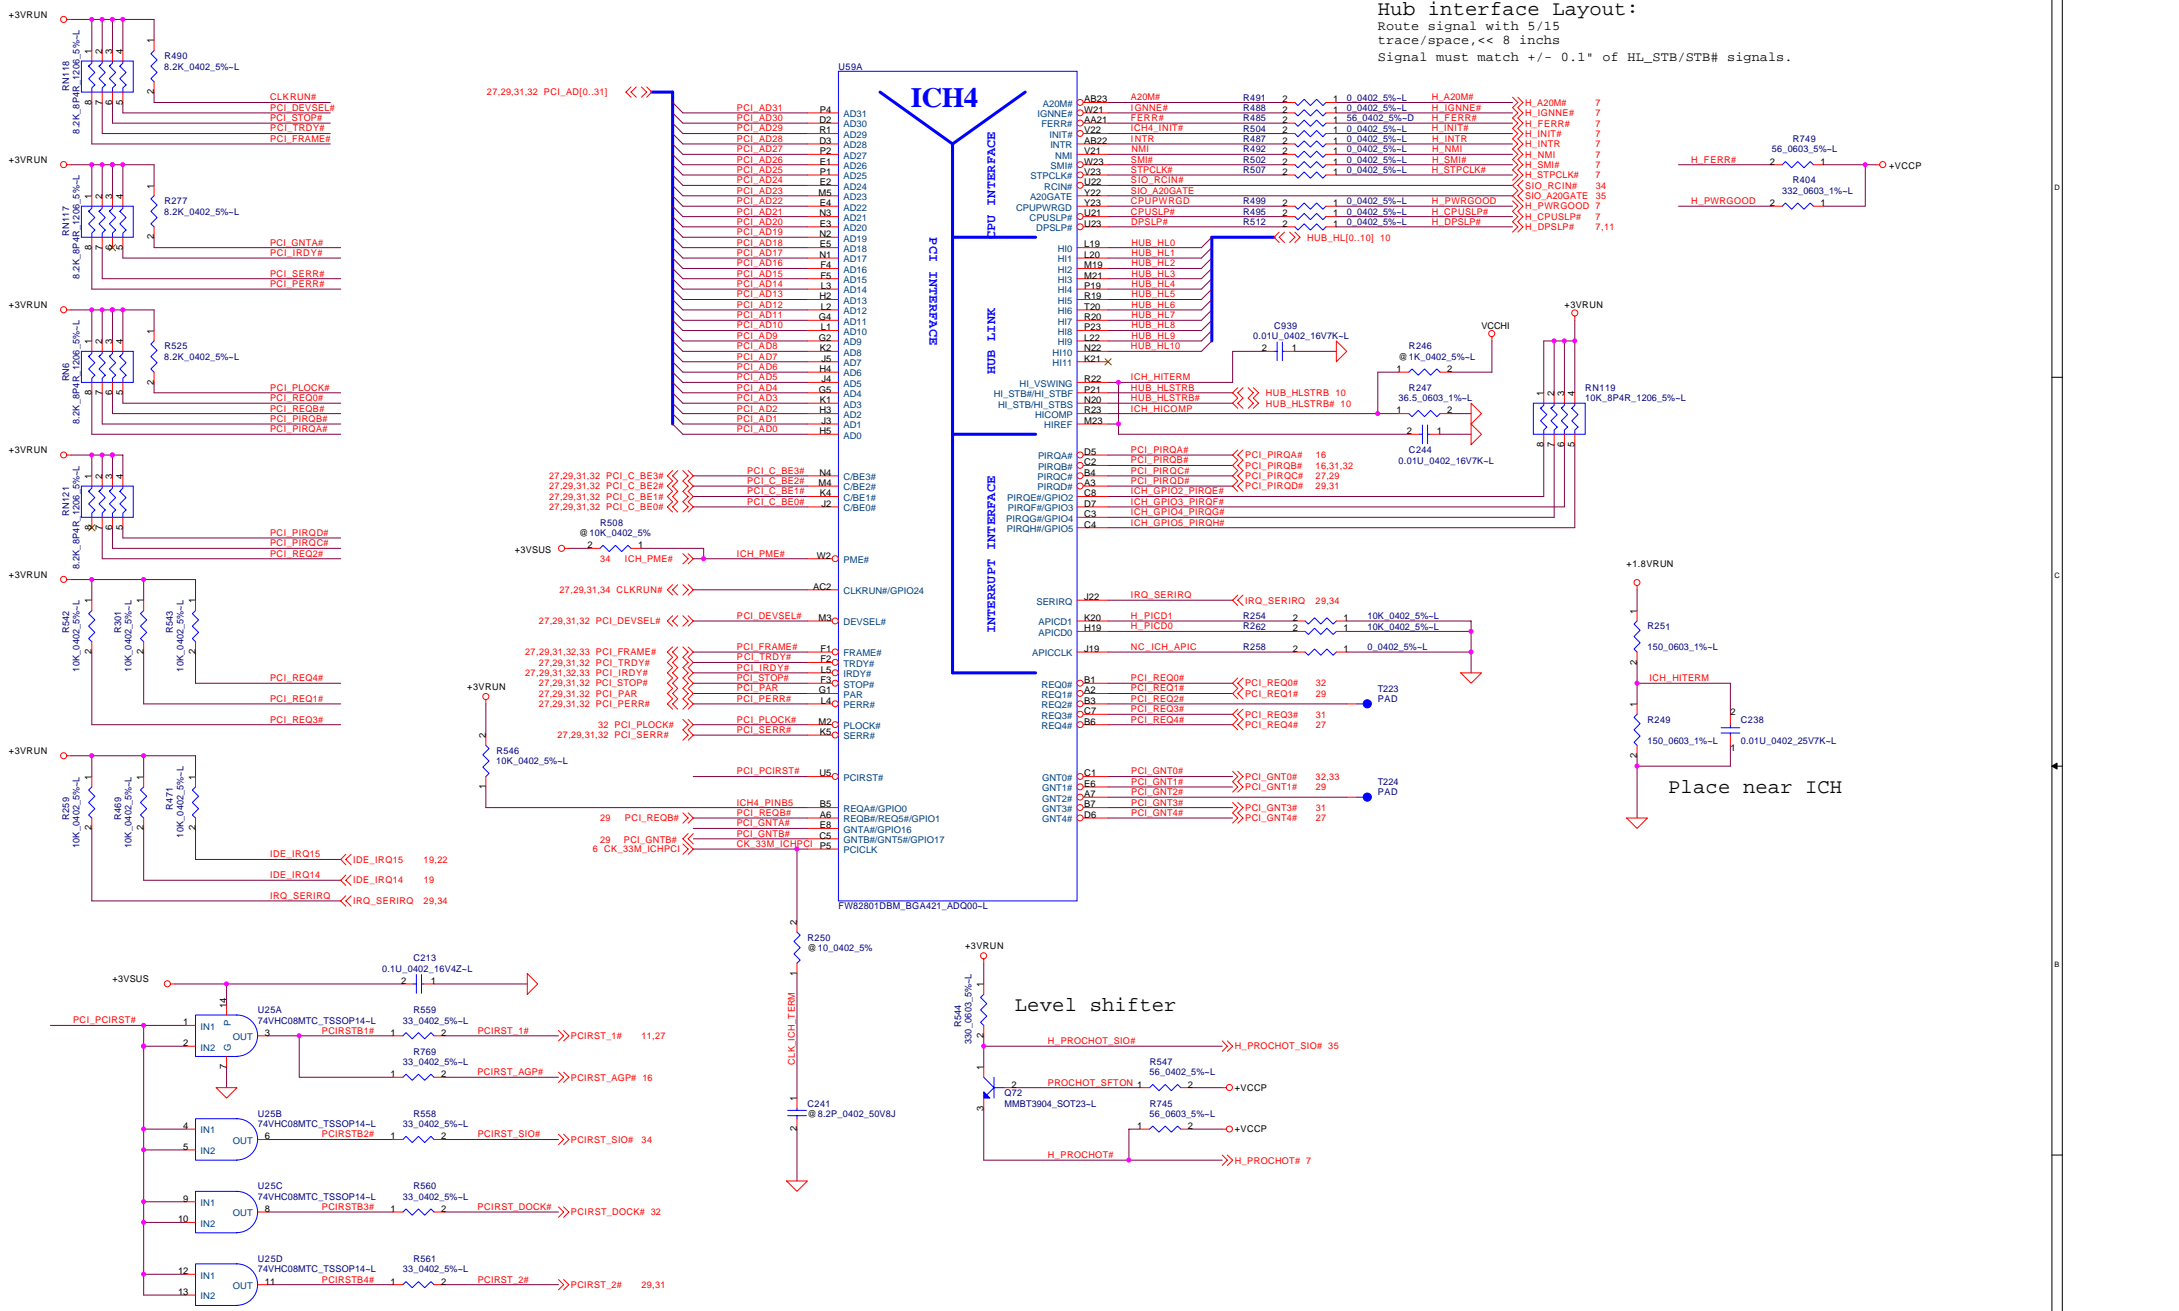
Hub interface Layout:
Route signal with 5/15
trace/space, << 8 inches
Signal must match +/- 0.1" of HL_STB#/STB# signals.

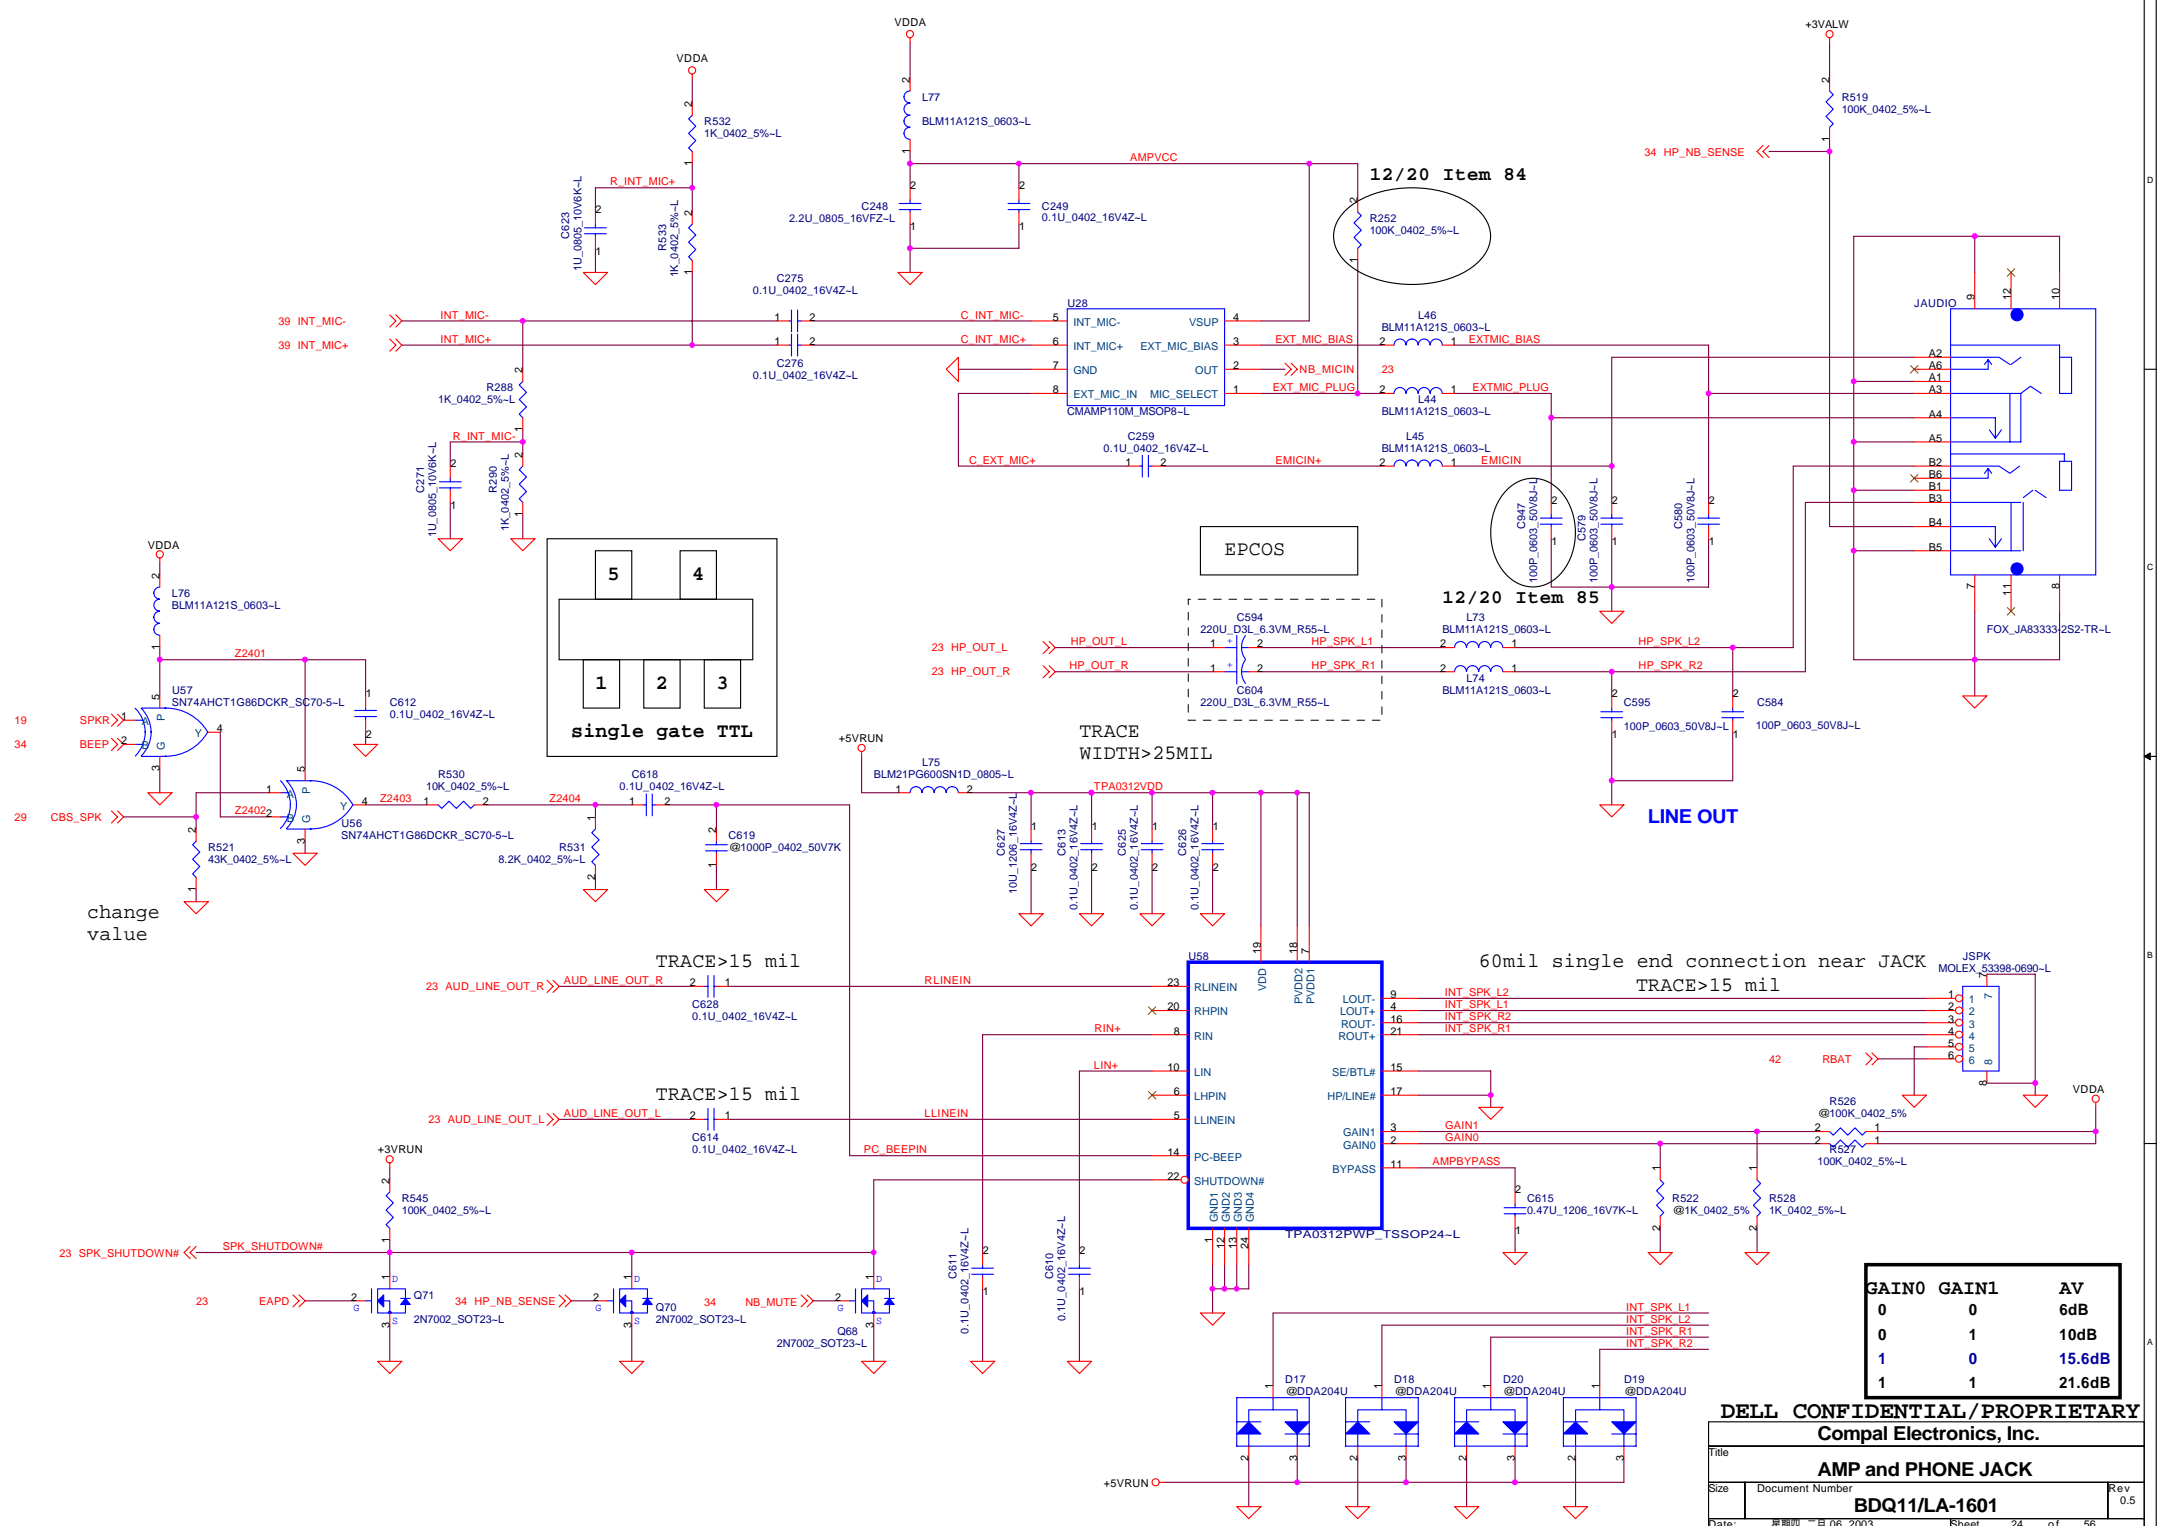
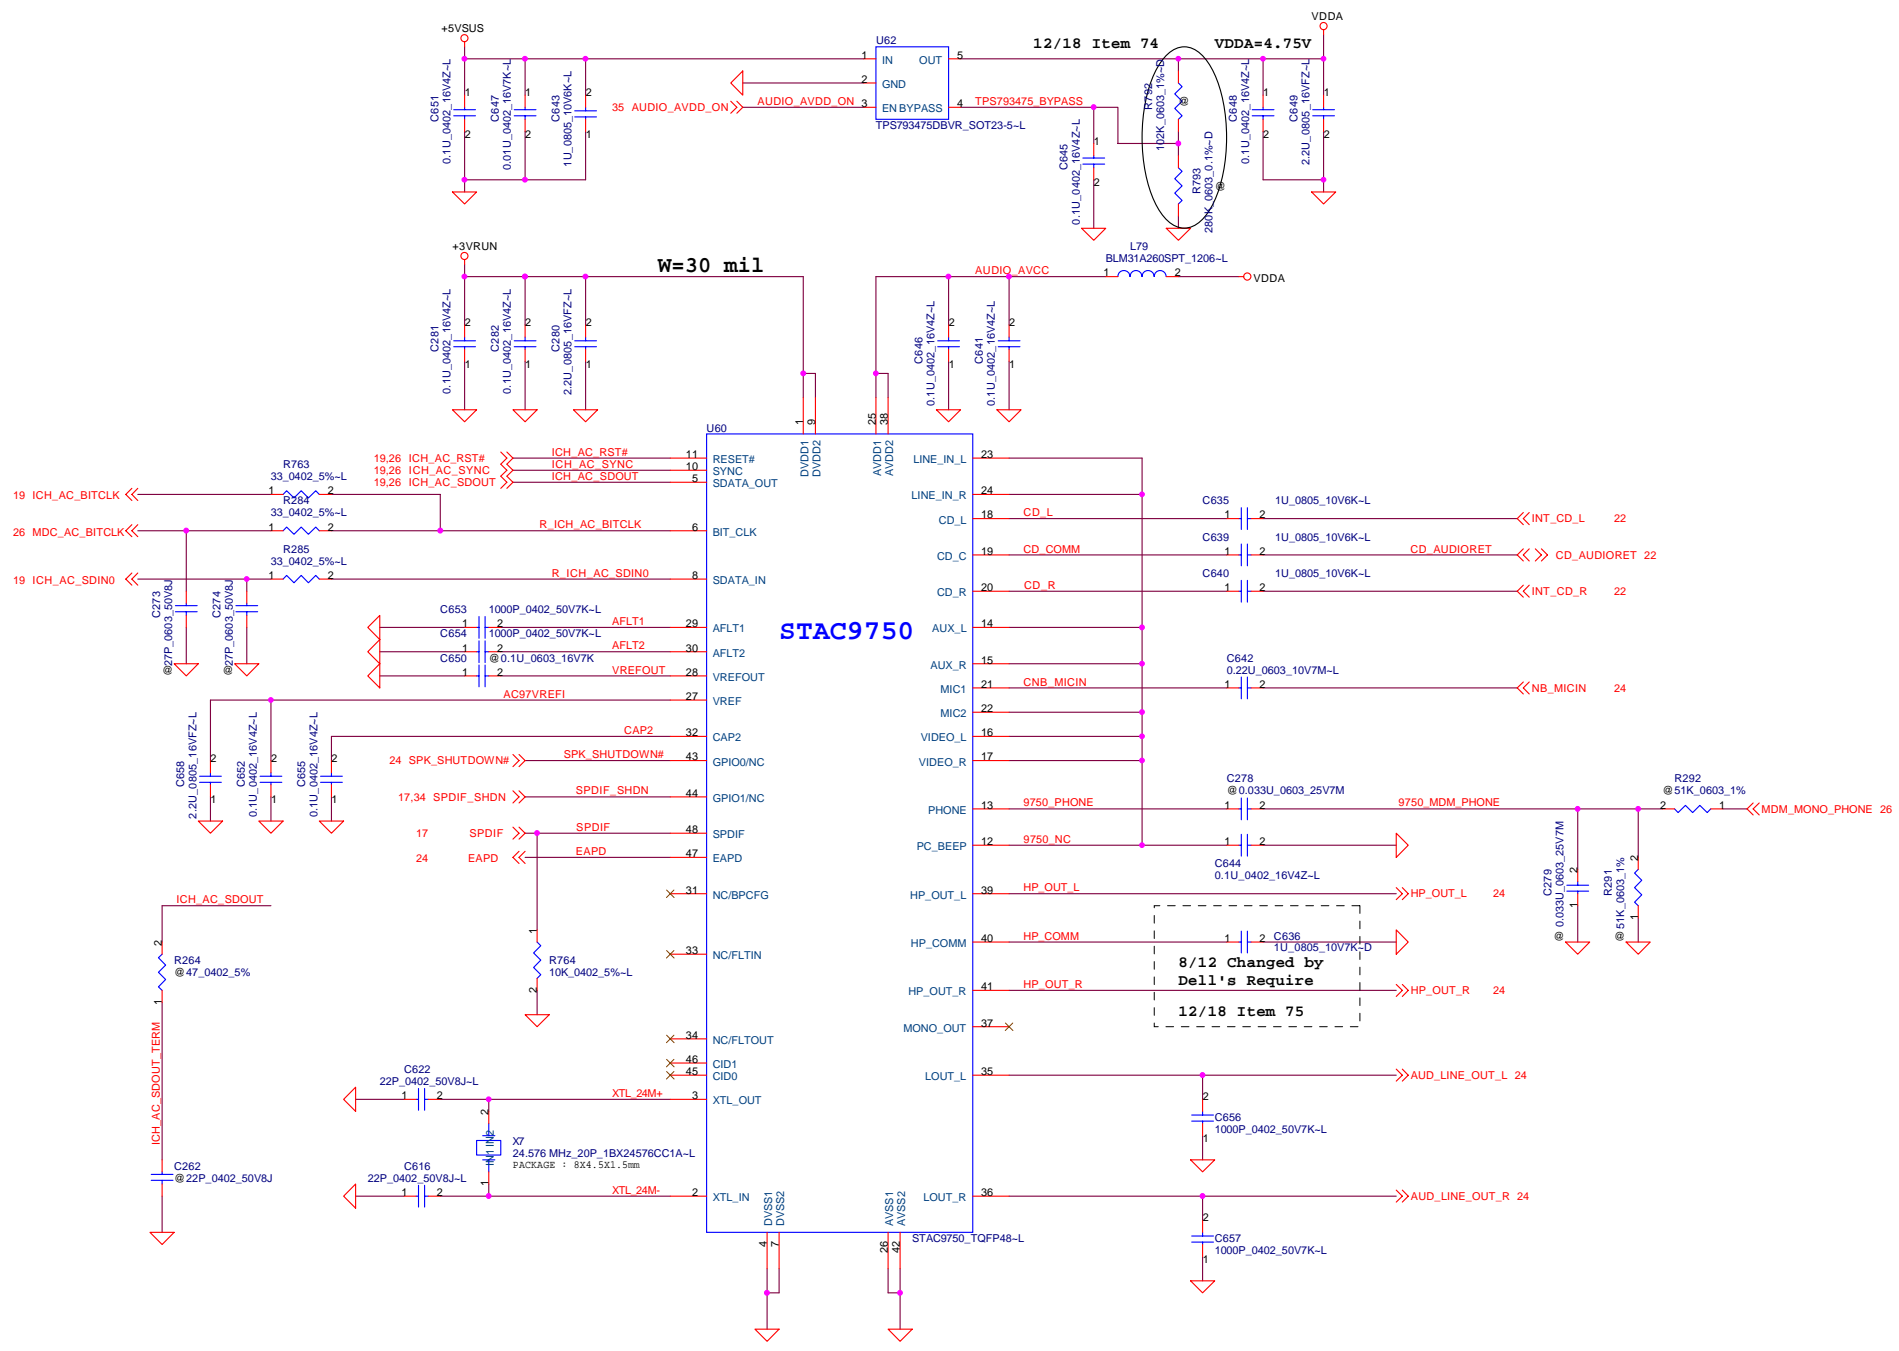
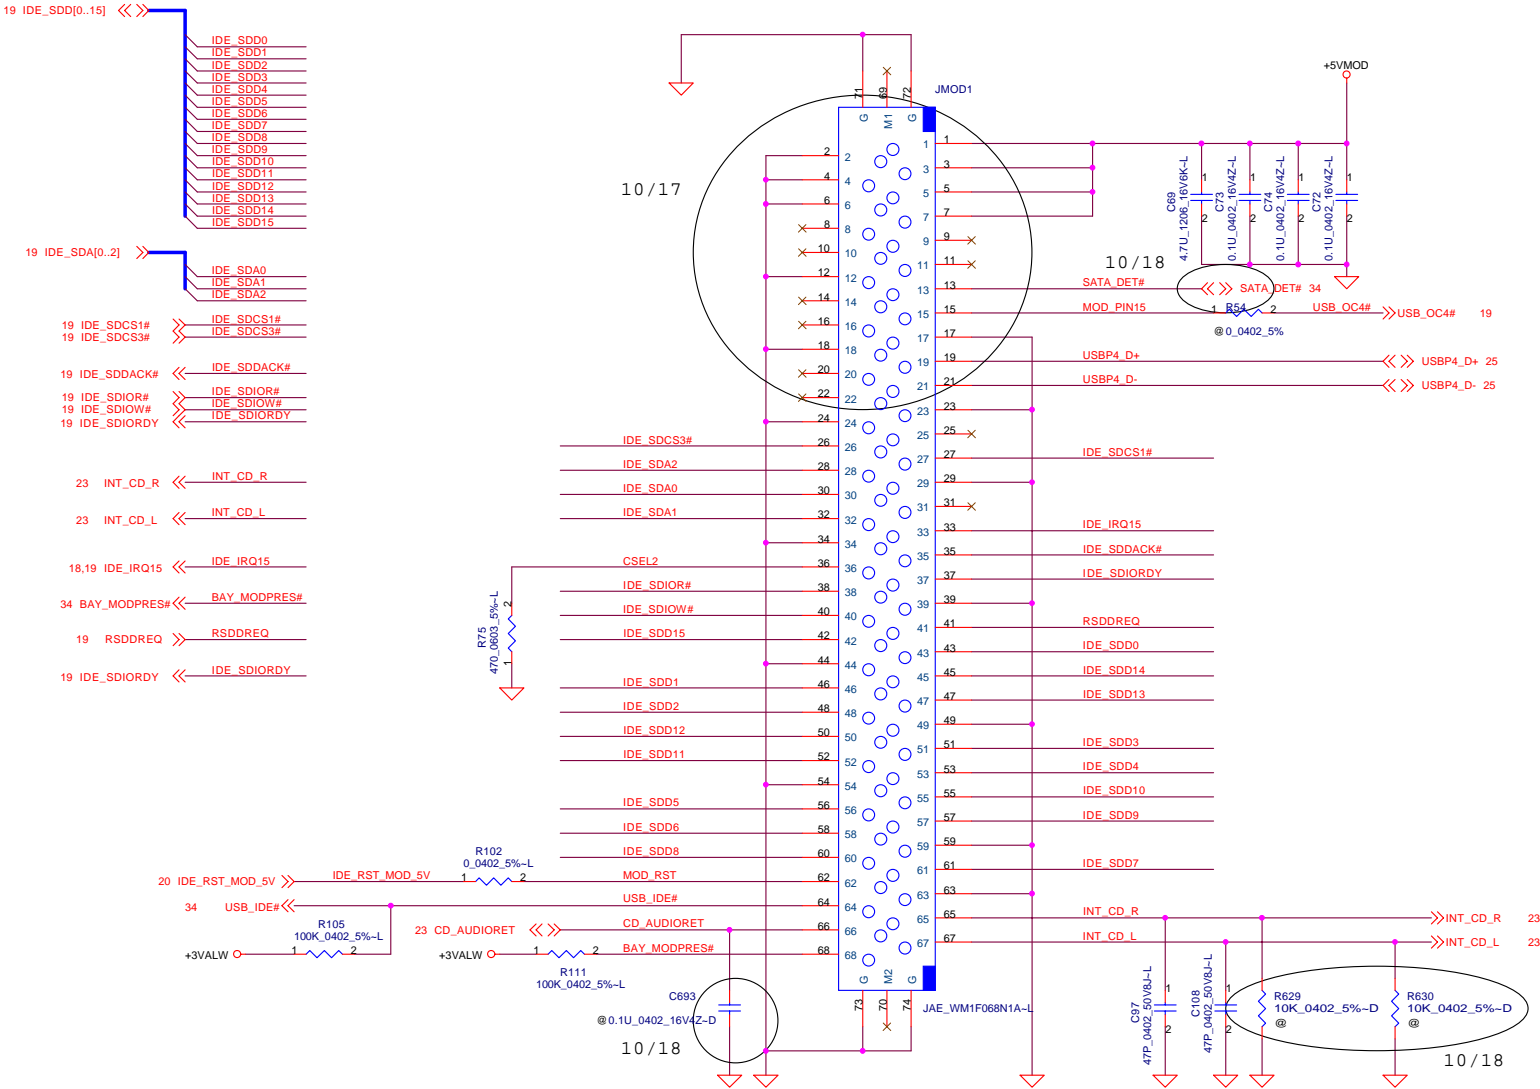
AMP and PHONE JACK		
BDQ11/LA-1601		
Date:	星期四, 二月 06, 2003	Sheet 24 of 56

GAIN0	GAIN1	AV
0	0	6dB
0	1	10dB
1	0	15.6dB
1	1	21.6dB
