Kapalua Schematic

BDQ11/LA1601 Schematic with Capture CIS and Function field
uFCPGA Banias
02-12-2003
REV: 0.5

Title Cover Sheet		
Size	Document Number BDQ11/LA-1601	Rev 0.5
Date: 星期三, 二月 12, 2003	Sheet 1	of 56

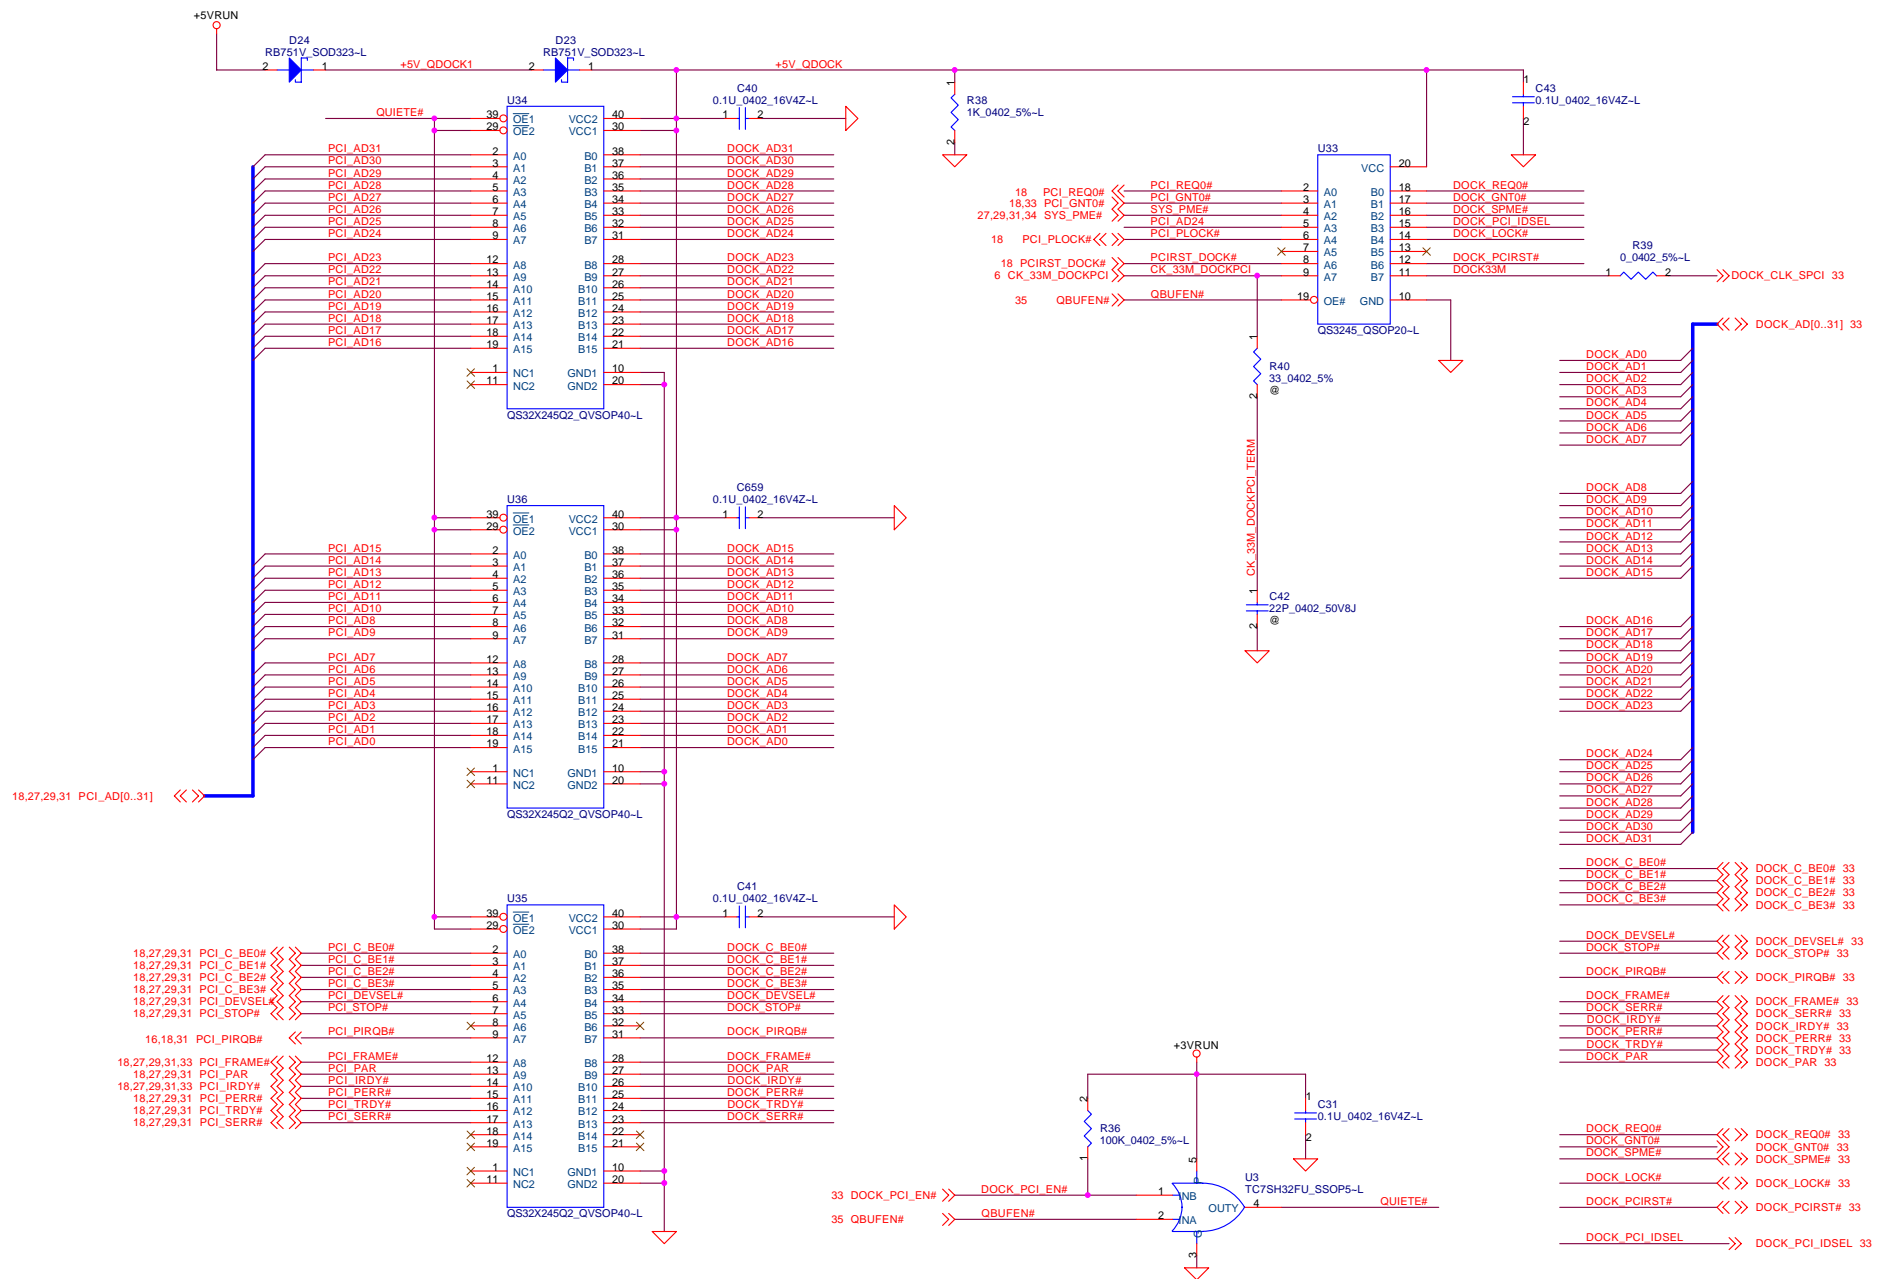
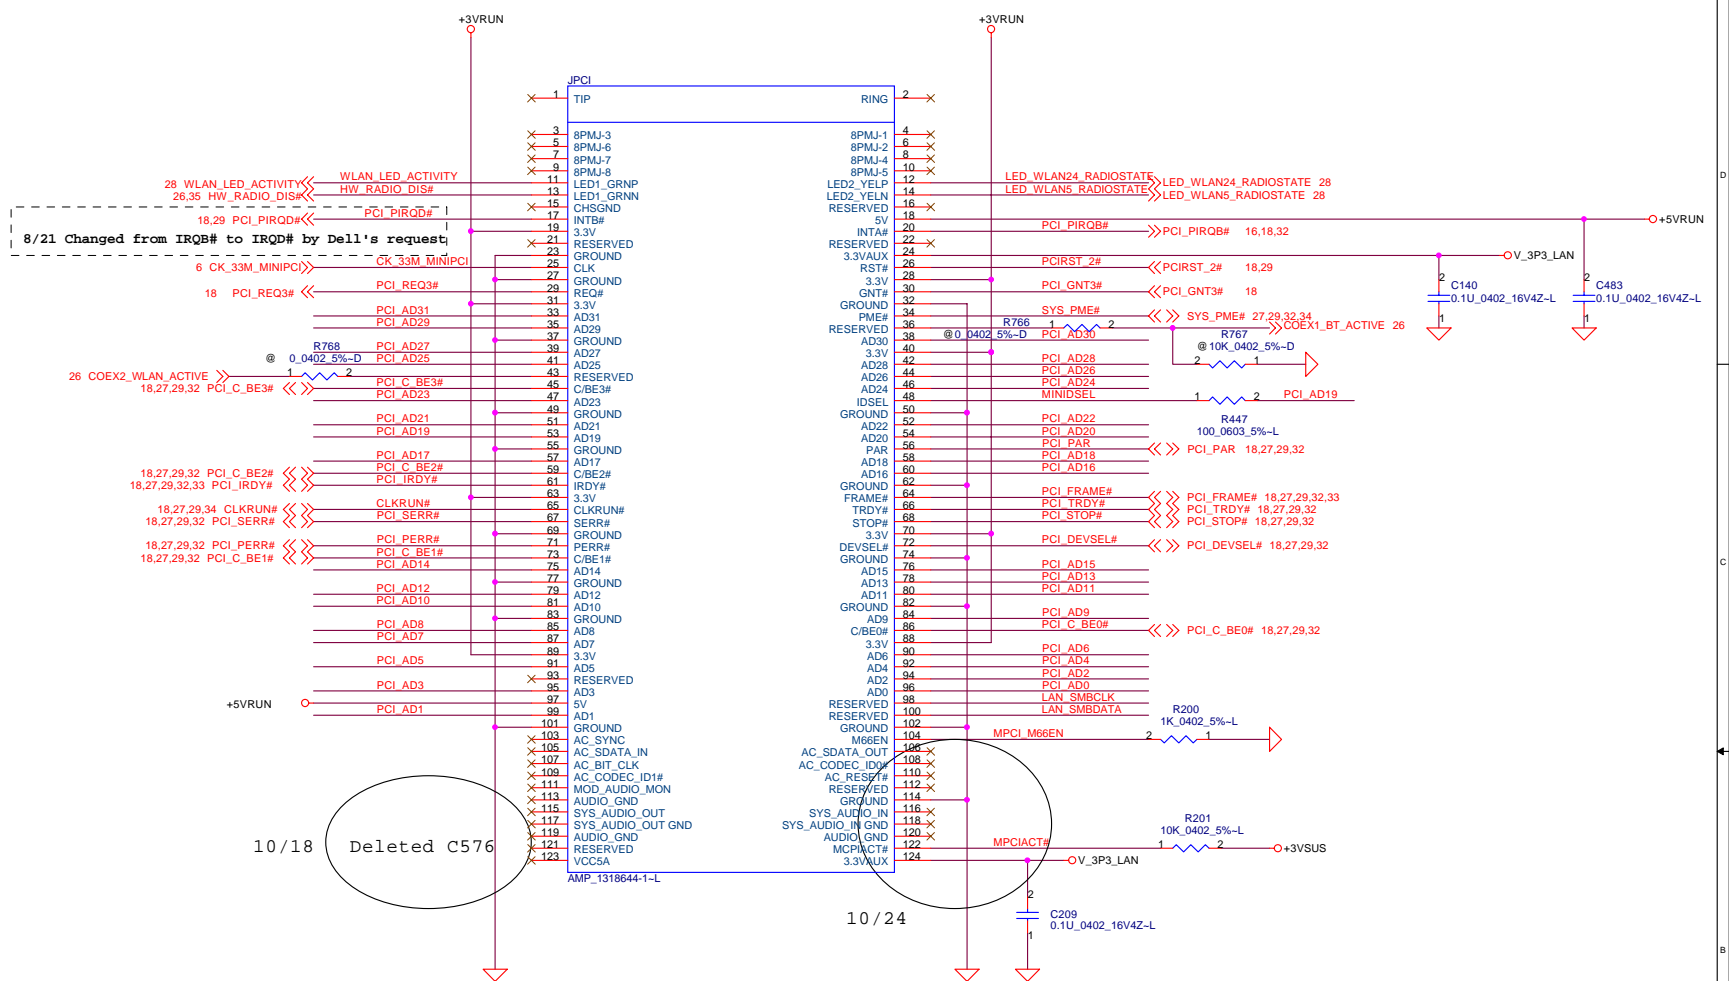
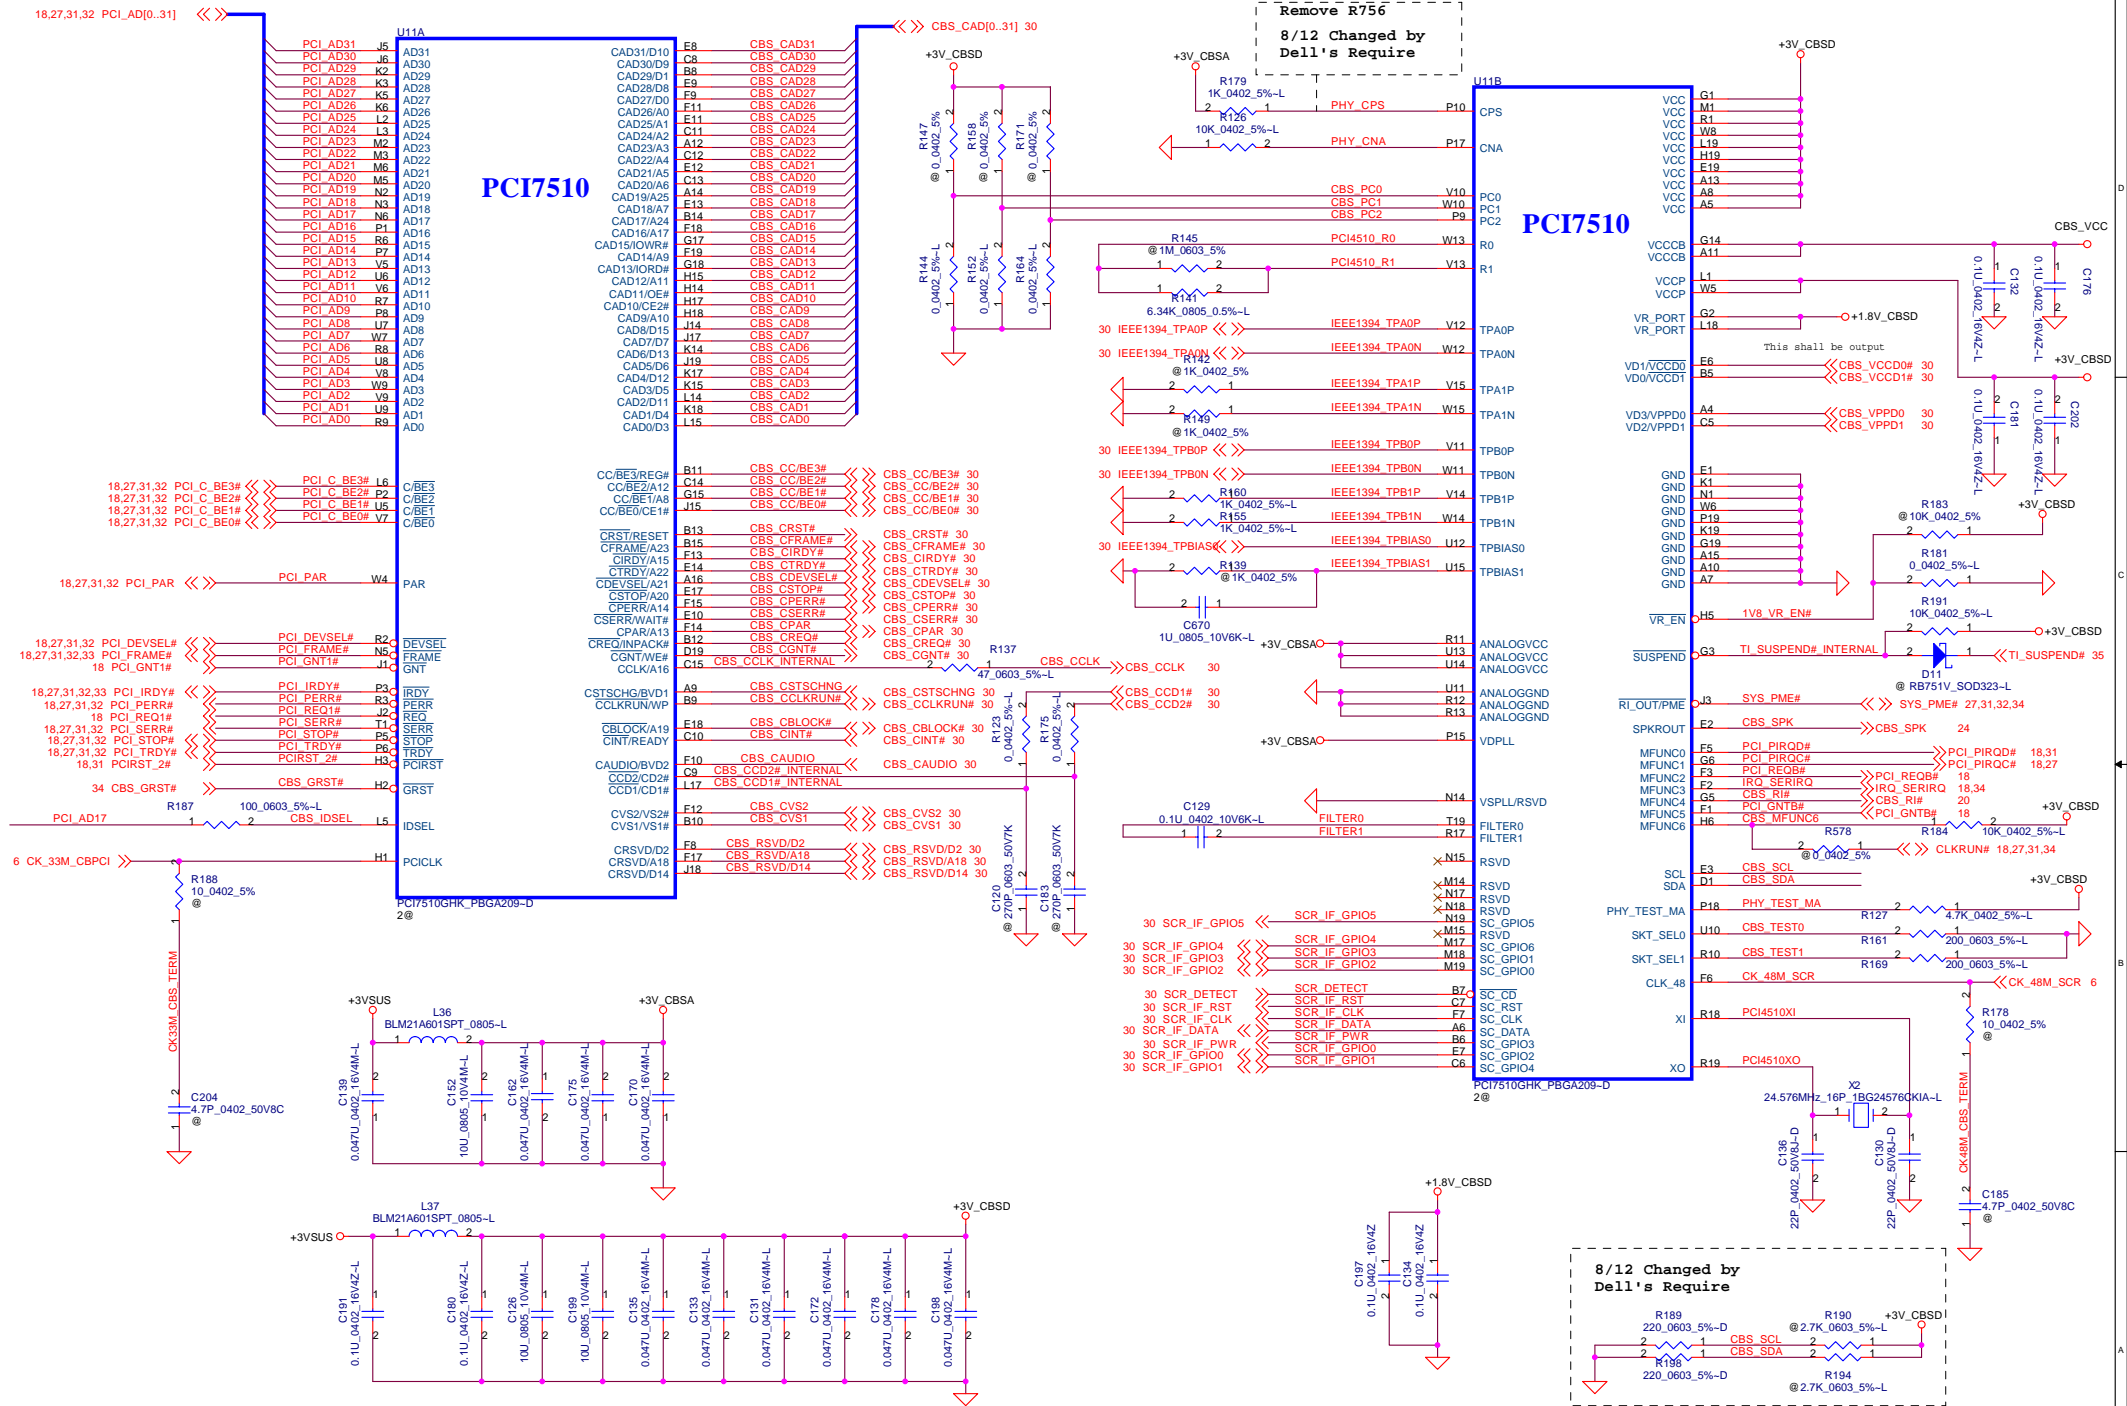
Title		
DOCKING BUFFER		
Size	Document Number	Rev
	BDQ11/LA-1601	0.5
Date:	星期四, 二月 06, 2003	Sheet 32 of 56

PLACE TERMINATIONS CLOSE TO DOCK CONNECTOR

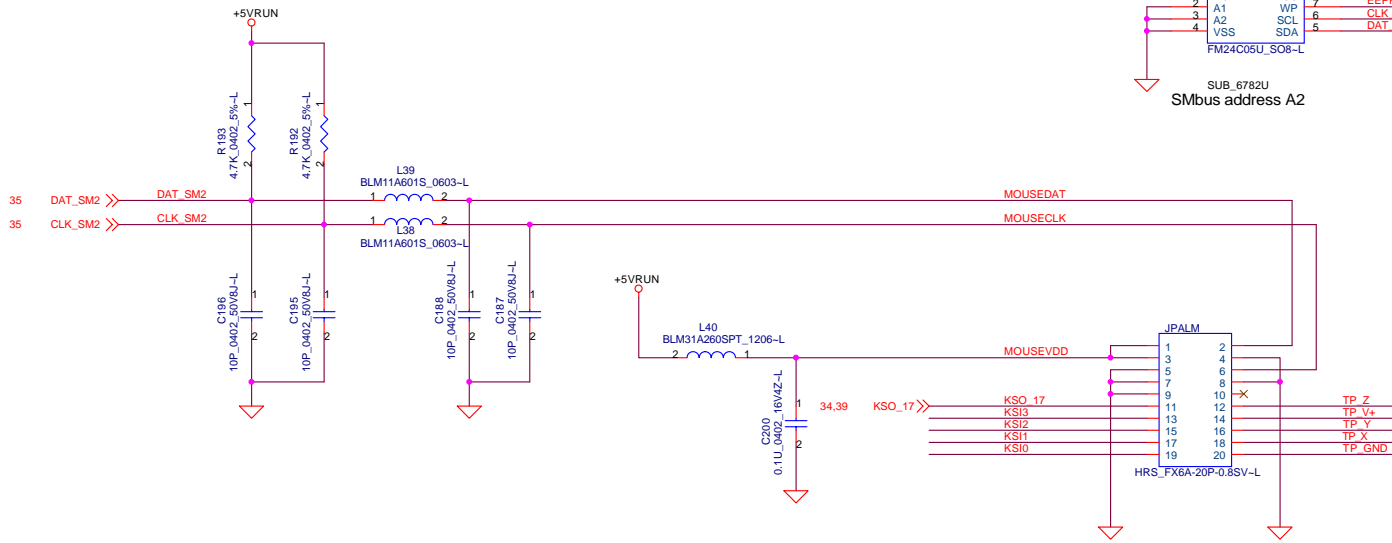
SUB_6782U
SMbus address A2

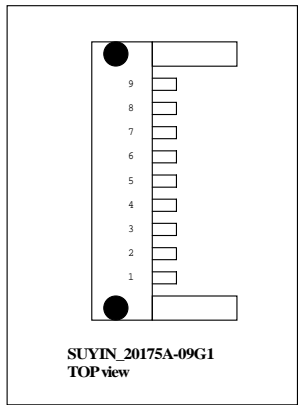
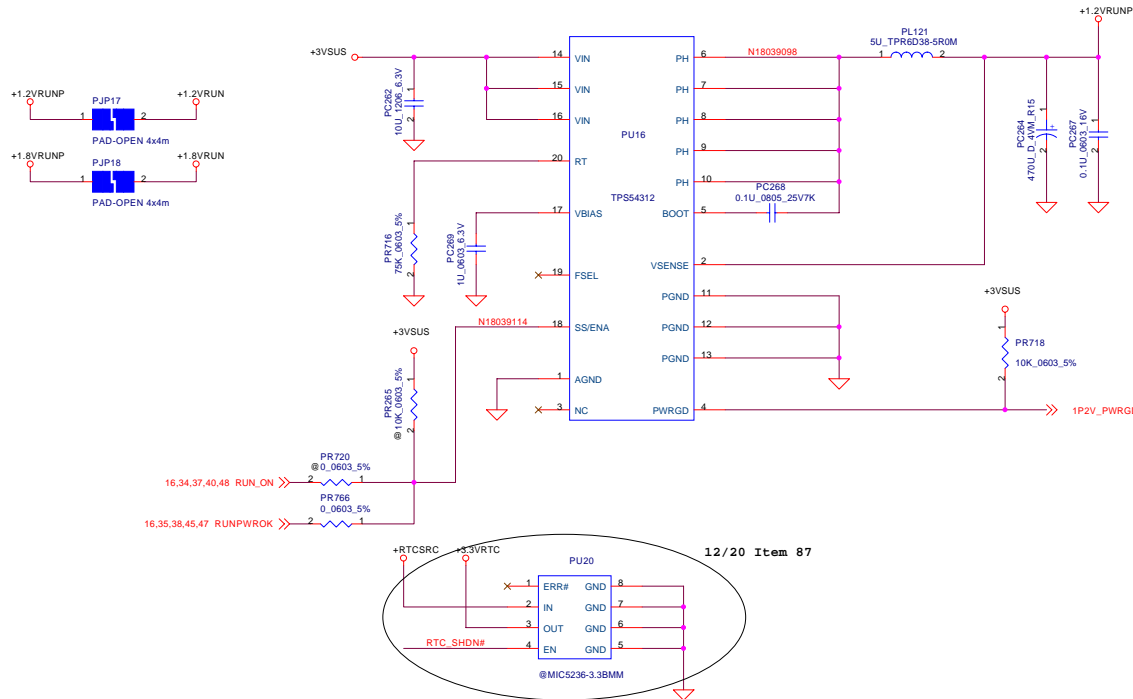
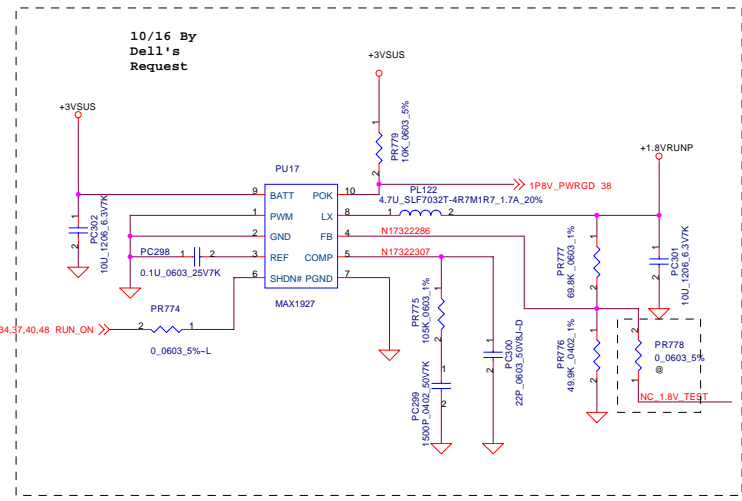
+1.2VRUN/+1.8VRUN SOURCE

Allows SUS planes to power ALW planes when possible

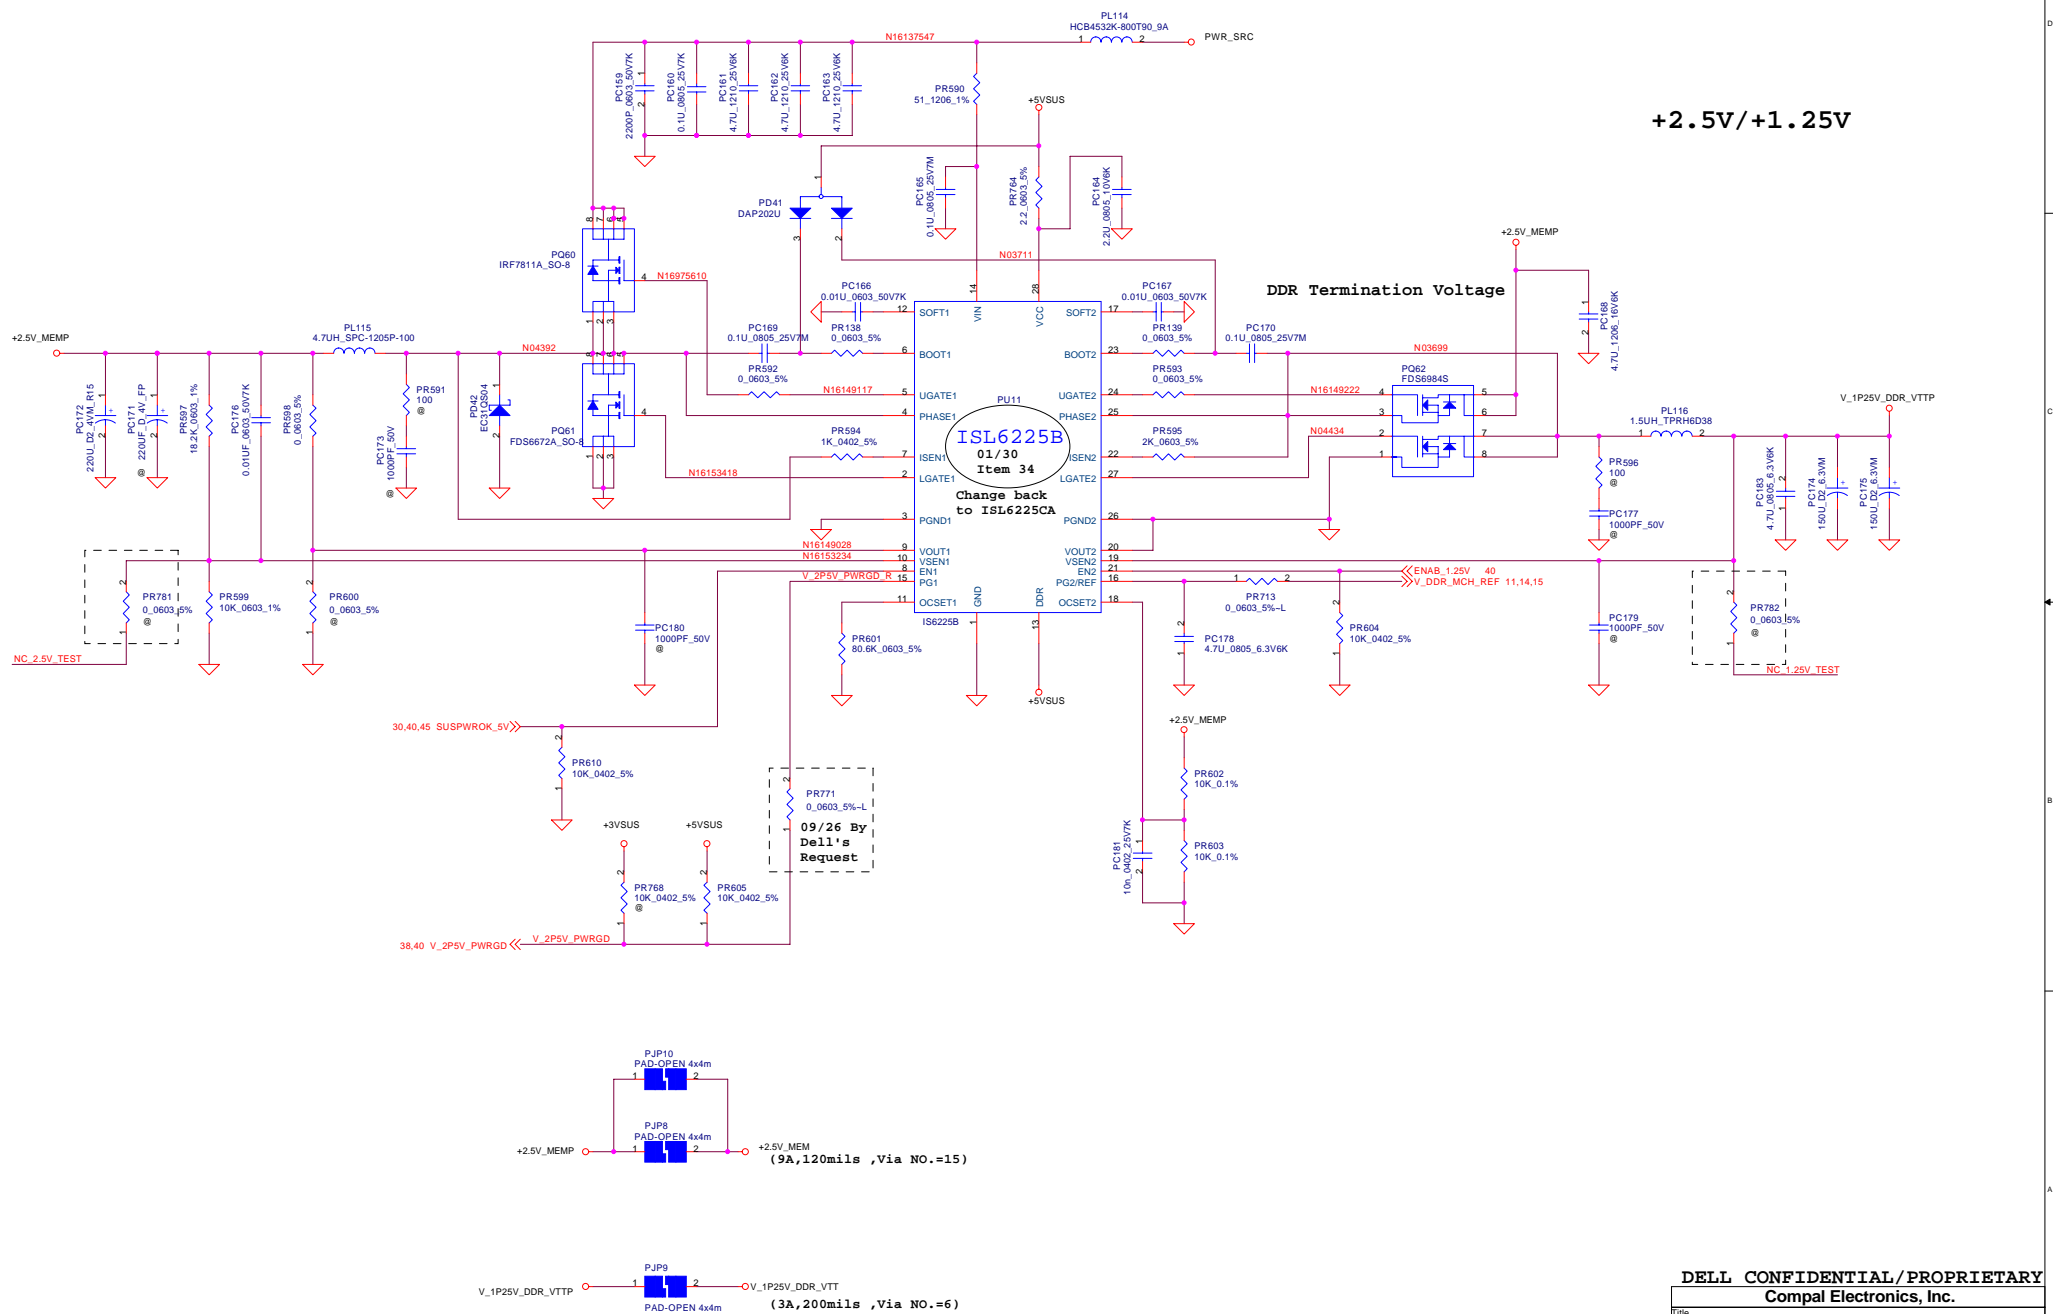
+2.5V/+1.25V

DDR Termination Voltage

ISL6225B
 01/30
 Item 34
 Change back to ISL6225CA

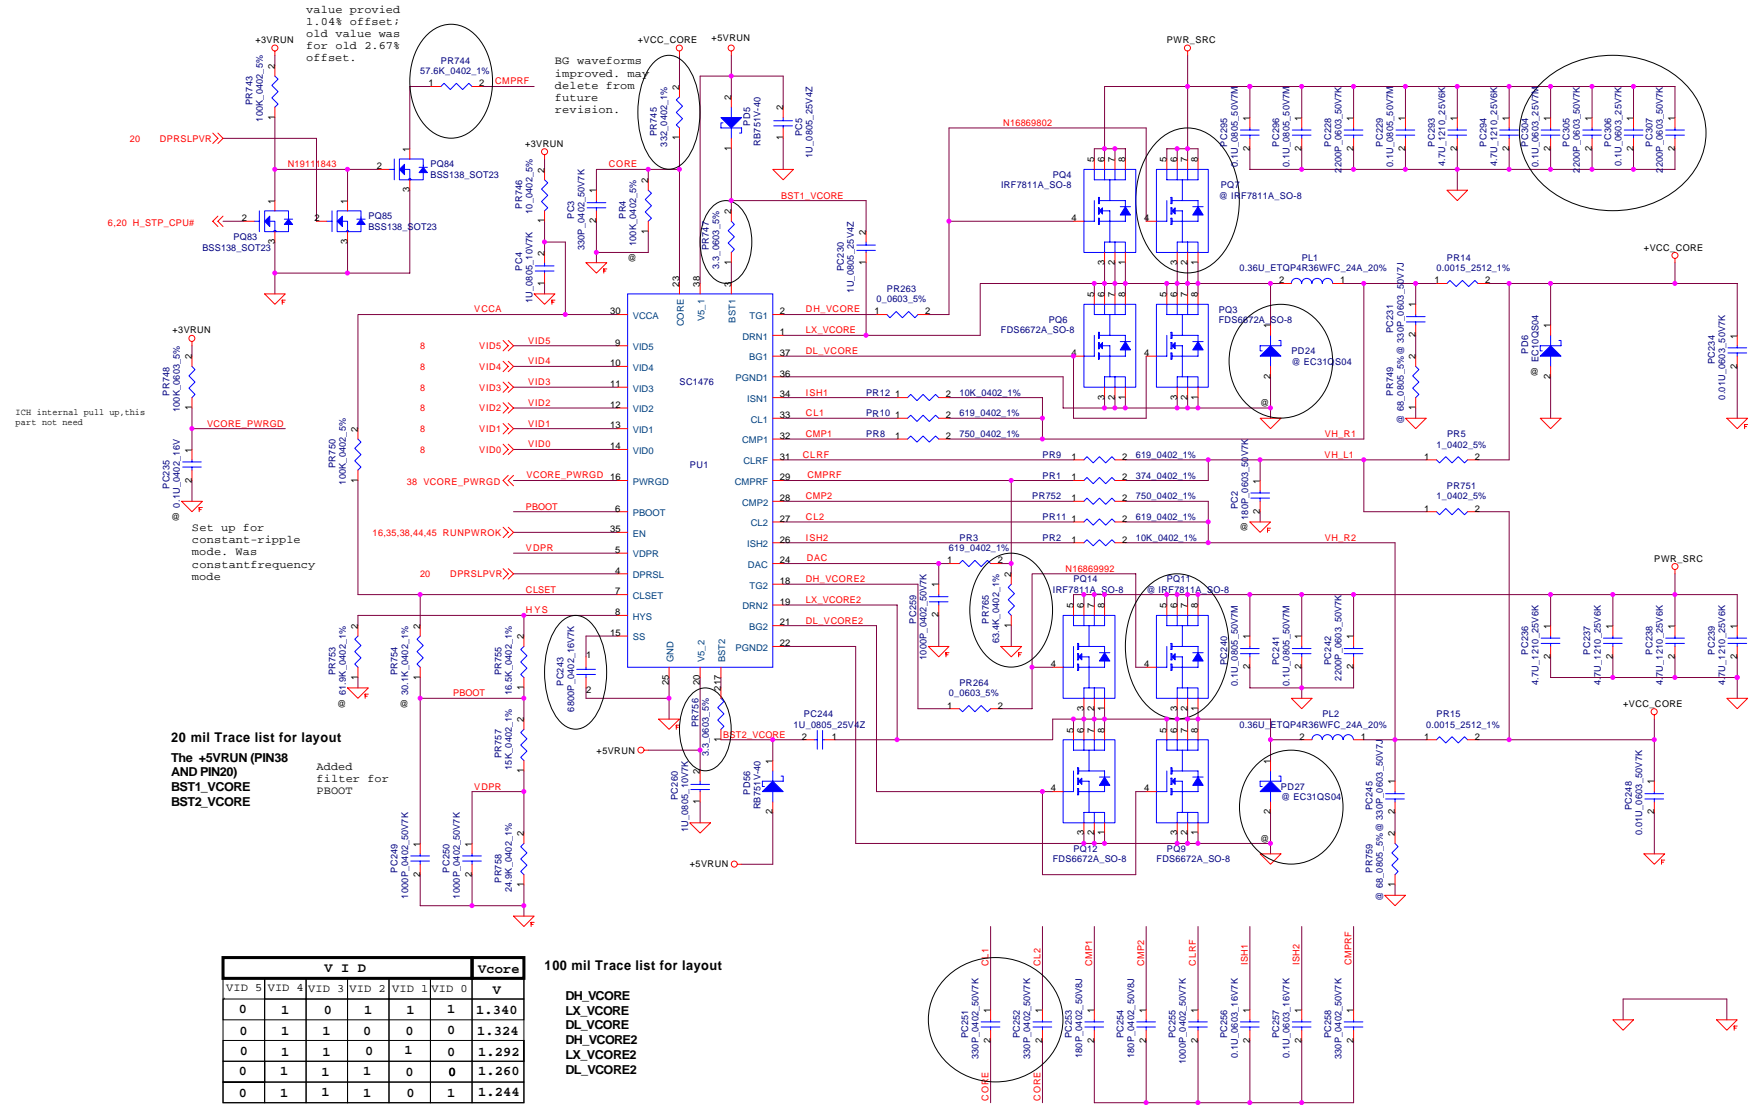
value provided
1.04% offset;
old value was
for old 2.67%
offset.

BG waveforms
improved, delete from
future
revision.

Set up for
constant-ripple
mode. Was
constant frequency
mode

20 mil Trace list for layout
The +5VRUN (PIN38
AND PIN20)
BST1_VCORE
BST2_VCORE

100 mil Trace list for layout
DH_VCORE
LX_VCORE
DL_VCORE
DH_VCORE2
LX_VCORE2
DL_VCORE2

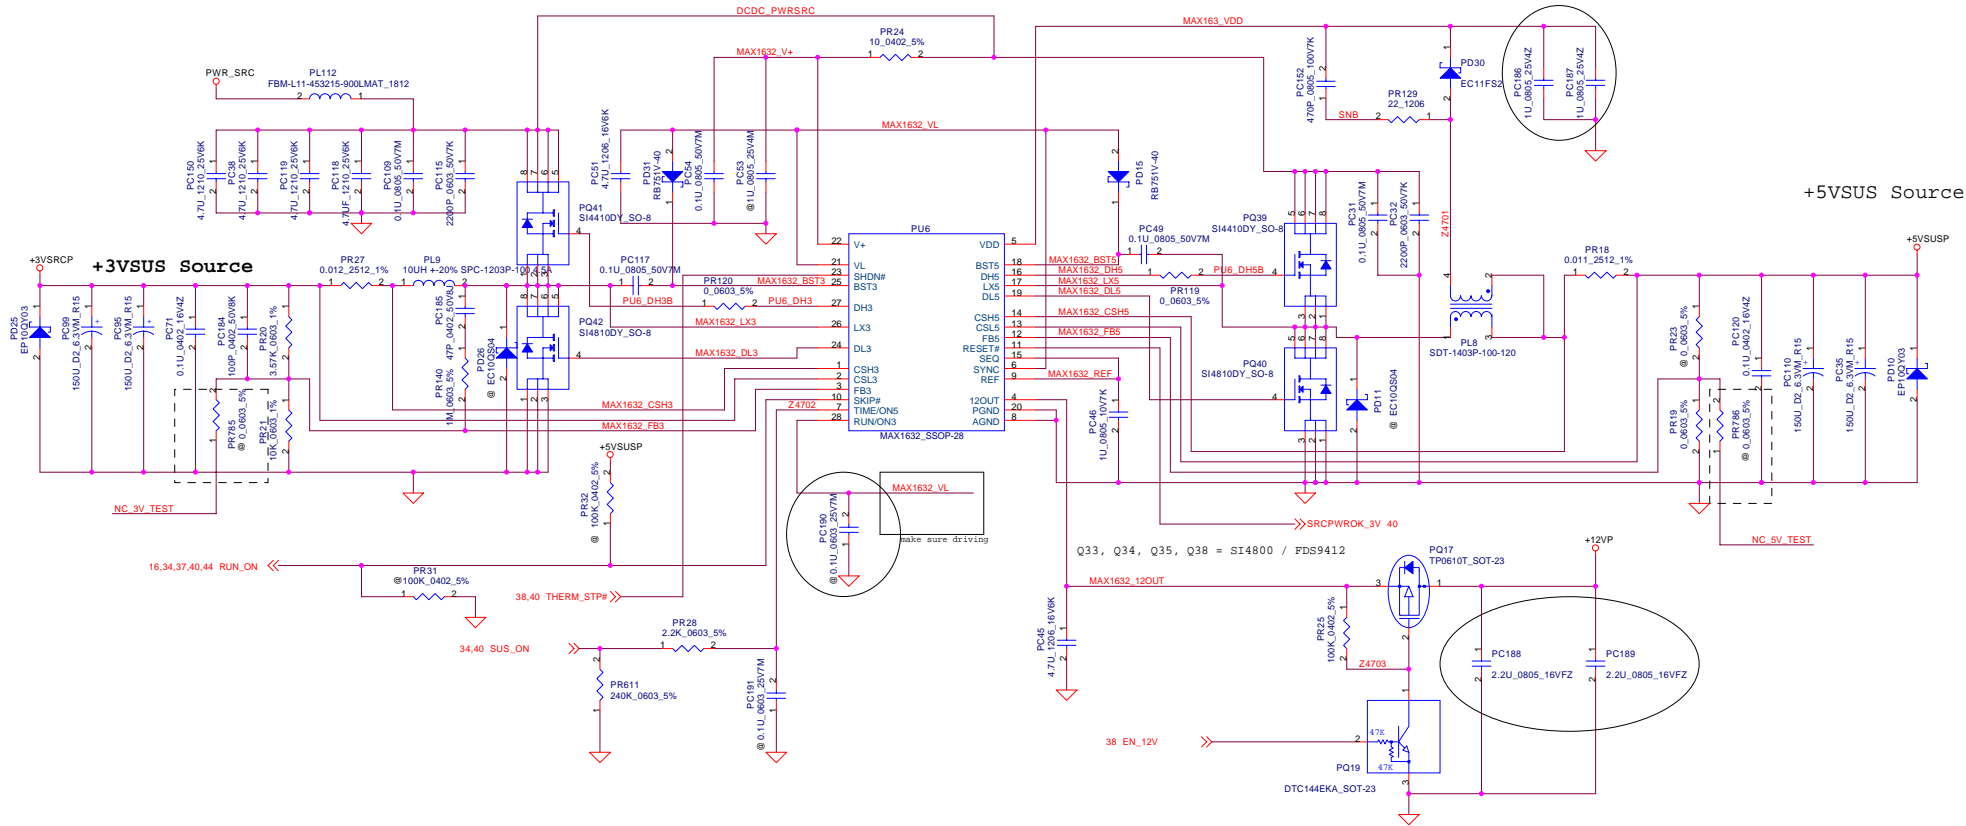
+5VSUS Source

+3VSUS Source

+5VALW Source

+3VALW Source

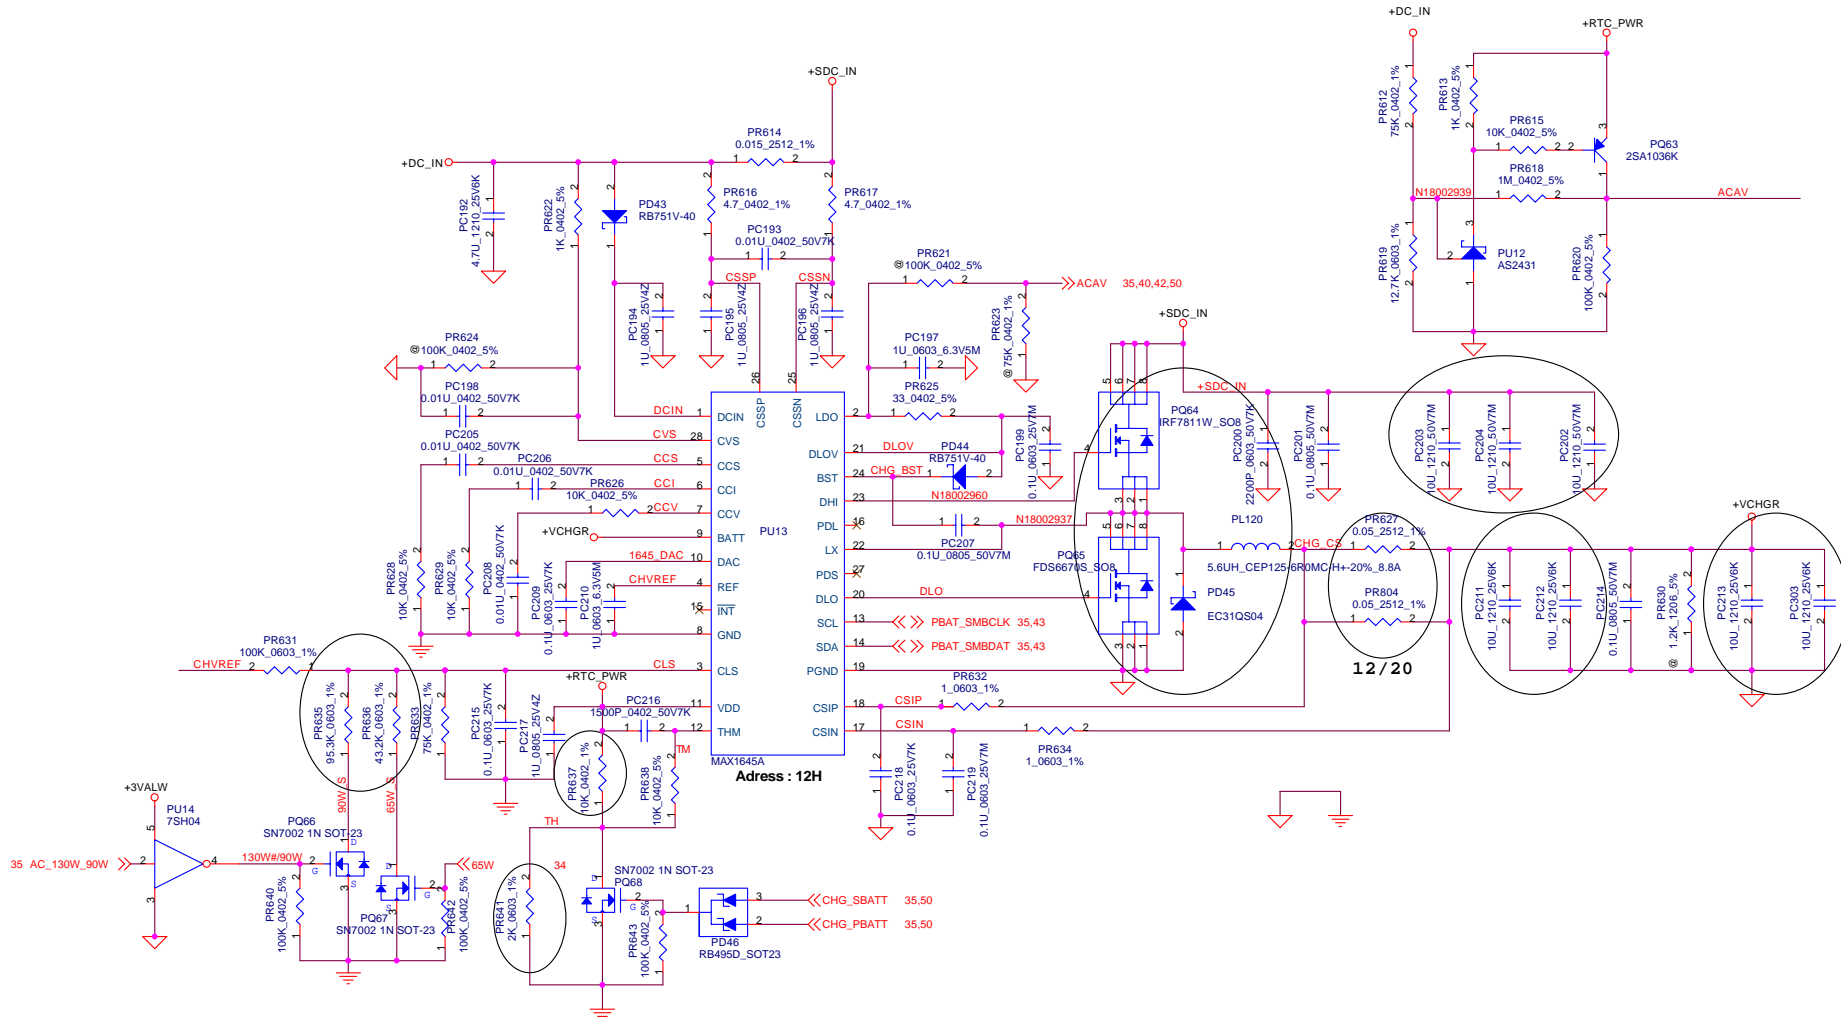
65W (2.93A)	90W (4.0A)	130W (5.85A)
65W	H	L	L
AC_130W_90W	H	L	H
