# LKB-ADDs, Plus Schematic

DDQ12/LA1901 Schematic with Capture CIS and Function field  
uFCPGA Banias  
01-02-2004  
REV: 3.0

**DELL CONFIDENTIAL/PROPRIETARY**  
Compal Electronics, Inc.

| Size | Document Number | DDQ12/11/01 with LA-1901 | Rev<br>3.0 |

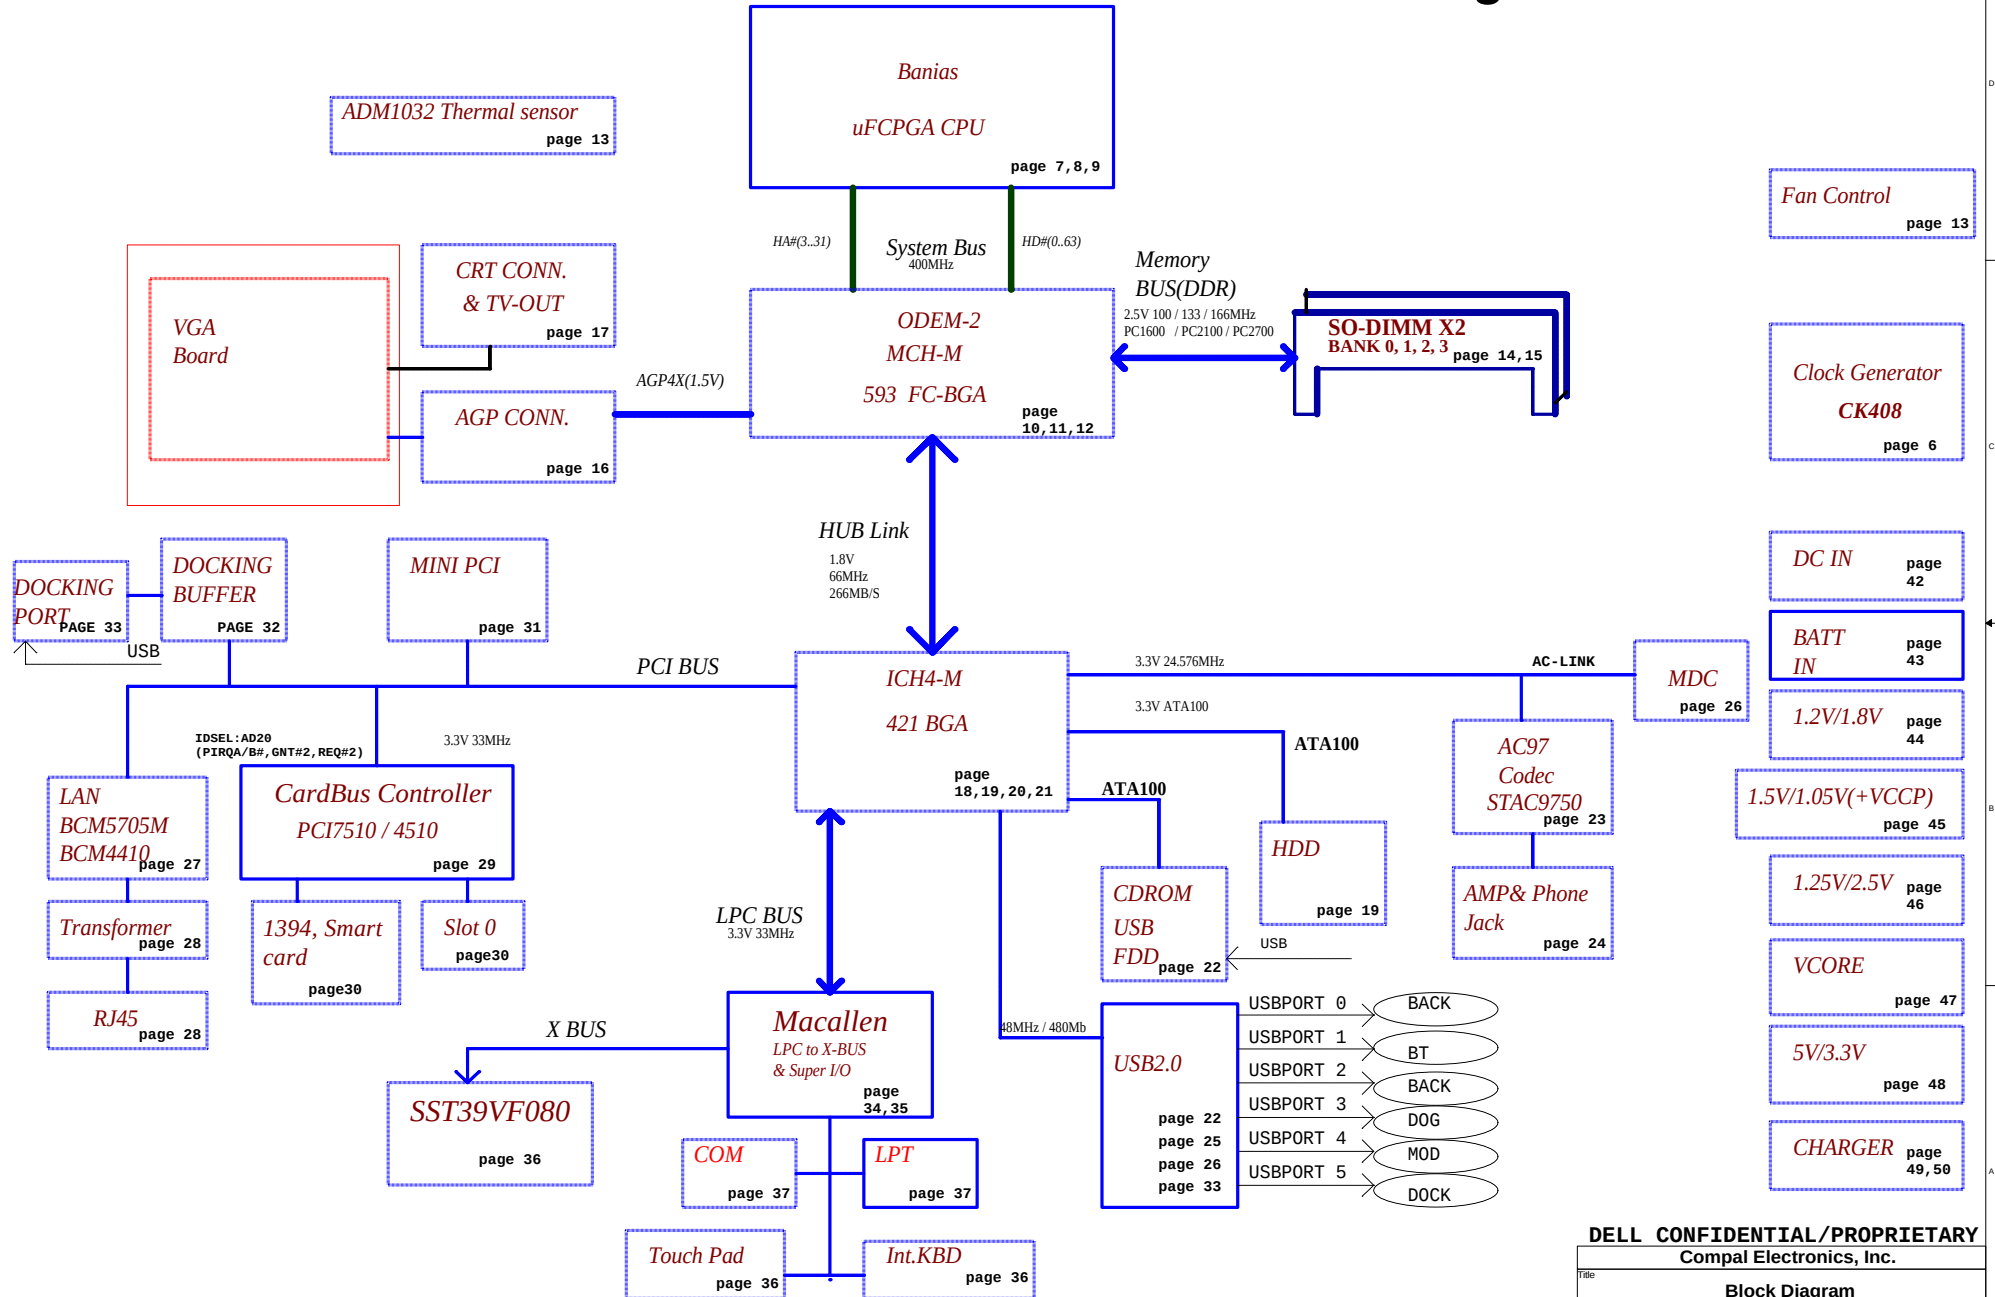
# Block Diagram

PM TABLE

| State \ power plane | +3VALW<br>+5VALW | +3VSUS<br>+5VSUS<br>+2.5V_MEM<br>+1.5VSUS | +5VRUN<br>+3VRUN<br>+1.8VRUN<br>+1.5VRUN<br>+1.2VRUN<br>+VCC_CORE<br>+VCCP<br>+12V |
| S0 | ON | ON | ON |
| S1 | ON | ON | ON |
| S3 | ON | ON | OFF |
| S5 S4/AC | ON | OFF | OFF |
| S5 S4/AC don't exist | OFF | OFF | OFF |

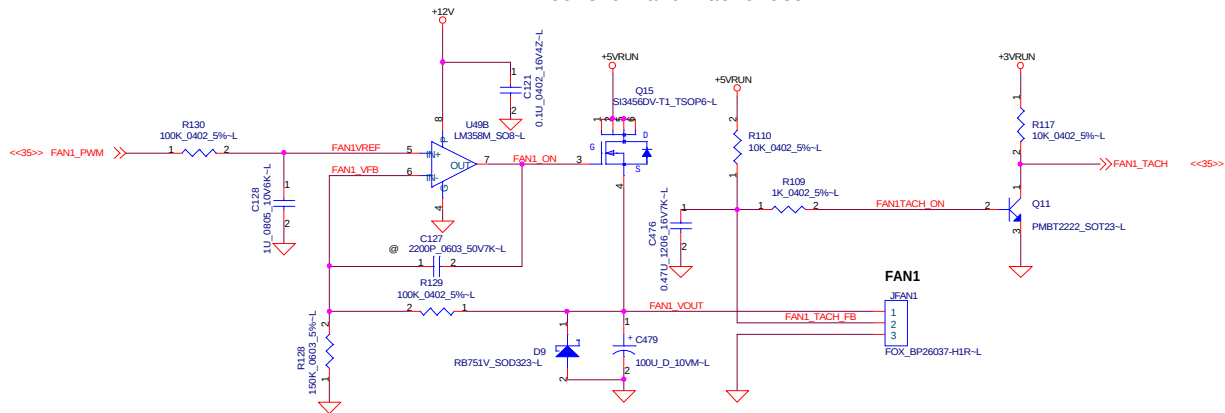
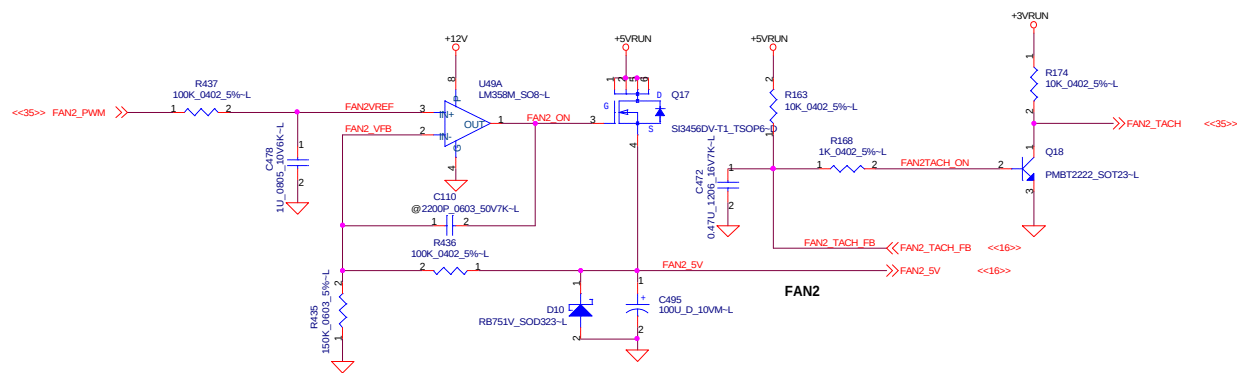
## FAN1 Control and Tachometer

| Title | | ITP Debug CONN. & FAN | |

| Item | Page# | Title | Date | Request Owner | Issue Description | Solution Description | Rev. |
|---|---|---|---|---|---|---|---|
| 30 | 13 | Fan soft<br>start | 10/17/2002 | Compal | No soft start will cause +5VRUN droop low | change C127 and C110 pop(don't do it per Bo's command) | X01 |

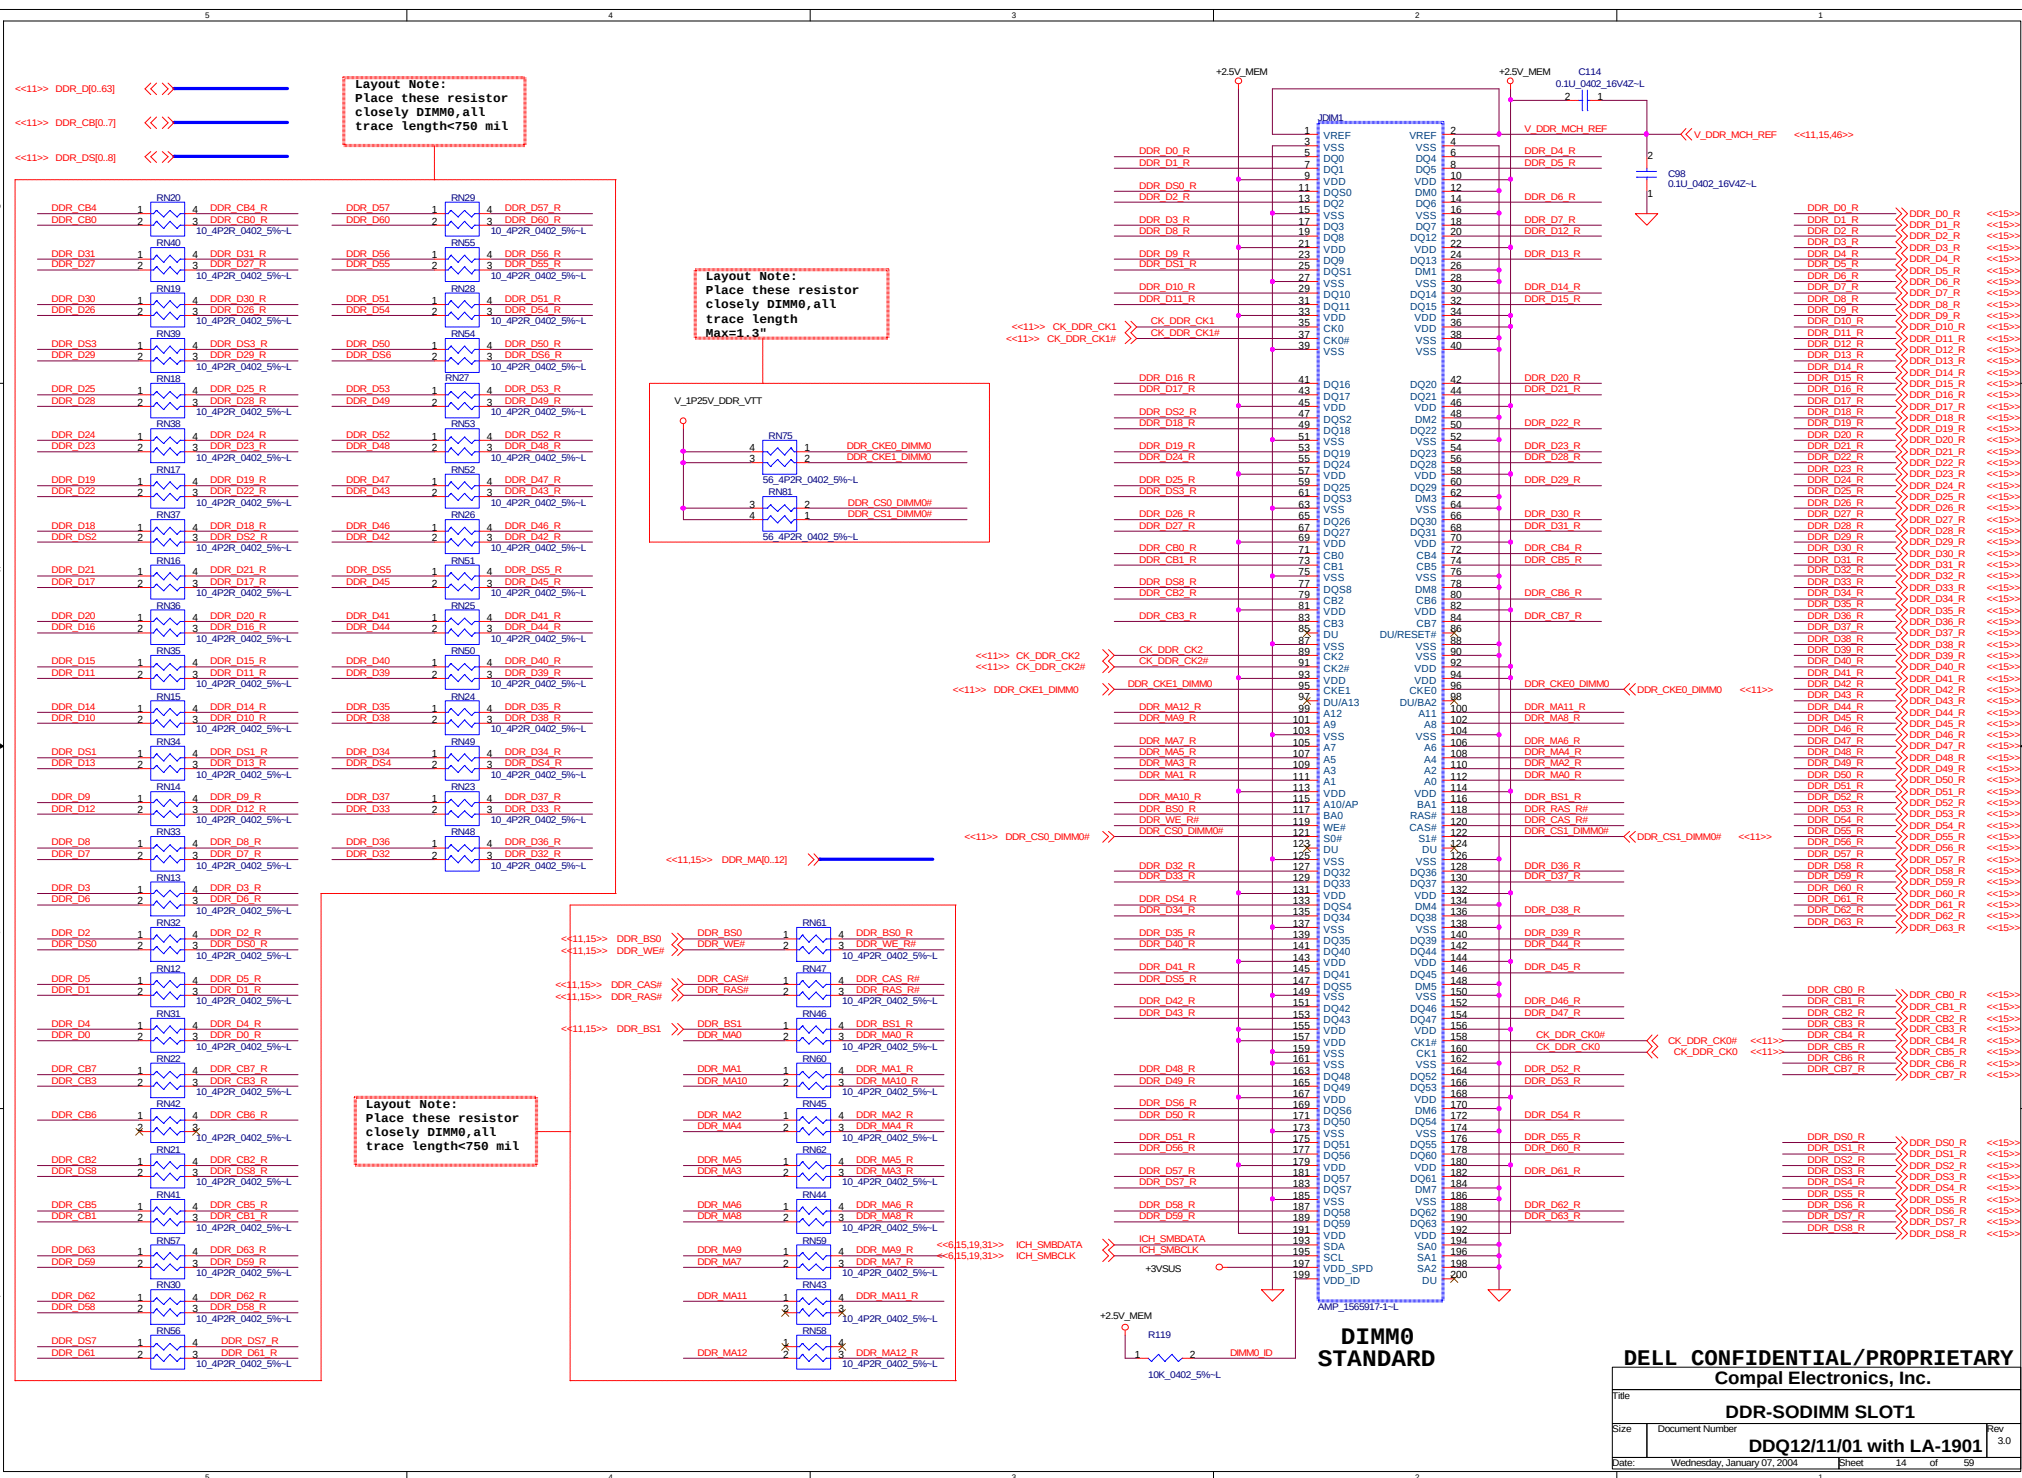
| DDR-SODIMM SLOT1 | | | | |

Layout Note:  
Place these resistor  
closely DIMM0, all  
trace length<750 mil

Layout Note:  
Place these resistor  
closely DIMM0, all  
trace length  
Max=1.3"

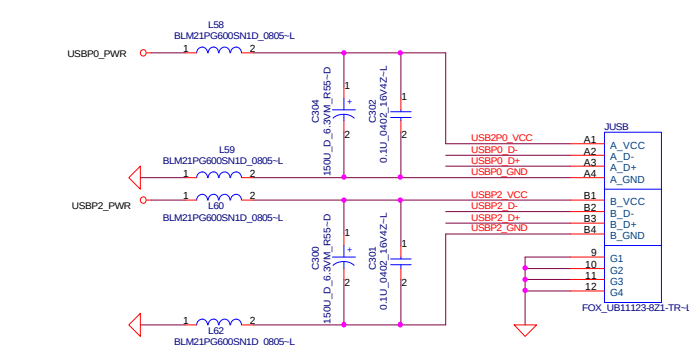
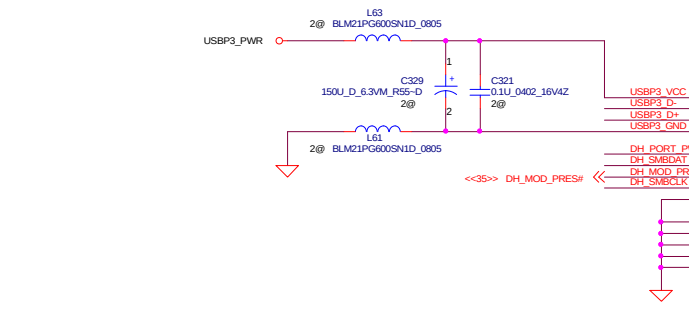
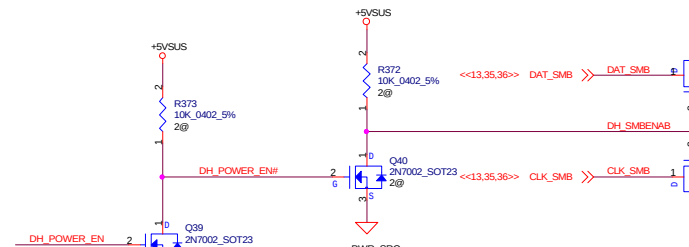
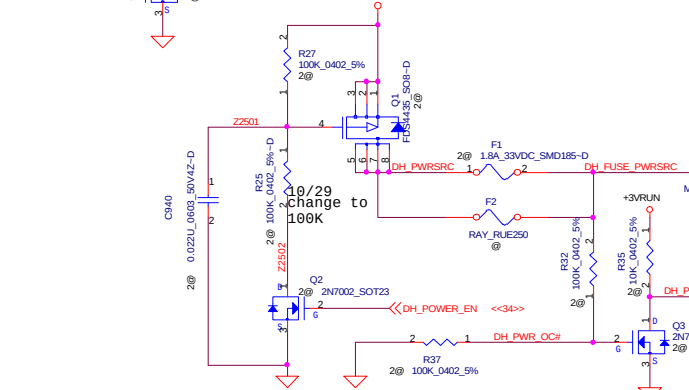
| DELL CONFIDENTIAL/PROPRIETARY | | |
|---|---|---|
| USB 2.0 | | |

| USB PORT# | DESTINATION |
| 0 | BACK |
| 1 | BT |
| 2 | BACK |
| 3 | DOG |
| 4 | MOD |
| 5 | DOCK |

| Item | Page# | Title | Date | Request Owner | Issue Description | Solution Description | Rev. |
|---|---|---|---|---|---|---|---|
| 108 | 25 | USB/DH | 02/11/2003 | Dell | Added TPS2042 to Replace TPS2043 for Lindbergh2 | Added U70 (1@) | X00 |

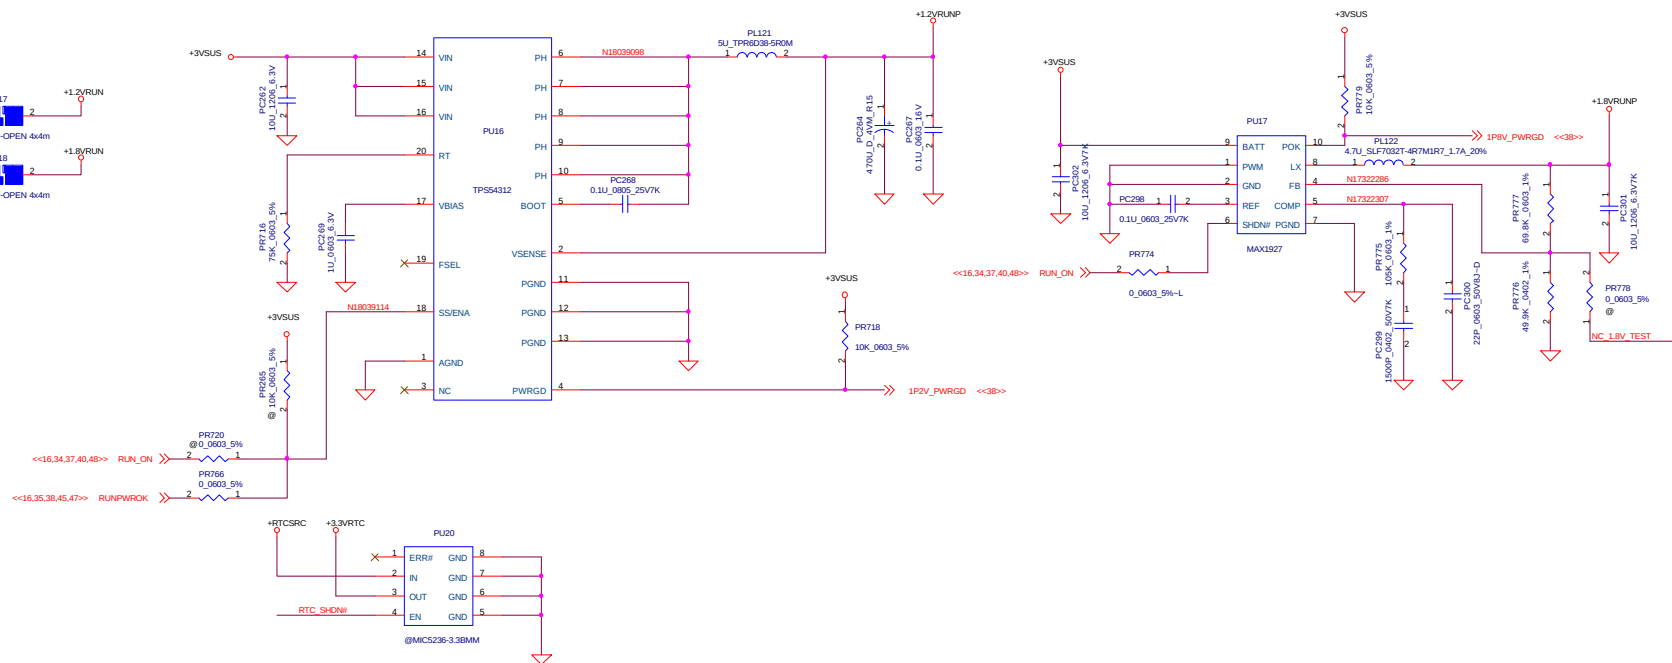
## +1.2VRUN/+1.8VRUN SOURCE

Allows SUS planes to power ALW planes when possible

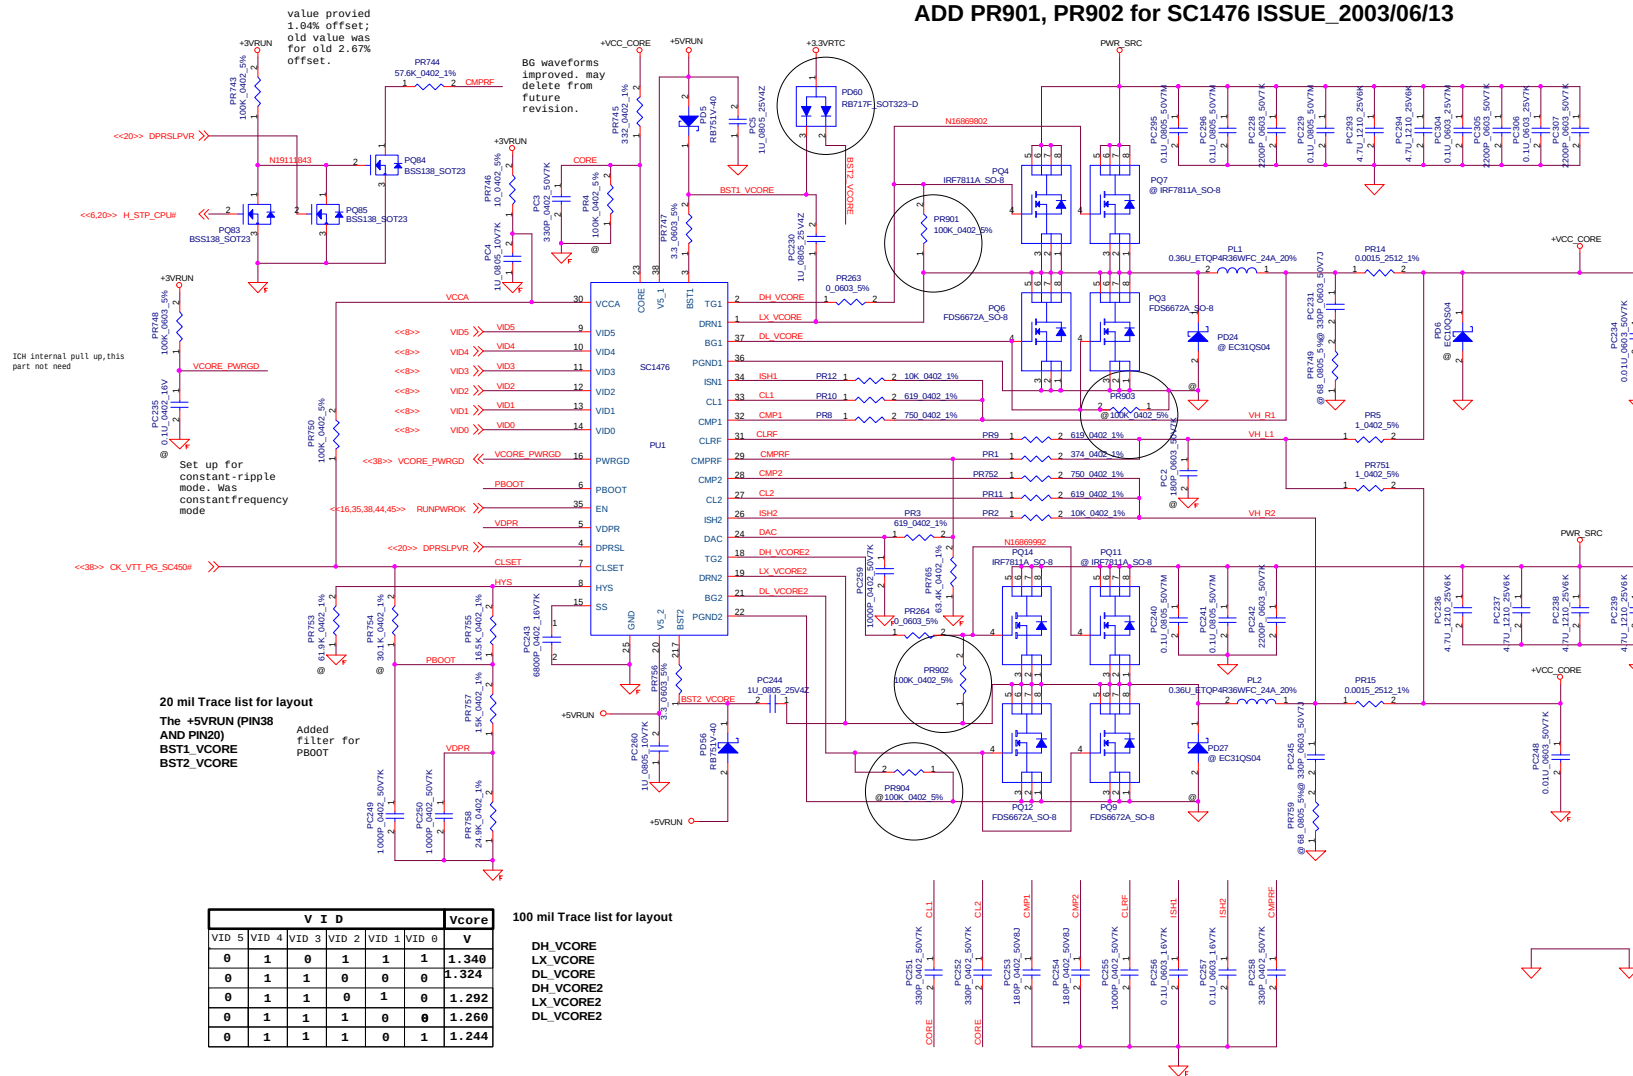
| SCHEM,PLN,MN,KAPALUA II VCC_CORE | | | |

**ADD PR901, PR902 for SC1476 ISSUE\_2003/06/13**

| V I D | | | | | | Vcore |

100 mil Trace list for layout

DH\_VCORE  
LX\_VCORE  
DL\_VCORE  
DH\_VCORE2  
LX\_VCORE2  
DL\_VCORE2
