| MODEL | REV | CHANGE LIST | Model | CT3/5 MB BOARD | |
| CT3/5 MB<br>31CT3MB0015<br>31CT3MB0031 | 1A | PAGE 2 --- Enable CLK48M from clocK generator for the PLL circuit of 7411, and disable the ocsillator circuit of PCI7411 PLL.<br>PAGE 3 --- Remove H/W shutdown circuit that supported ADM1032.<br><br>PAGE 4 --- Use X7R type to replace Y5V type for CPU Decoupling/Bypass capacitor.<br>PAGE 10 --- Add a terminal resistor R706 for -CODE_RST# to improve signal quality.<br>PAGE 11 --- 1. Add a 10K pull-up resistor on MCH_SYNC# for booting.<br>2. Change the power plane of PCIE_WAKE# from 3VSUS to 3V_S5 to solve system can't turn off issue.<br>3. Change the power plane of ICH_THRM# and SCI_# from 3VSUS to +3V to reduce leakage.<br><br>PAGE 12 --- We can also use 5VSUS to instead of 5V_S5 to save cost of MOSFET(A06402).<br>PAGE 15 --- Add a level-shift cicuit for EDID interface.<br>PAGE 17 --- 1. Add a off-page and a EMI solution for CLK48M.<br>2. Remove the reserve resistors (R693~R695) of parallel interface for PCI1510.<br><br>PAGE 18 --- Remove R696, connect controller and power switch directly .<br>PAGE 19 --- Change R682&R683 value from 56 ohms to 0 ohm cause of BOM error at A-test.<

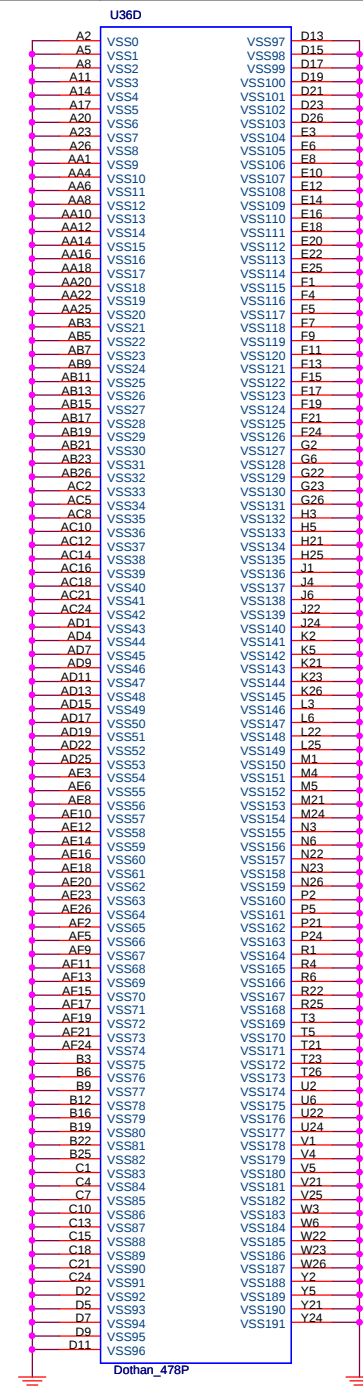
## CPU de-coupling capacitor

**SI stage:**  
Use X7R type to replace Y5V type for Decoupling/Bypass capacitor.

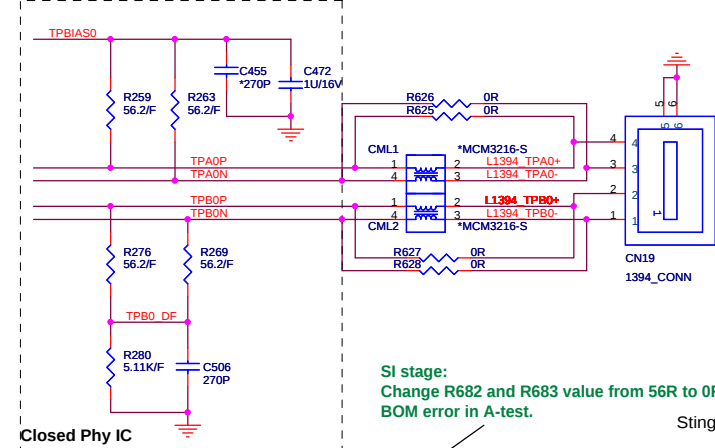
## IEEE 1394 CONNECTOR

SI stage:  
Change R682 and R683 value from 56R to 0R cause of  
BOM error in A-test.

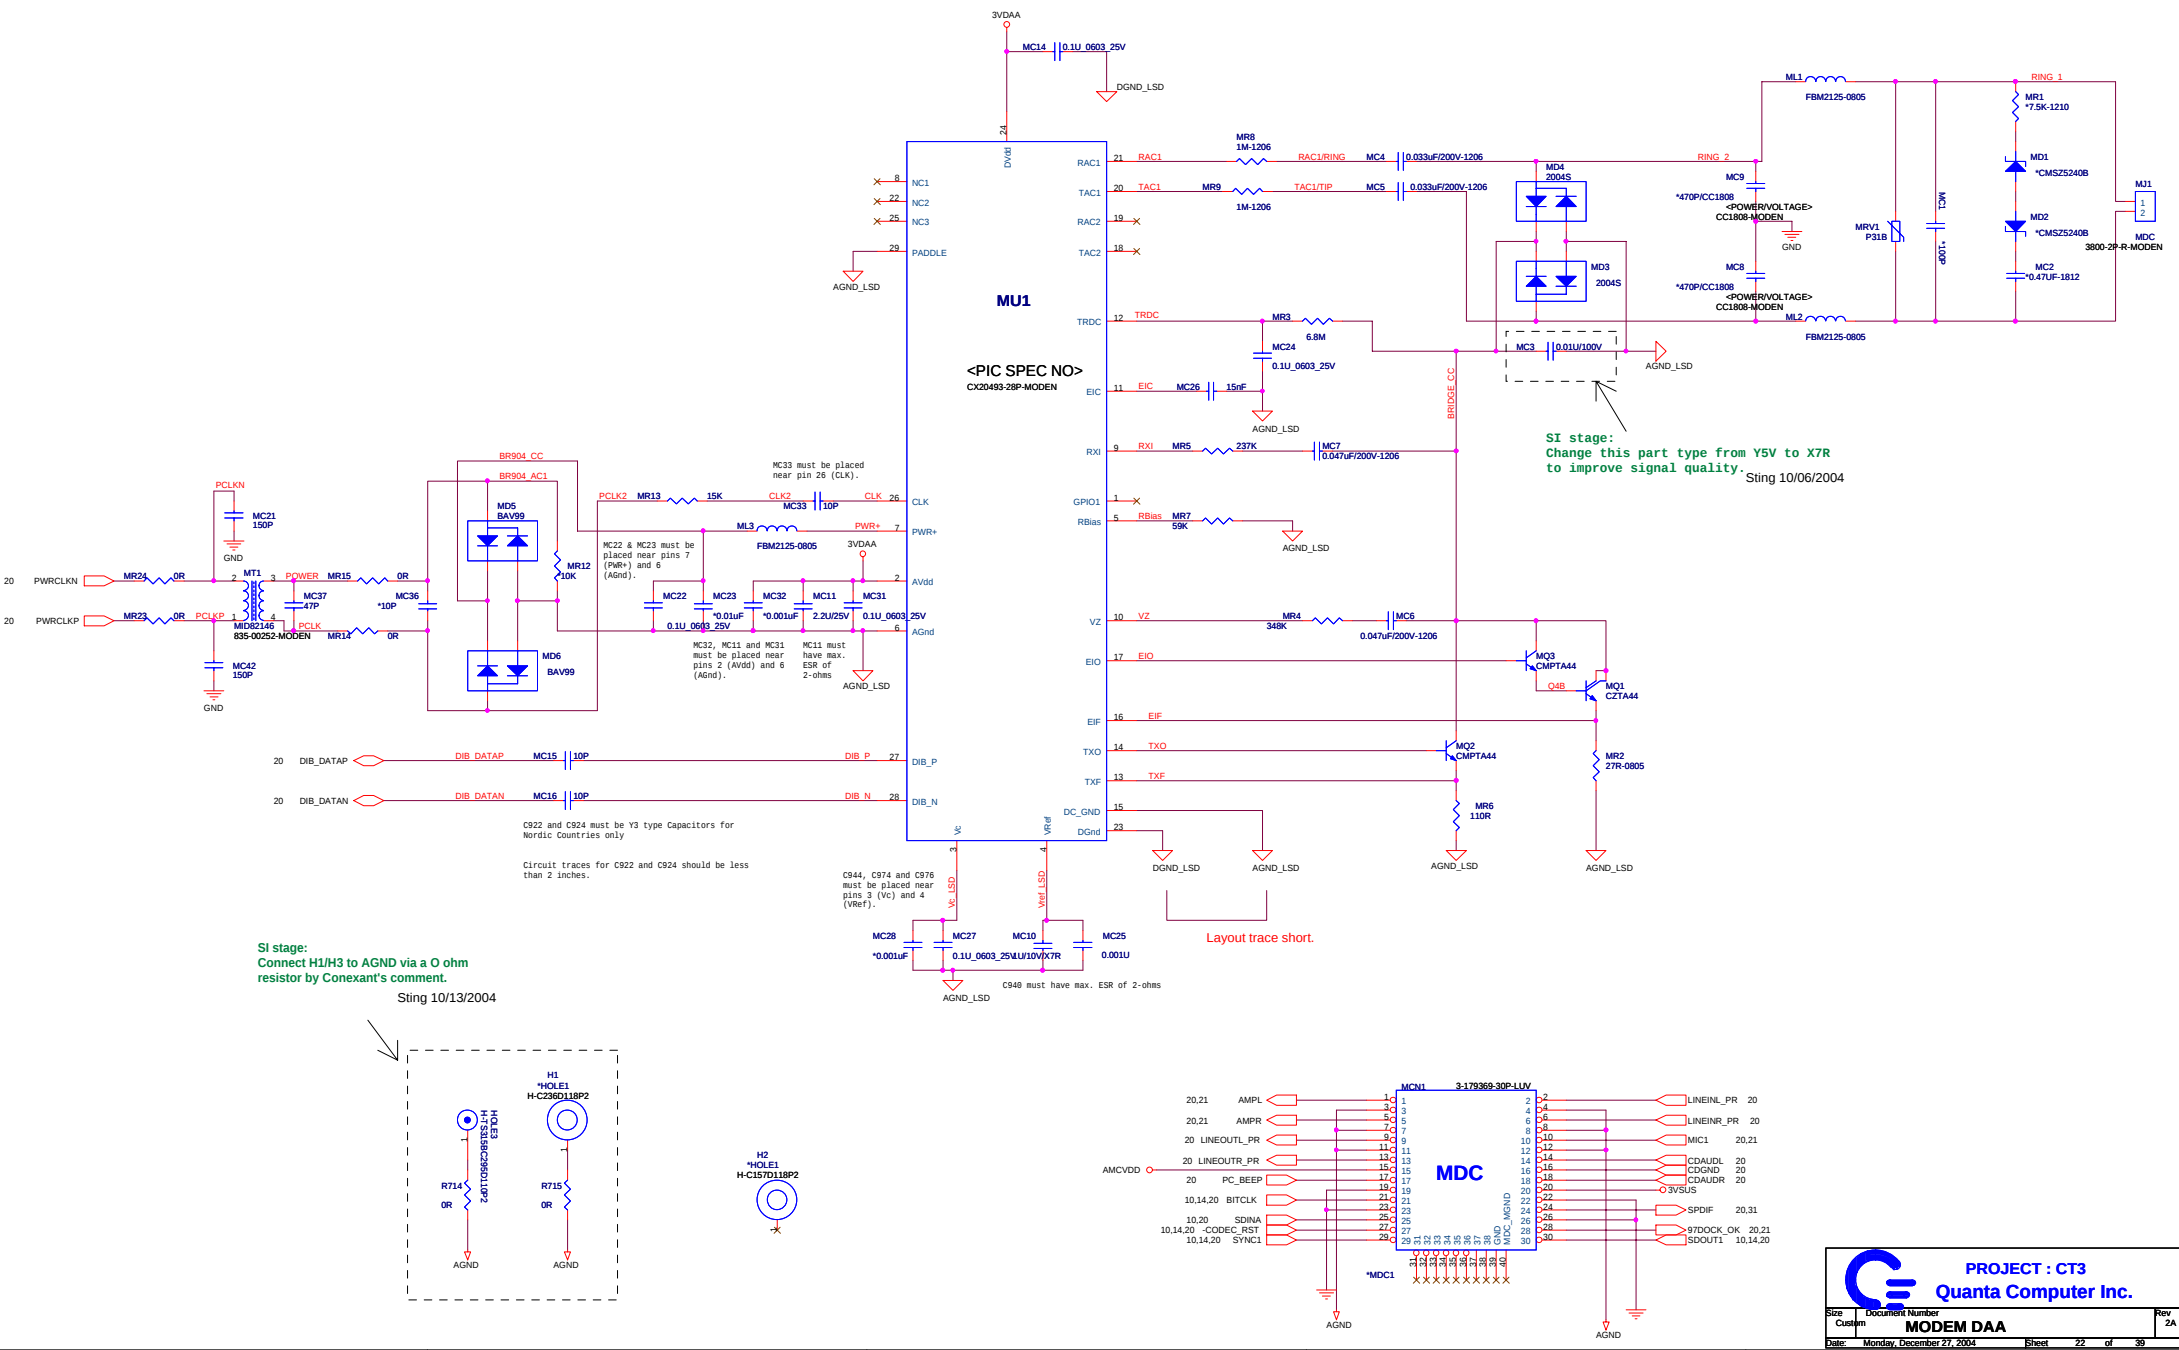
SI stage:  
Connect H1/H3 to AGND via a 0 ohm resistor by Conexant's comment.  
Sting 10/13/2004

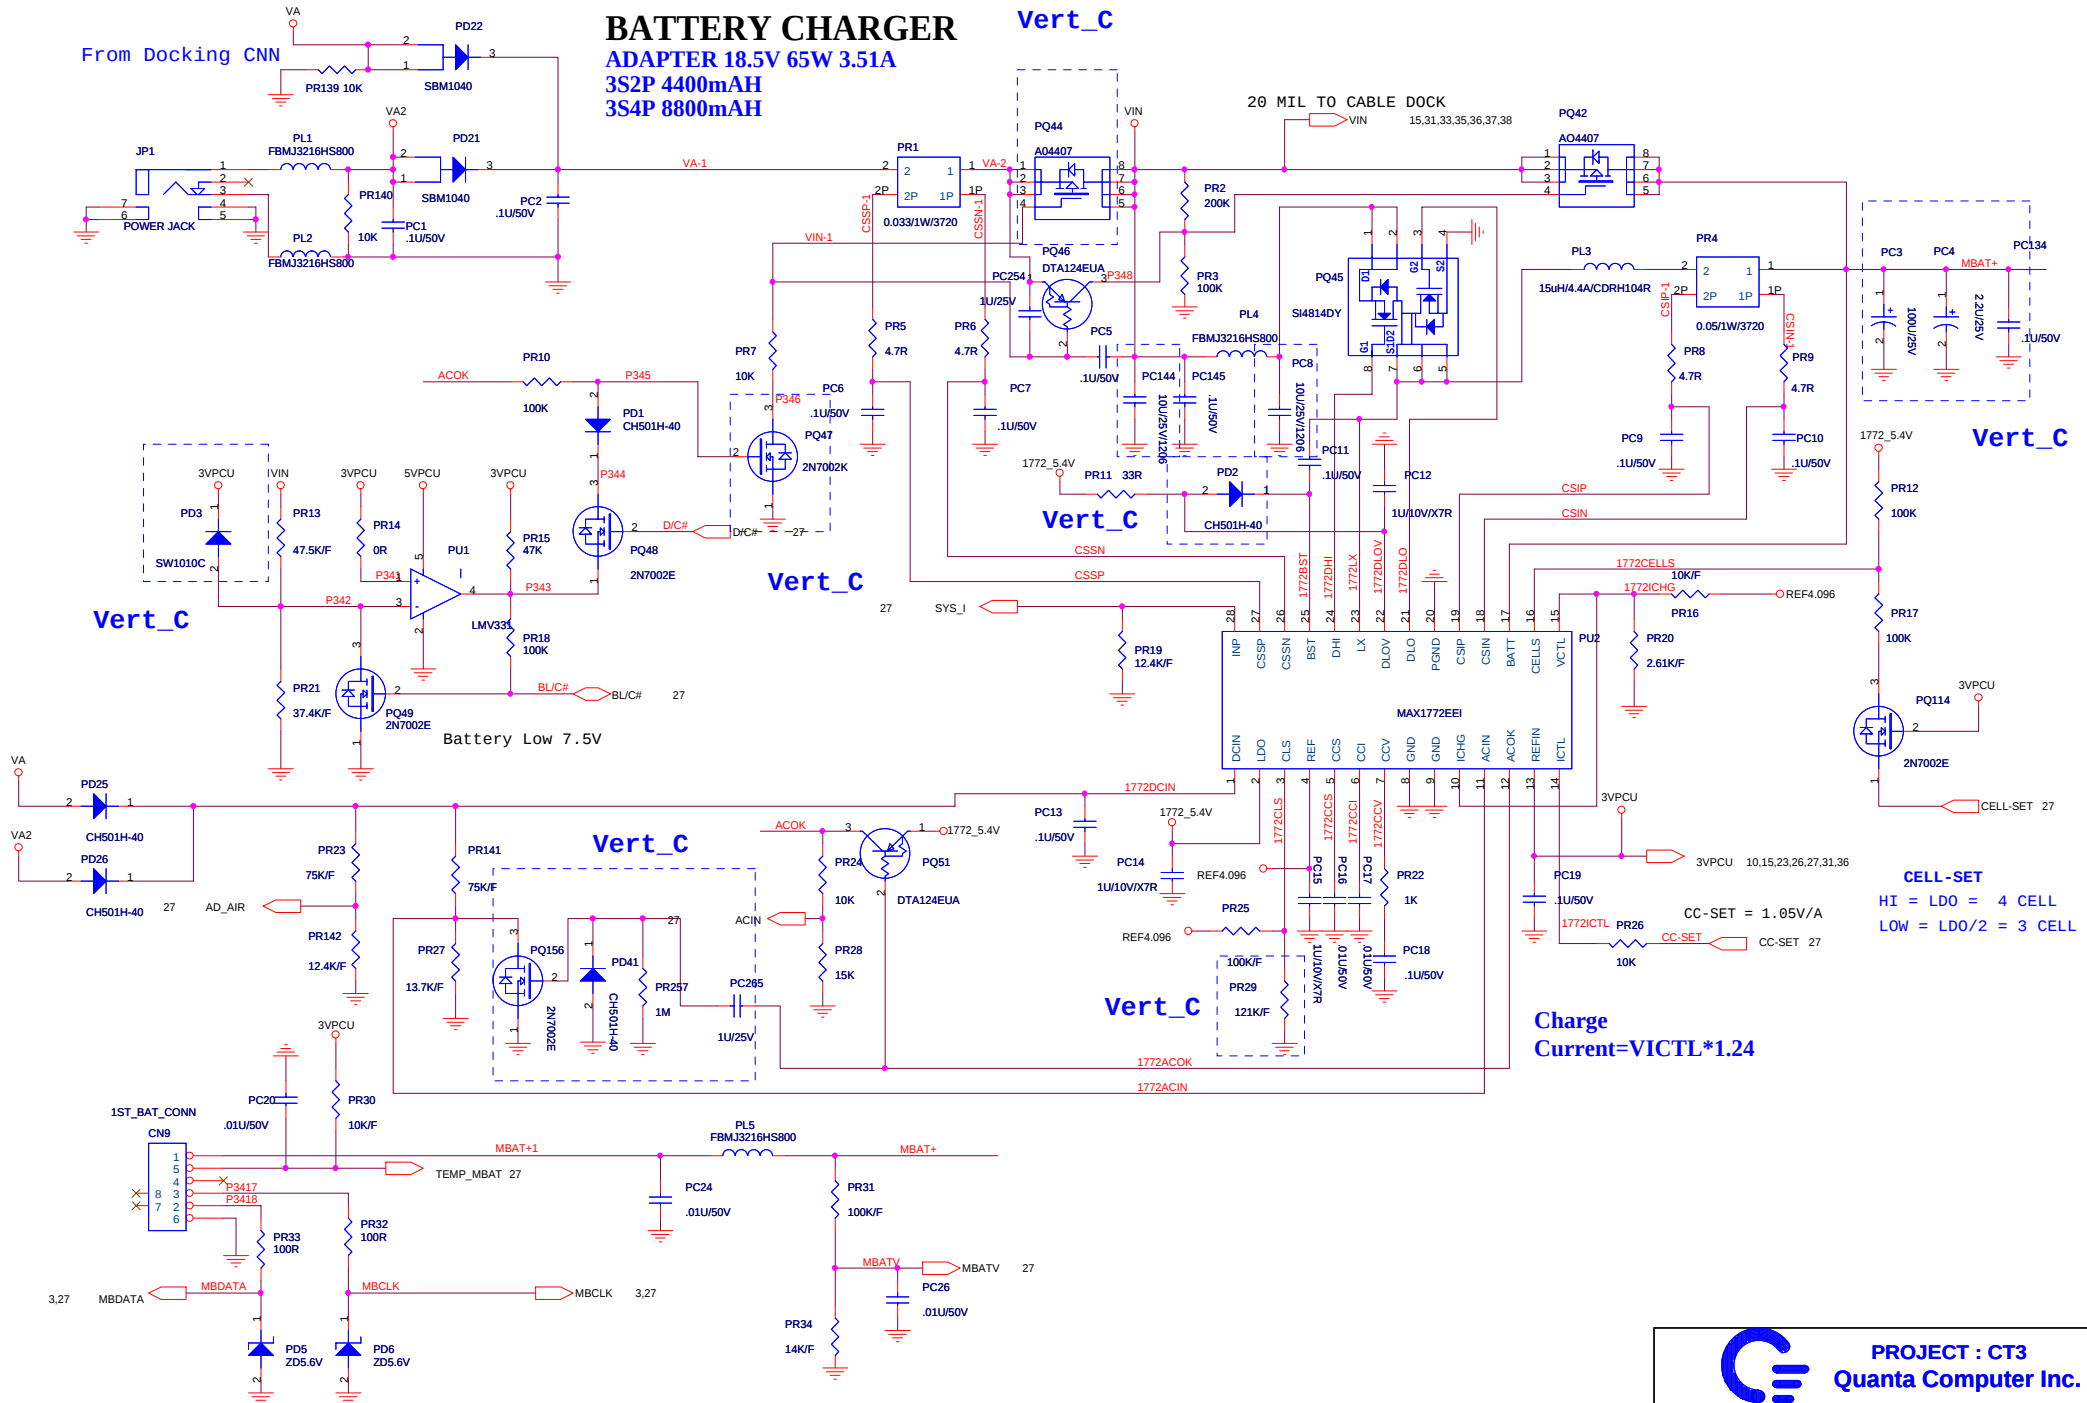
# BATTERY CHARGER

ADAPTER 18.5V 65W 3.51A  
3S2P 4400mAh  
3S4P 8800mAh

Charge  
Current=VICTL\*1.24

CELL-SET  
HI = LDO = 4 CELL  
LOW = LDO/2 = 3 CELL
