PROJECT : ZU2  
Quanta Computer Inc.

| | Yonah/Merom CPU(POWER/GND)-2 | 1A |

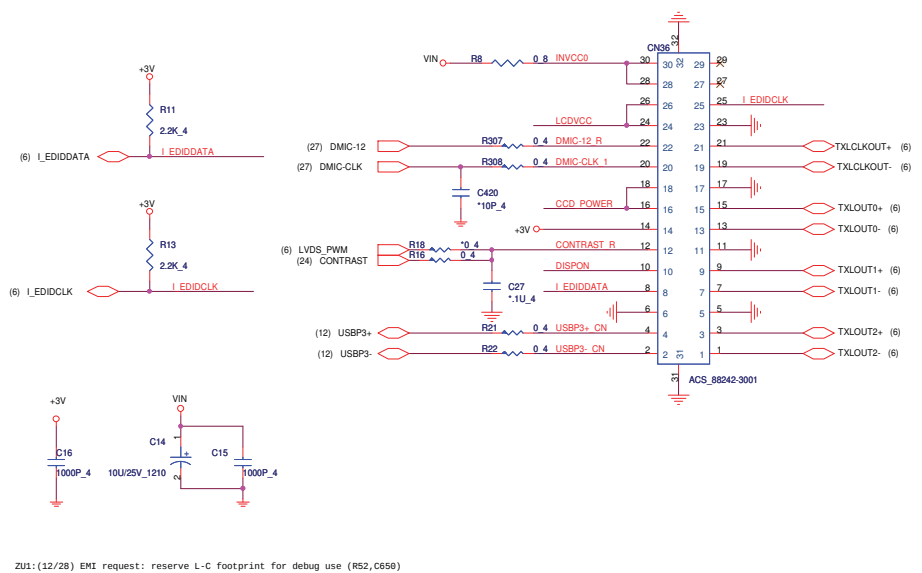
LVDS

(3/19)Change MB LCD connector pin define(CN3) and LCD cable pin define to cover production line issue  
(Inverter short with signal to burn system)->ZR1 issue  
(1)pin 27,29->NC  
(2)pin 8->INT\_LVDS\_EDIDDATA

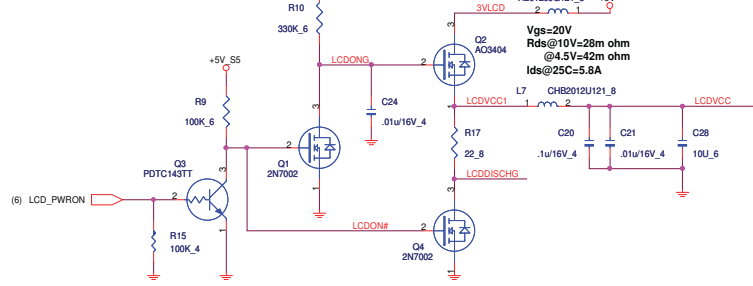
LCD Power

1/29:By Alan: AAT4280 fail on power ON rising time and falling time. EA.Additionally, some LCD panels will have garbage. follow ZR1 circuit.

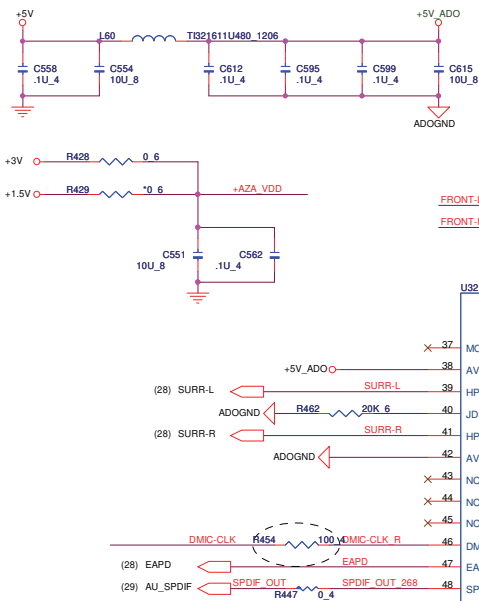
## CODEC (ALC268)

EMI suggest:  
Add Additional two more bridge resistor  
between ADDGND and GND,stuff R330 for Int-SPK issue

Tied at one point only  
under the codec or  
near the codec

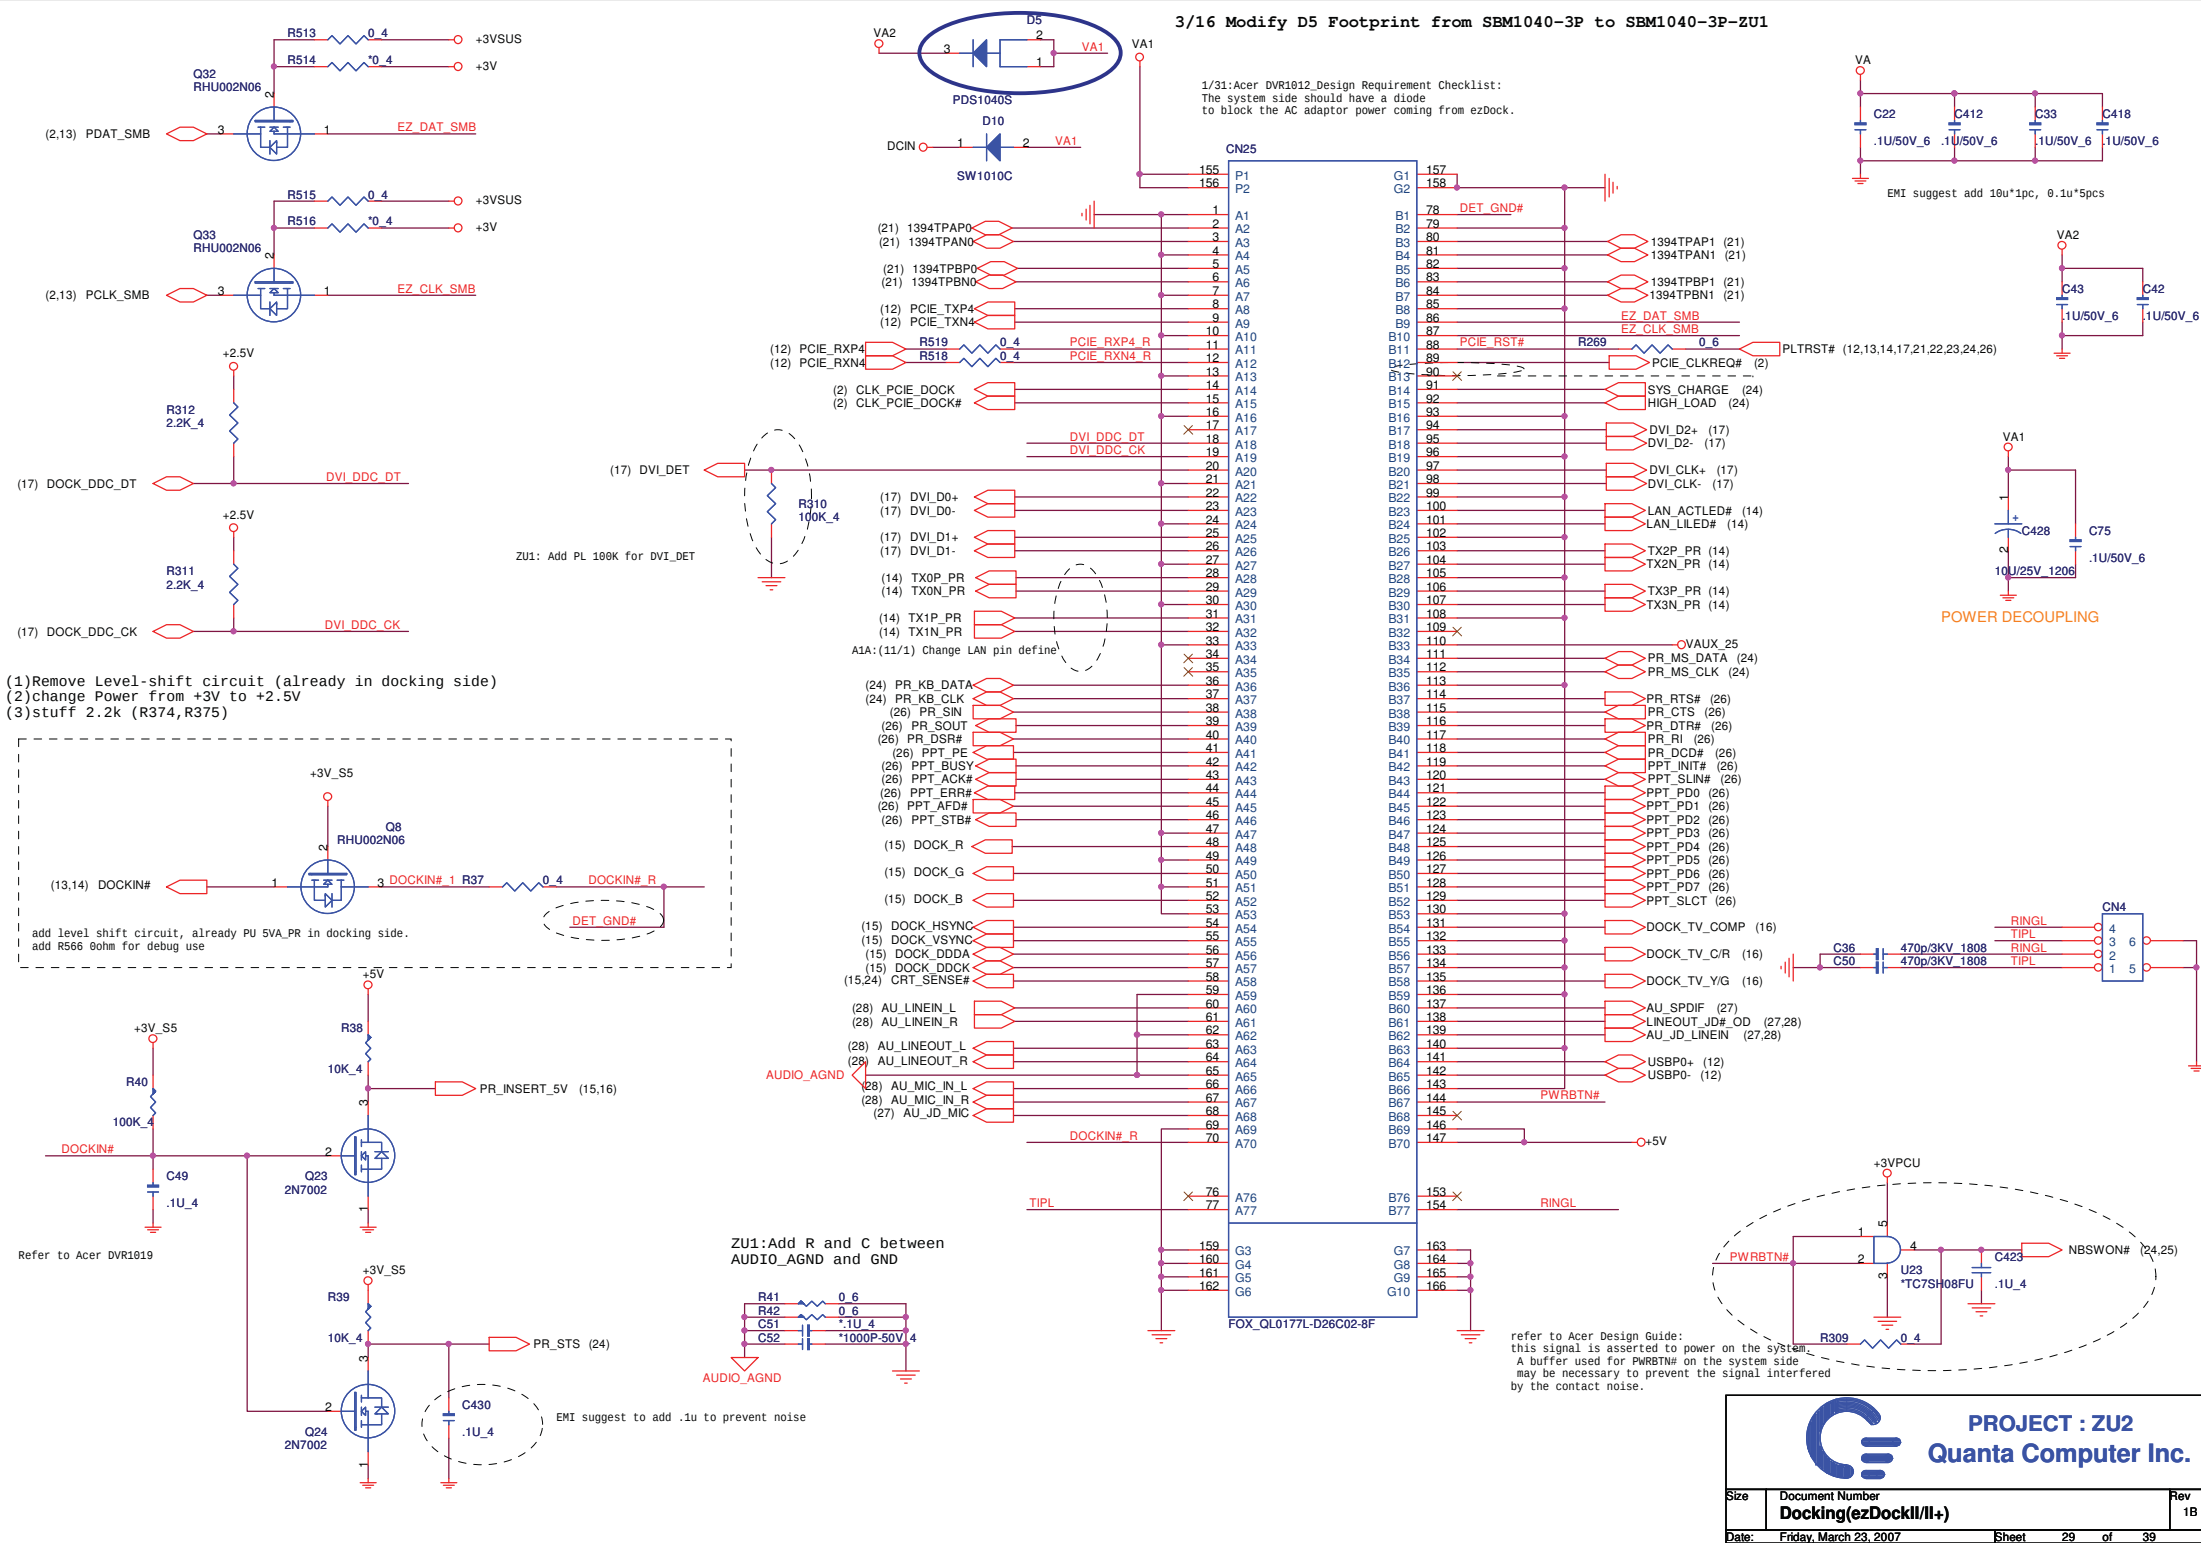
3/16 Modify D5 Footprint from SBM1040-3P to SBM1040-3P-ZU1

1/31: Acer DVR1012 Design Requirement Checklist:  
The system side should have a diode to block the AC adaptor power coming from ezDock.

EMI suggest add 10u\*1pc, 0.1u\*5pcs

refer to Acer Design Guide:  
this signal is asserted to power on the system.  
A buffer used for PWRBTN# on the system side  
may be necessary to prevent the signal interfered  
by the contact noise.

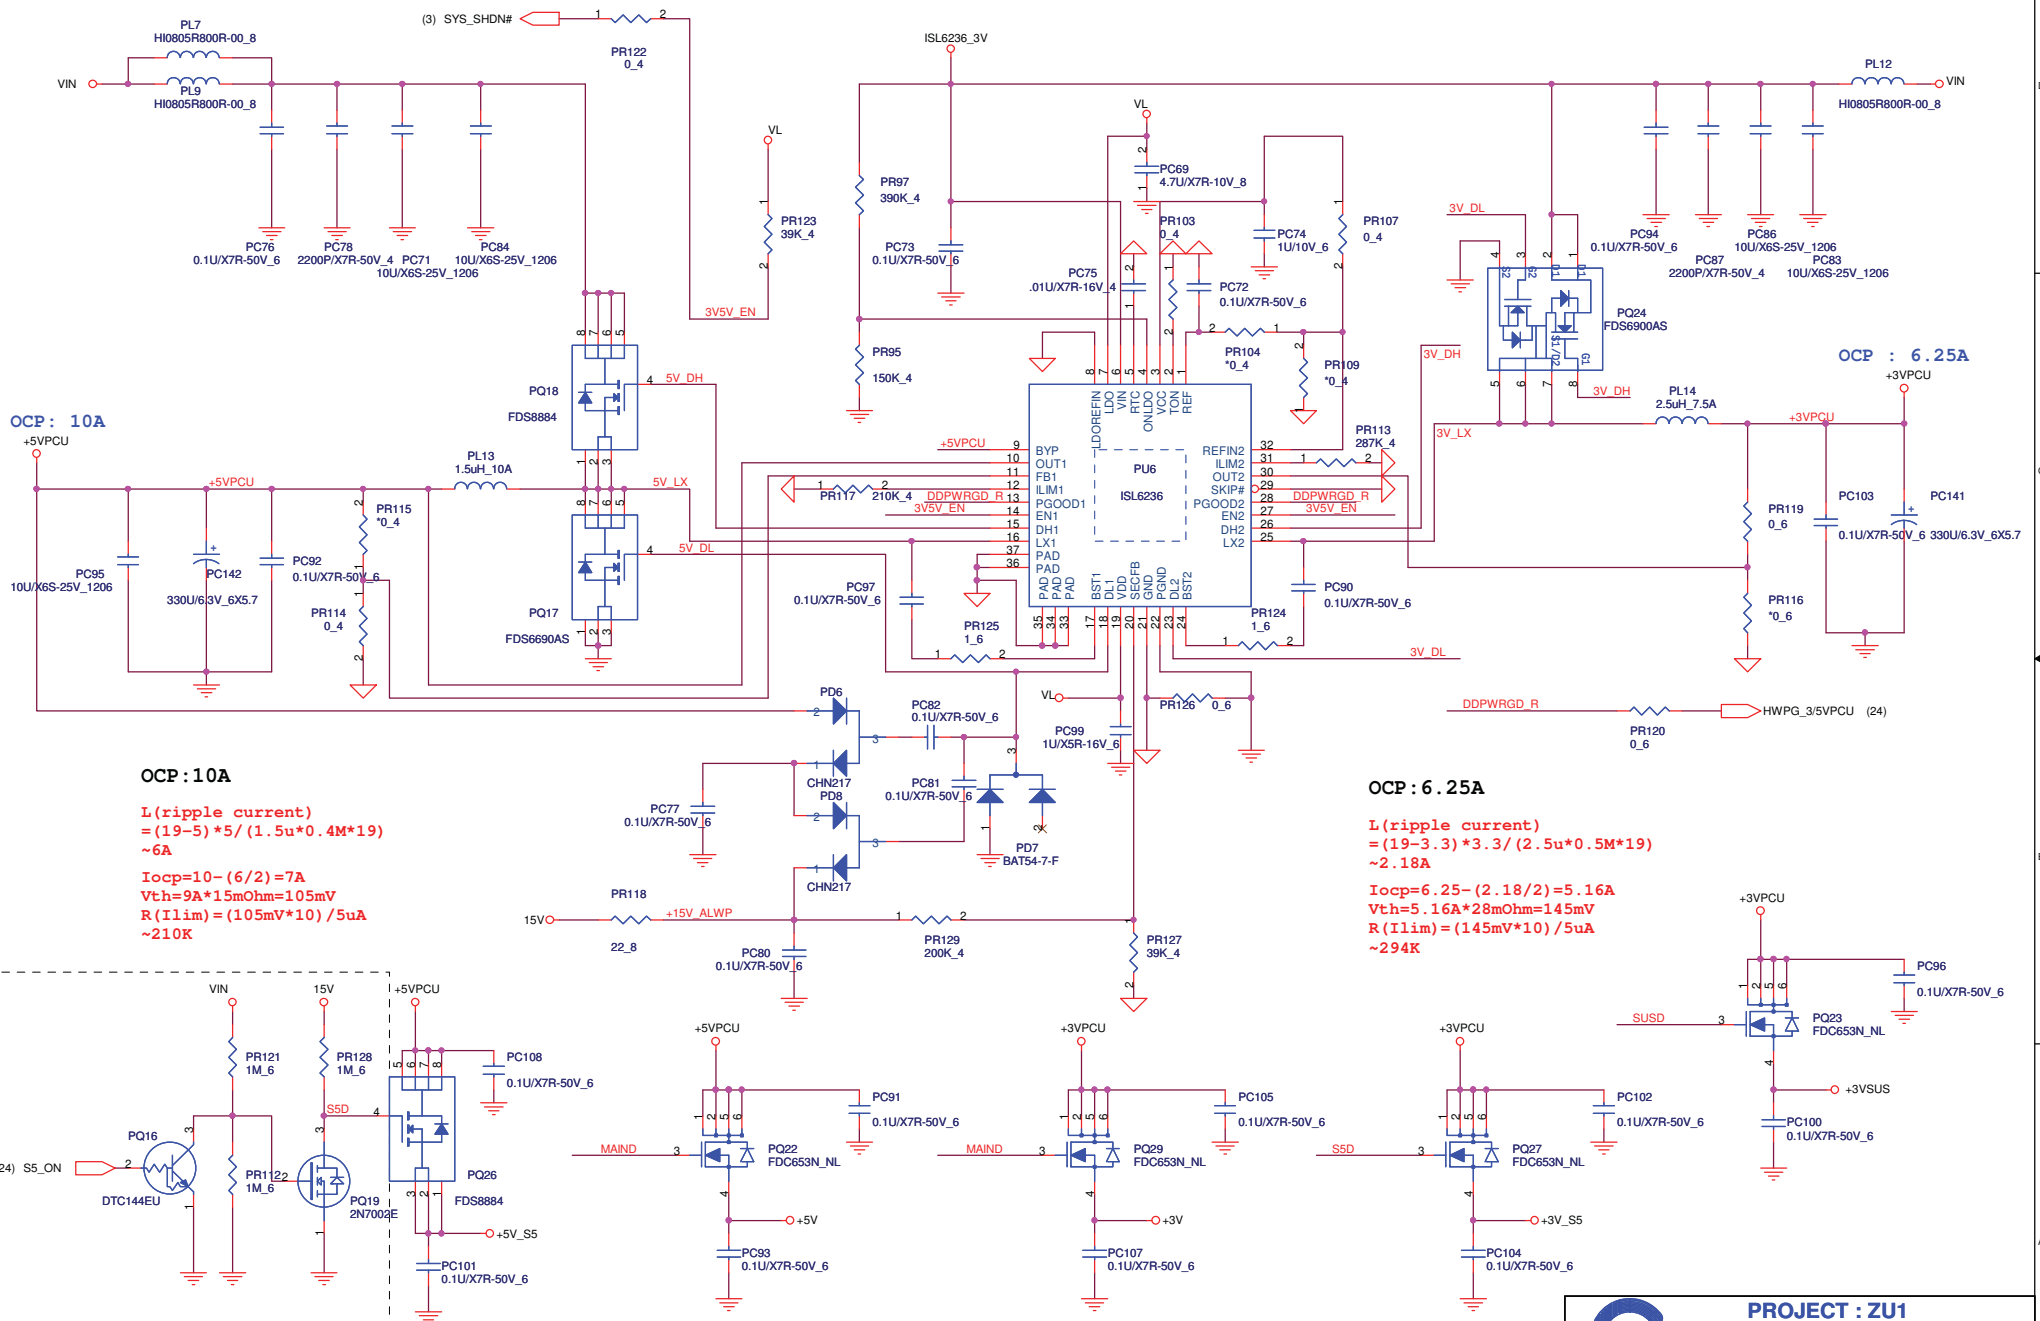
C2A: (12/18) change S5\_On control circuit

B1C: (11/29) change P26 from FDS6690AS (BAM6690022) to FDS8884 (BAM8884006)
