# Model : P75/55IMx

Intel Merom CPU + PM965 + ICH8-M Chipset  
Santa Rosa plantfrom (No supported AMT)

# P75/55IMx SYSTEM BLOCK DIAGRAM

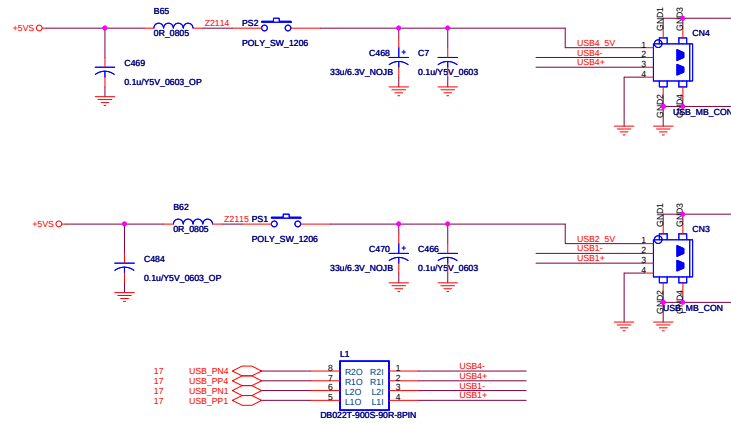
## USB PORT CONN

USB CONN change from 3 ports to 2 ports @ REVA2  
One USB ports w/I charger remove to daughter board and add eSATA port@ REVA2

| Symbol | What change | Page | Why change | Note |
|---|---|---|---|---|
| Modify 27 | L14 from FRC1394 change to ATCM3216 and Add L20 | 21 | CN5 and CN11(USB) split, cause of ME change location | |
